MONITORING REPORT Contract # 210-2042 Tenmile Lakes Fish Passage

Produced by: TLBP May 2012

SHUTTER CR BRIDGE #6

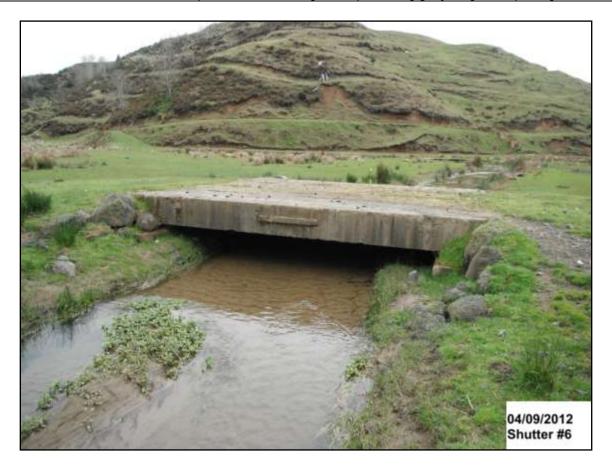
| Summary: Fish Passage and Sediment Abatement Site Conditions | | | | |
|--|---|---|---|--|
| Armoring and fill condition. | Excellent | Excellent | Good | |
| Maintenance records/ <u>dates</u> . | Cracks in bridge | No Maintenance | This project is | |
| Bridge observations. | caused during | Needed. Site is | currently meeting | |
| Goal Observations. | installationRepaired | meeting project goals | our goals. | |

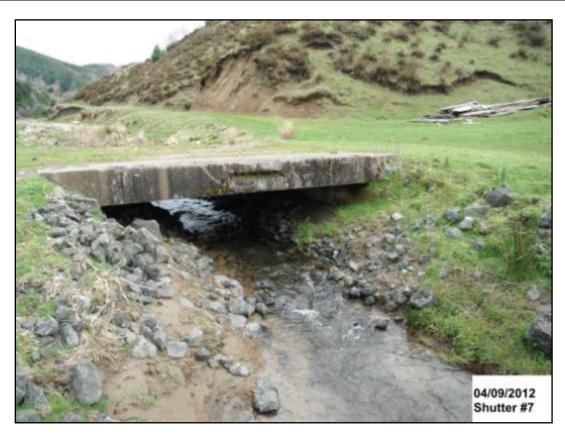
SHUTTER CR BRIDGE #7

| Fish Passage and Sediment Abatement Site Conditions | | | | |
|---|---|---|---|--|
| Armoring and fill | Excellent | Fair/Poor | Fair/Poor | |
| Maintenance | Cracks in bridge | Armoring has eroded | Armoring has eroded | |
| records/ <u>dates</u> . | caused during | from downstream | from downstream side | |
| Bridge observations. | installationRepaired | side of bridge. | of bridge. Project is | |

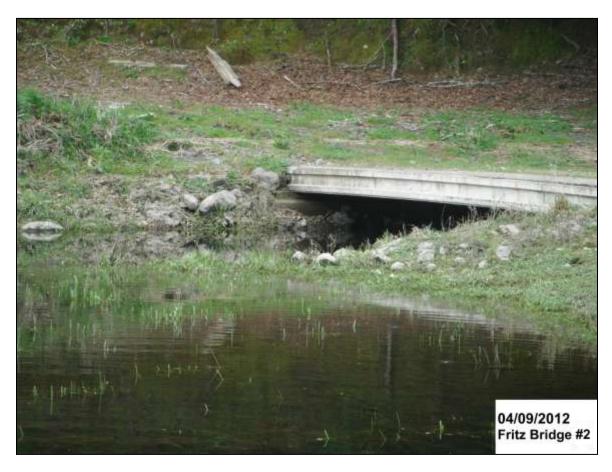
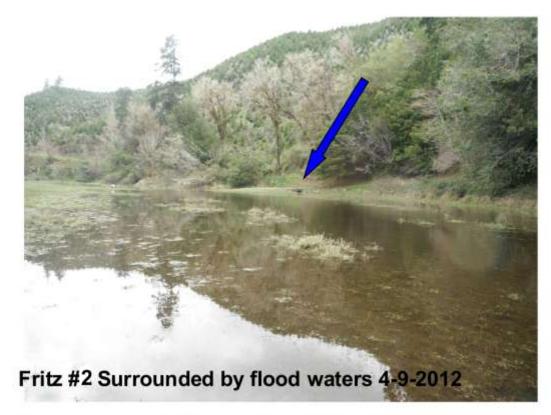
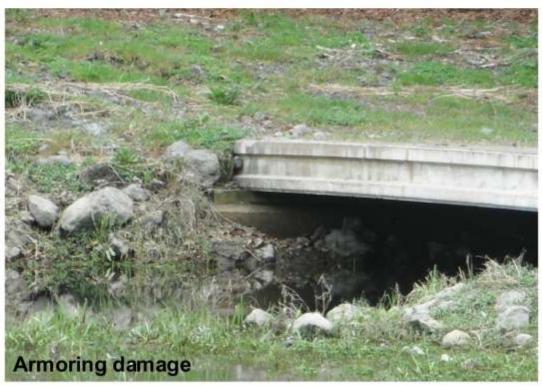
FRITZ BRIDGE #2

| Fish Passage and Sediment Abatement Site Conditions | | | | |
|---|---|---|---|--|
| Armoring and fill condition. | Excellent | Excellent | Good | |
| Maintenance records/ <u>dates</u> . | No maintenance is | No maintenance is | Some armoring | |
| Bridge observations. | needed at this time. | needed at this time. | missing from | |
| Goal Observations. | Project is currently | Project is currently | downstream side. | |

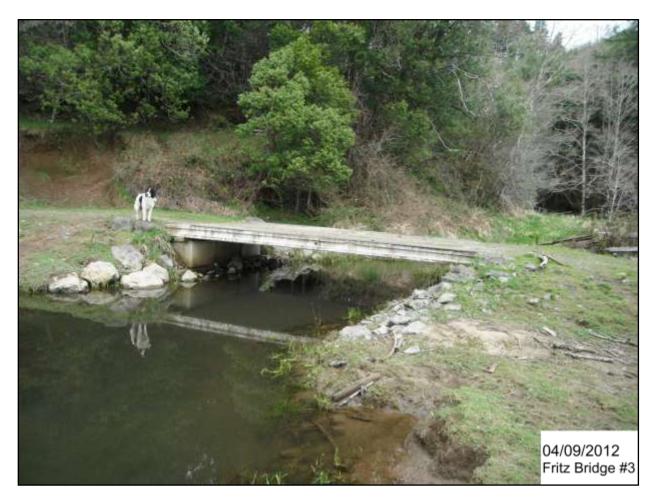
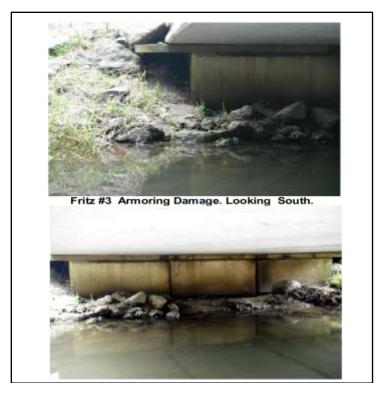
FRITZ BRIDGE #3

| Fish Passage and Sediment Abatement Site Conditions | | | | |
|---|--|---|---|--|
| Armoring and fill condition. | Excellent | Excellent | Fair/Good | |
| Maintenance records/ <u>dates</u> . Bridge observations. Goal Observations. | No maintenance is needed at this time. Project is currently meeting our goals. | Site is currently meeting project goals | South side armoring could be reinforced. Site is currently meeting project goals. | |

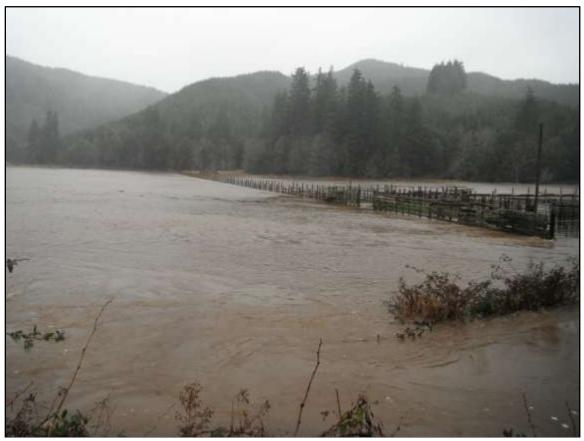
Fritz Bridge #3 is on the far side of this field. (Jan 19, 2012) Severe flooding stresses bridges in this area, but the bridge held up well.

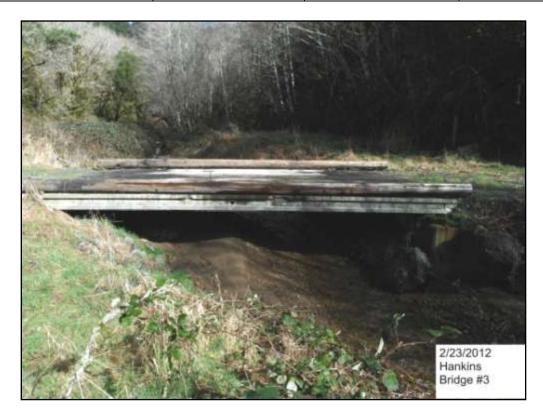
HANKINS BRIDGE #3

| Fish Passage and Sediment Abatement Site Conditions | | | | |
|---|---|---|---|--|
| Armoring and fill condition. | Excellent | Excellent | Good – Some | |
| | | | armoring missing | |

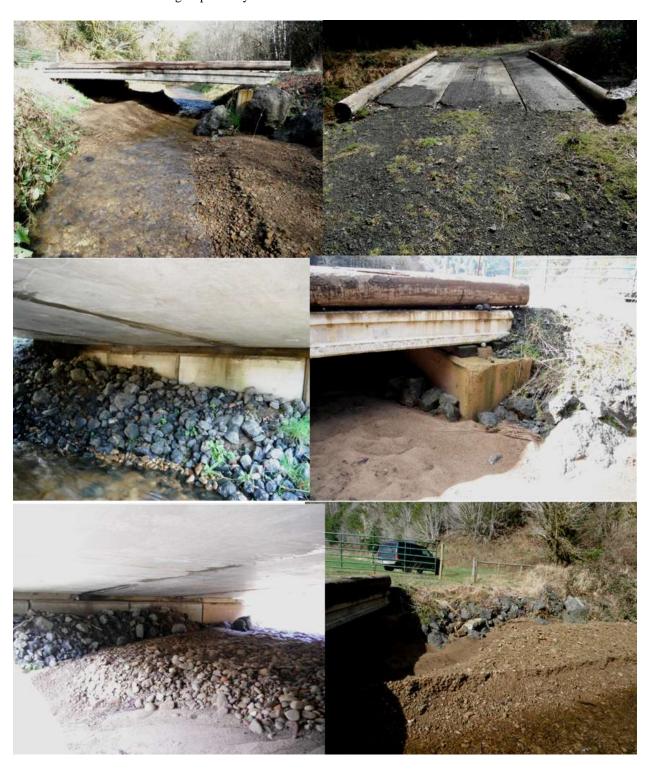
Hankins Bridge #3 2/23/2012

| Fish Passage and Sediment Abatement Site Conditions | | | | |
|---|---|---|---|--|
| Maintenance records/ <u>dates</u> . | Approach is a little | Gravel was added to | Excellent | |
| Bridge observations. | rough. | improve approaches, | spawning gravel | |
