# Tenmile Lakes Basin Partnership

## 2006 Project Presentation

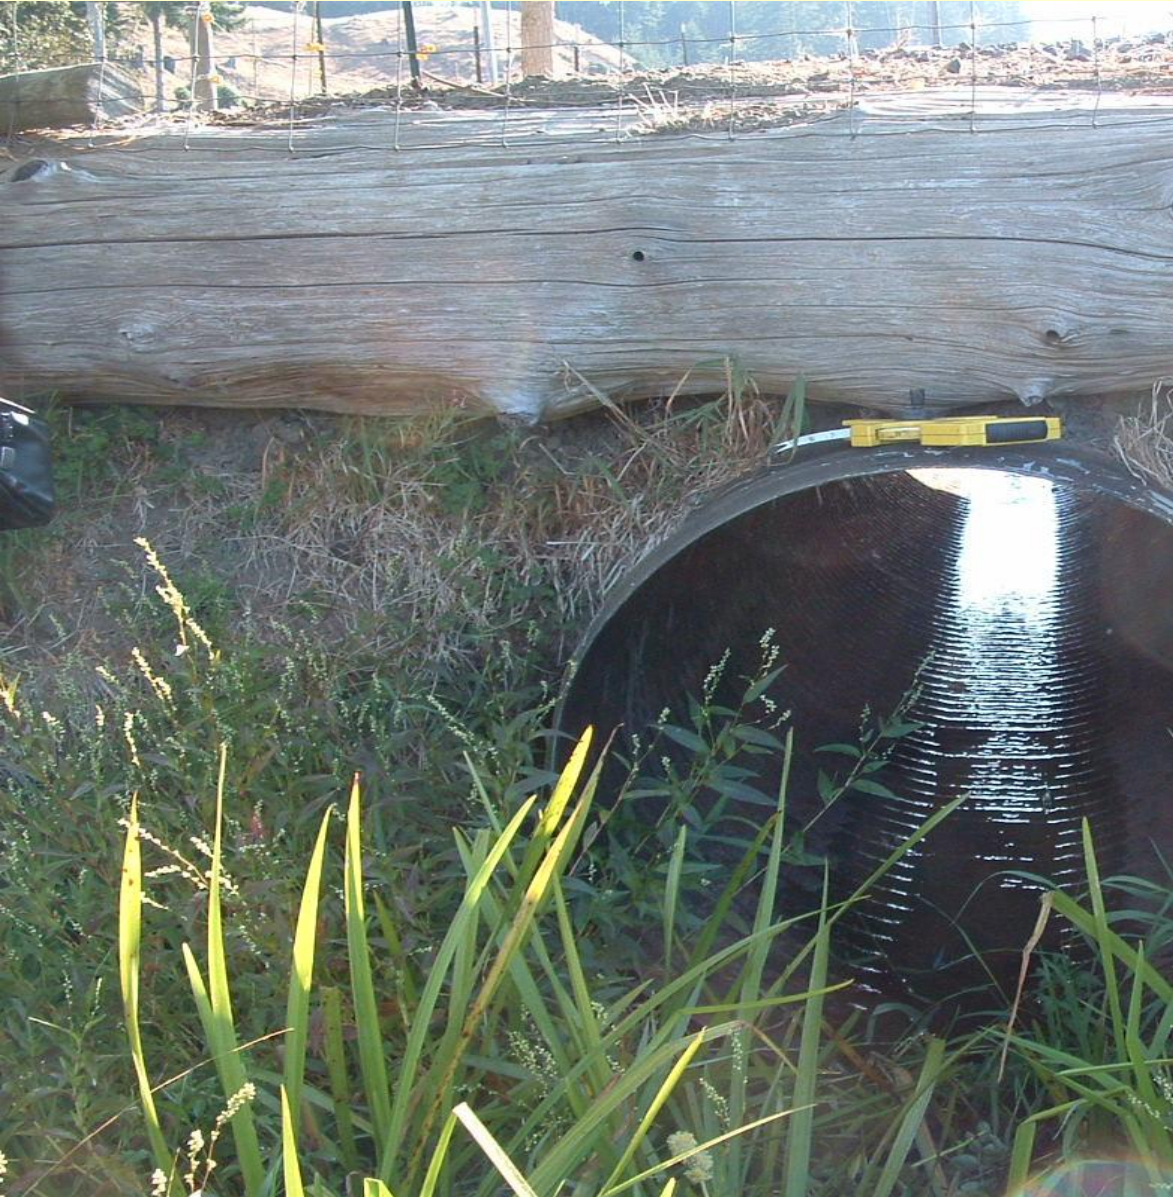
# Freelund Bridge #1

### **PROBLEM:**

Undersized and failing culvert.

Improperly placed.

Creating sediment loading and restriction of fish passage

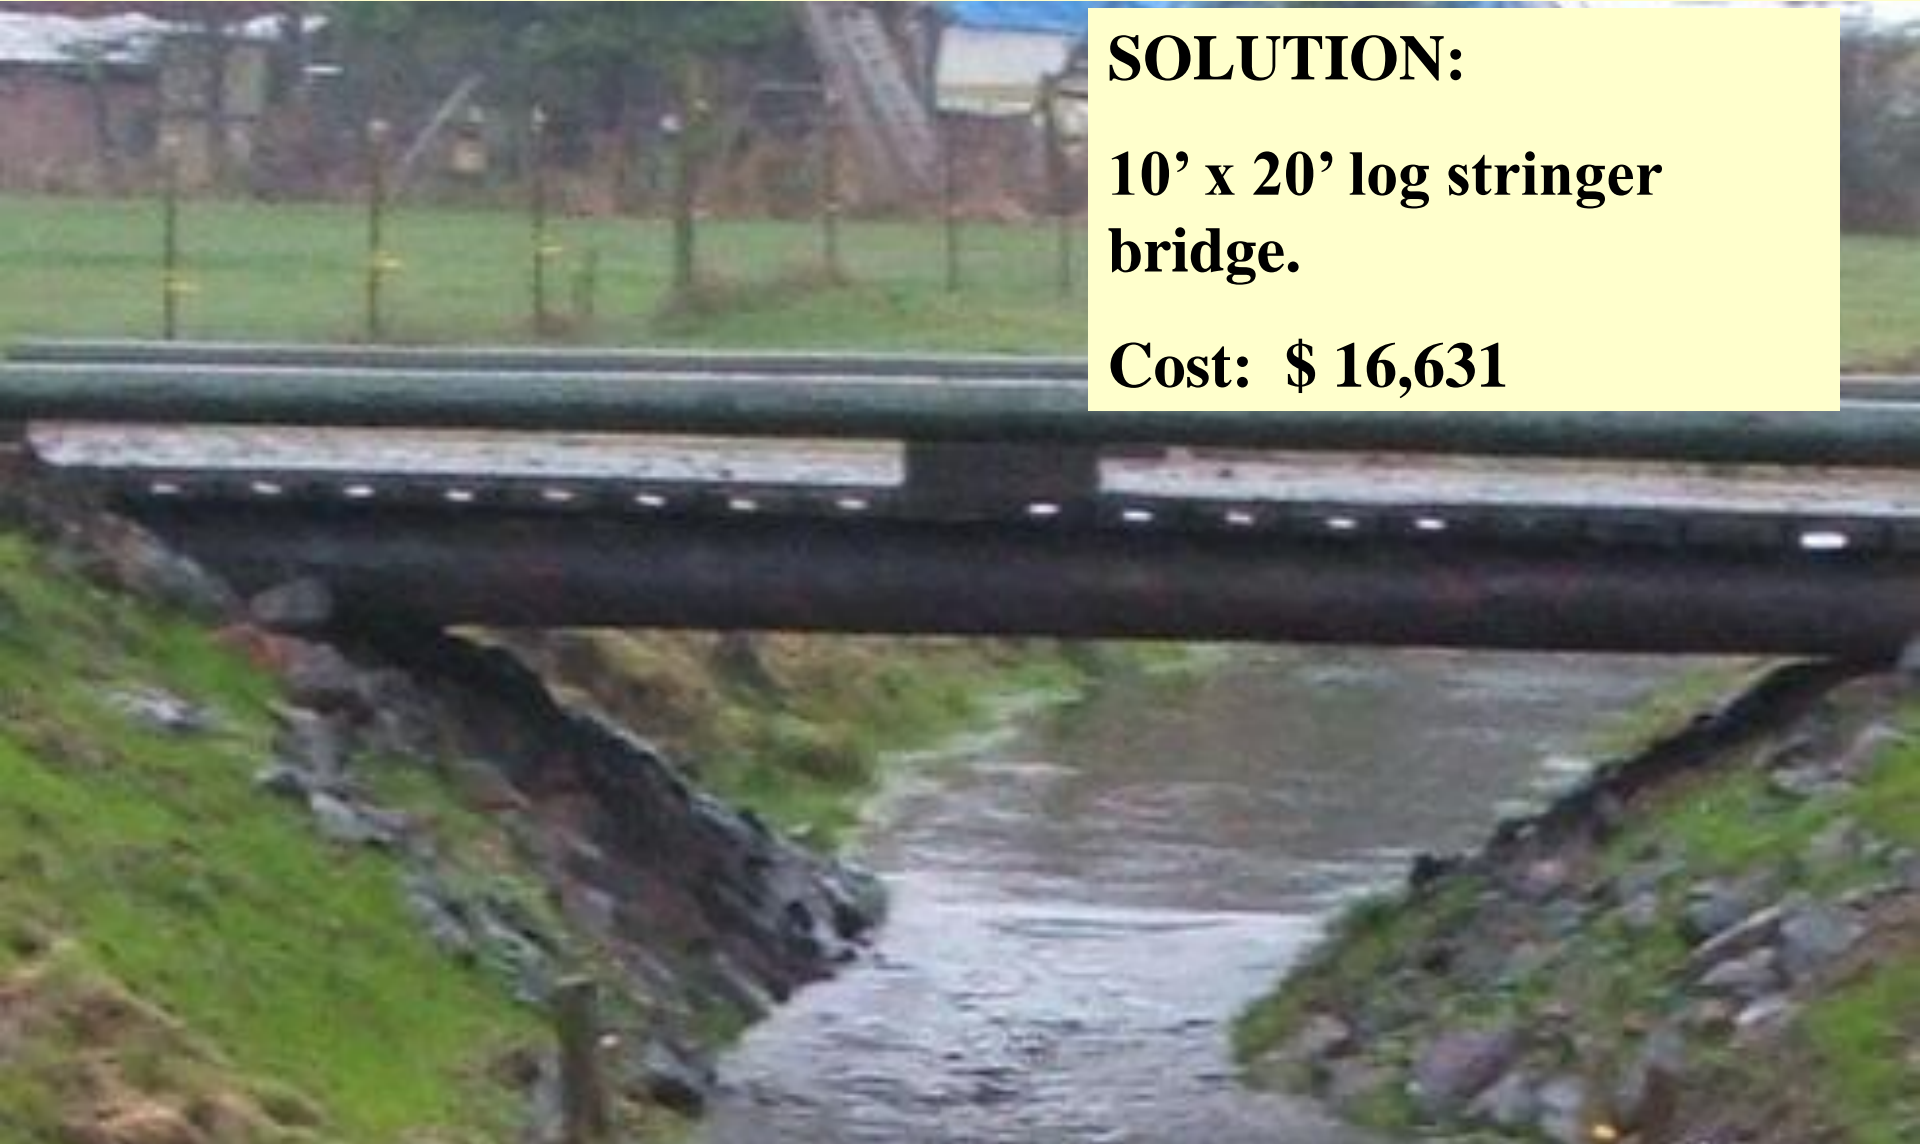
# Freelund Bridge #1

**SOLUTION:**

**10' x 20' log stringer  
bridge.**

**Cost: \$ 16,631**

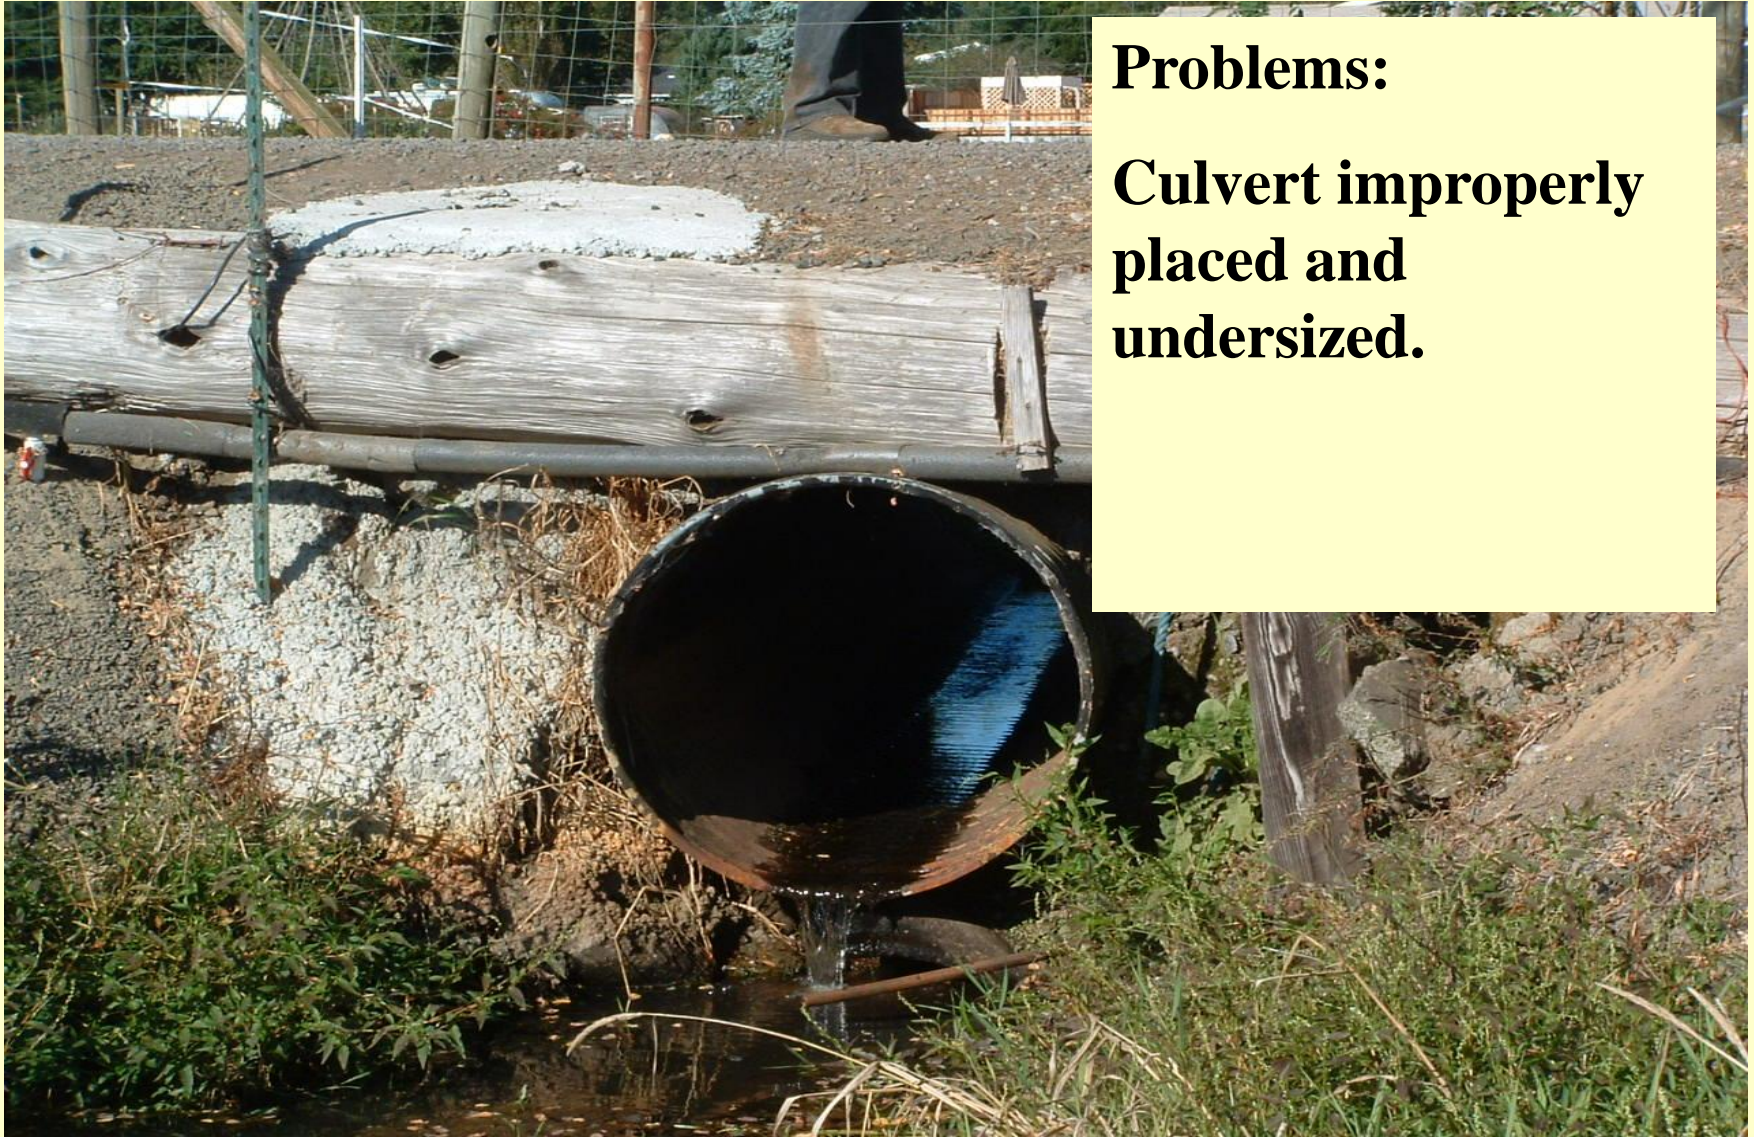
# Freelund Bridge #2

**Problems:**

**Culvert improperly placed and undersized.**

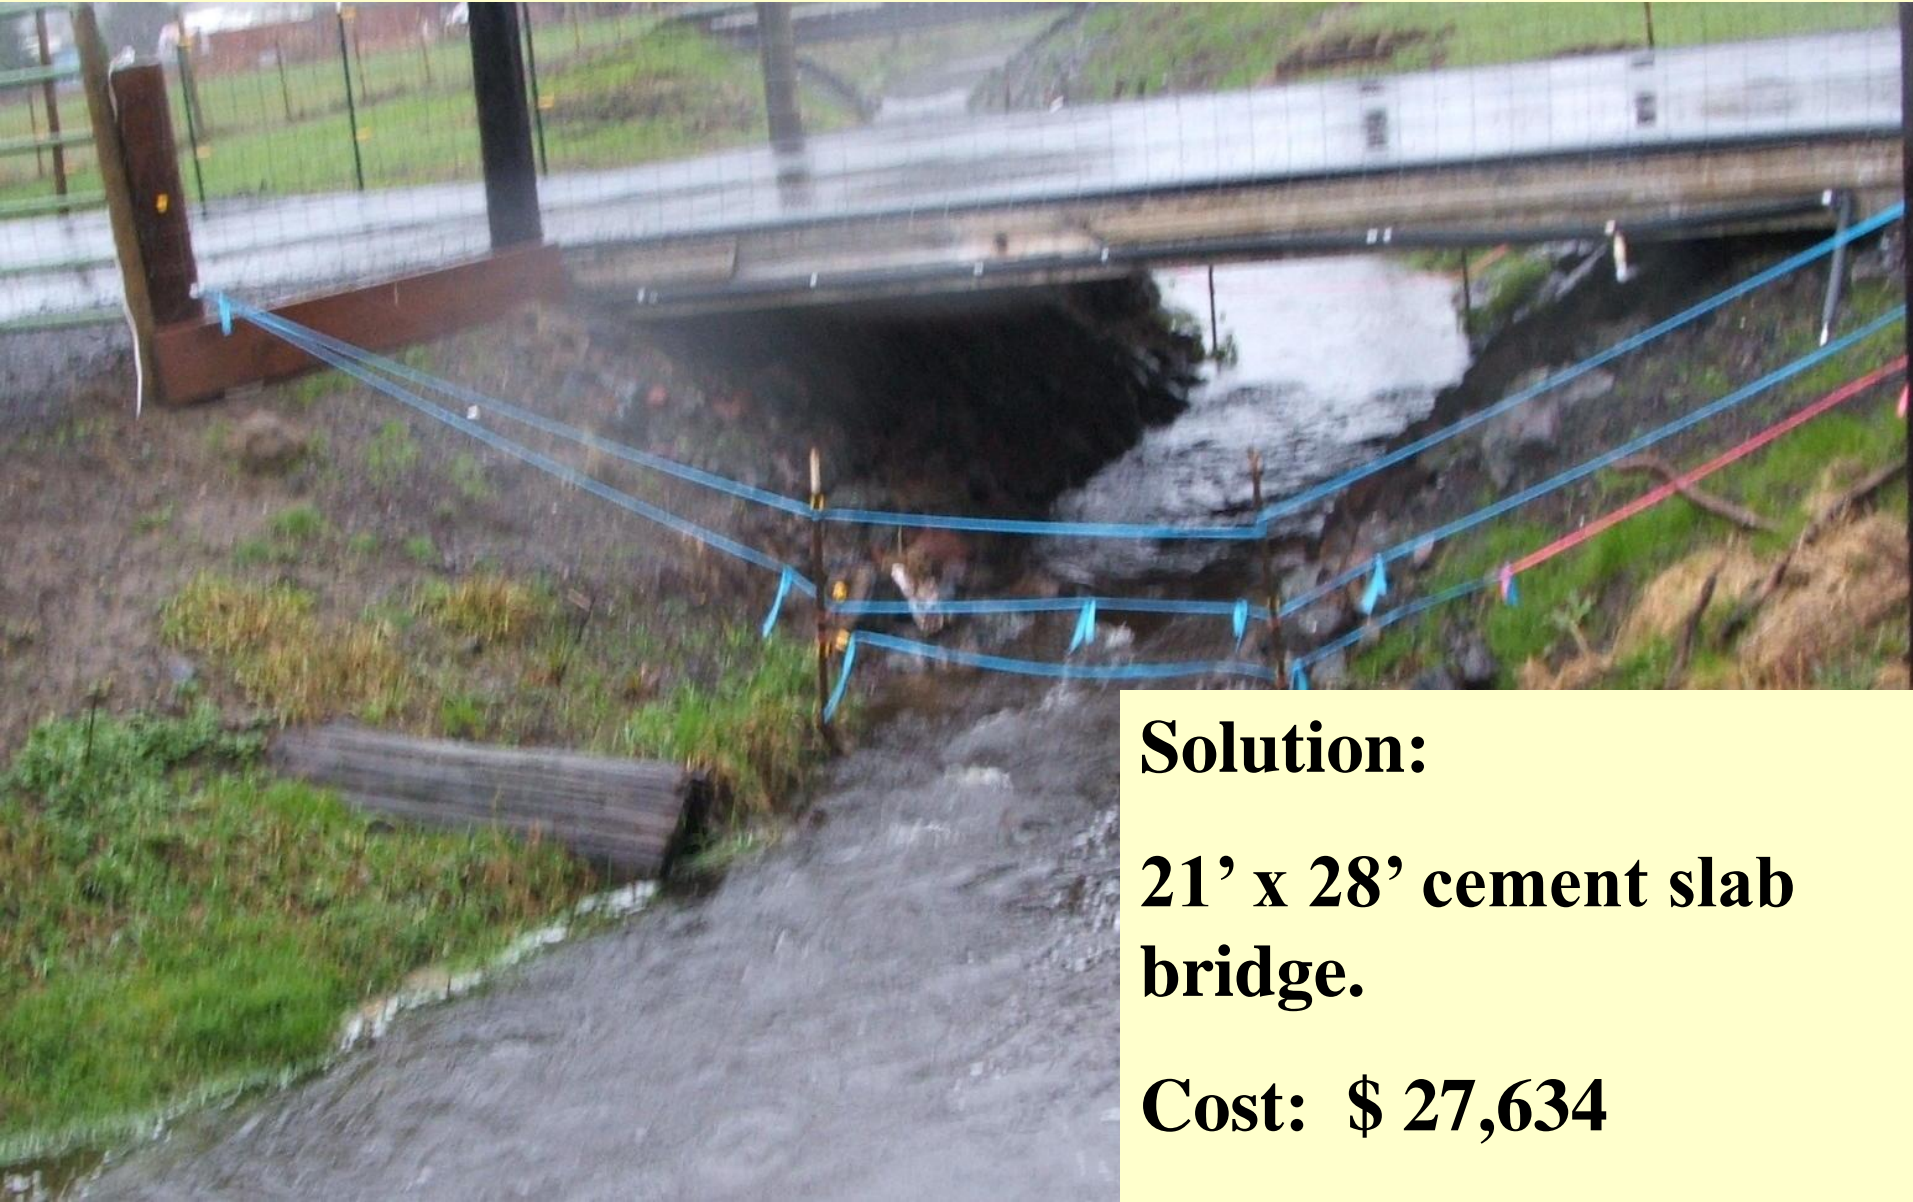
# Freelund Bridge #2

**Solution:**

**21' x 28' cement slab  
bridge.**

**Cost: \$ 27,634**

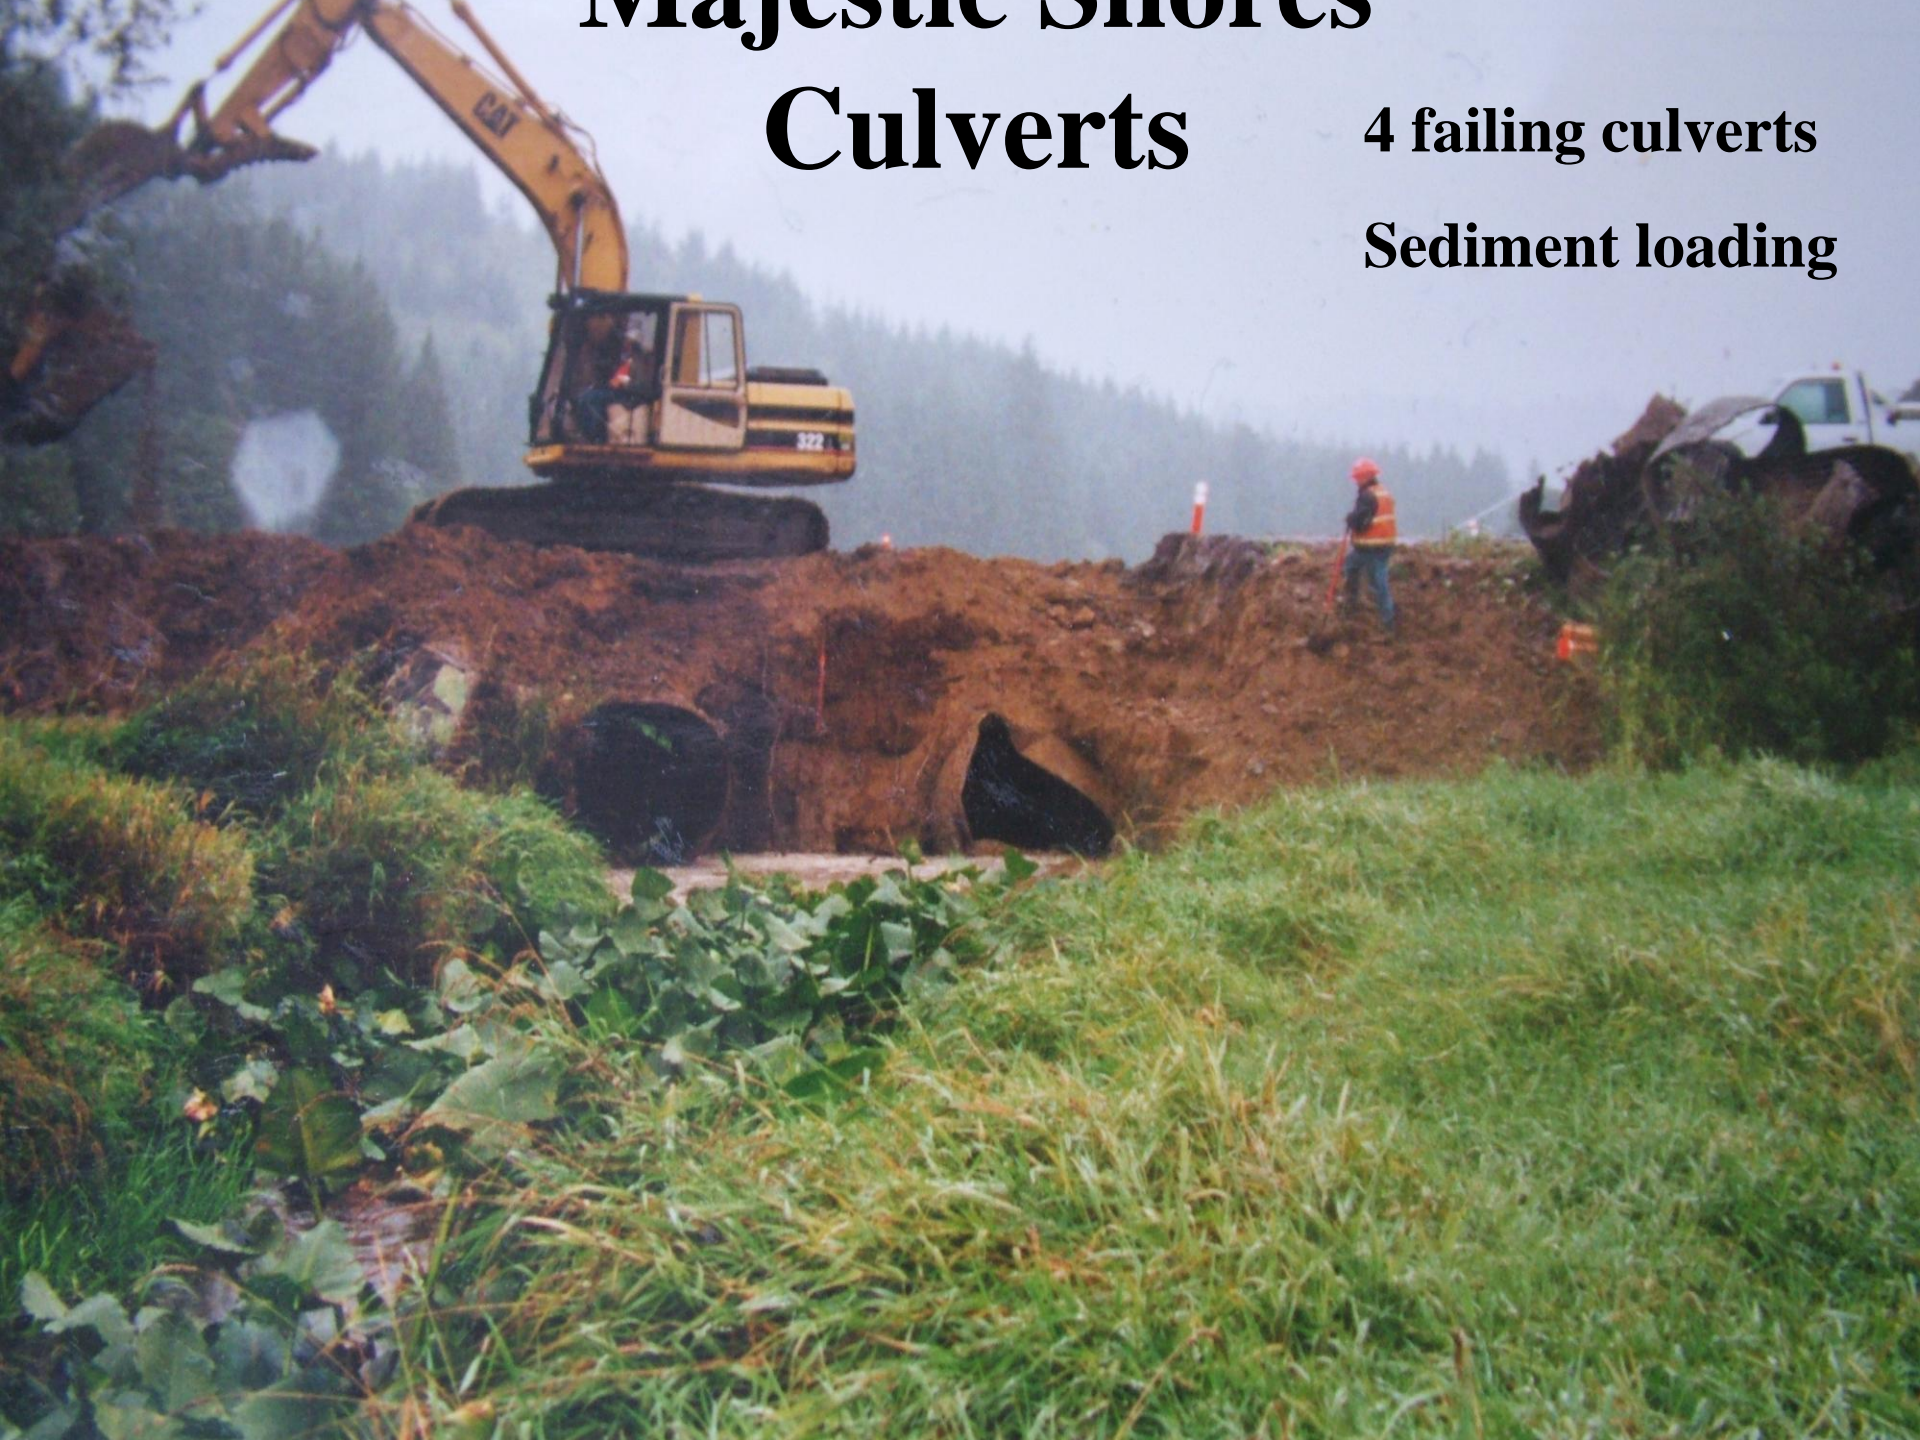
# **Culverts**

**4 failing culverts**

**Sediment loading**

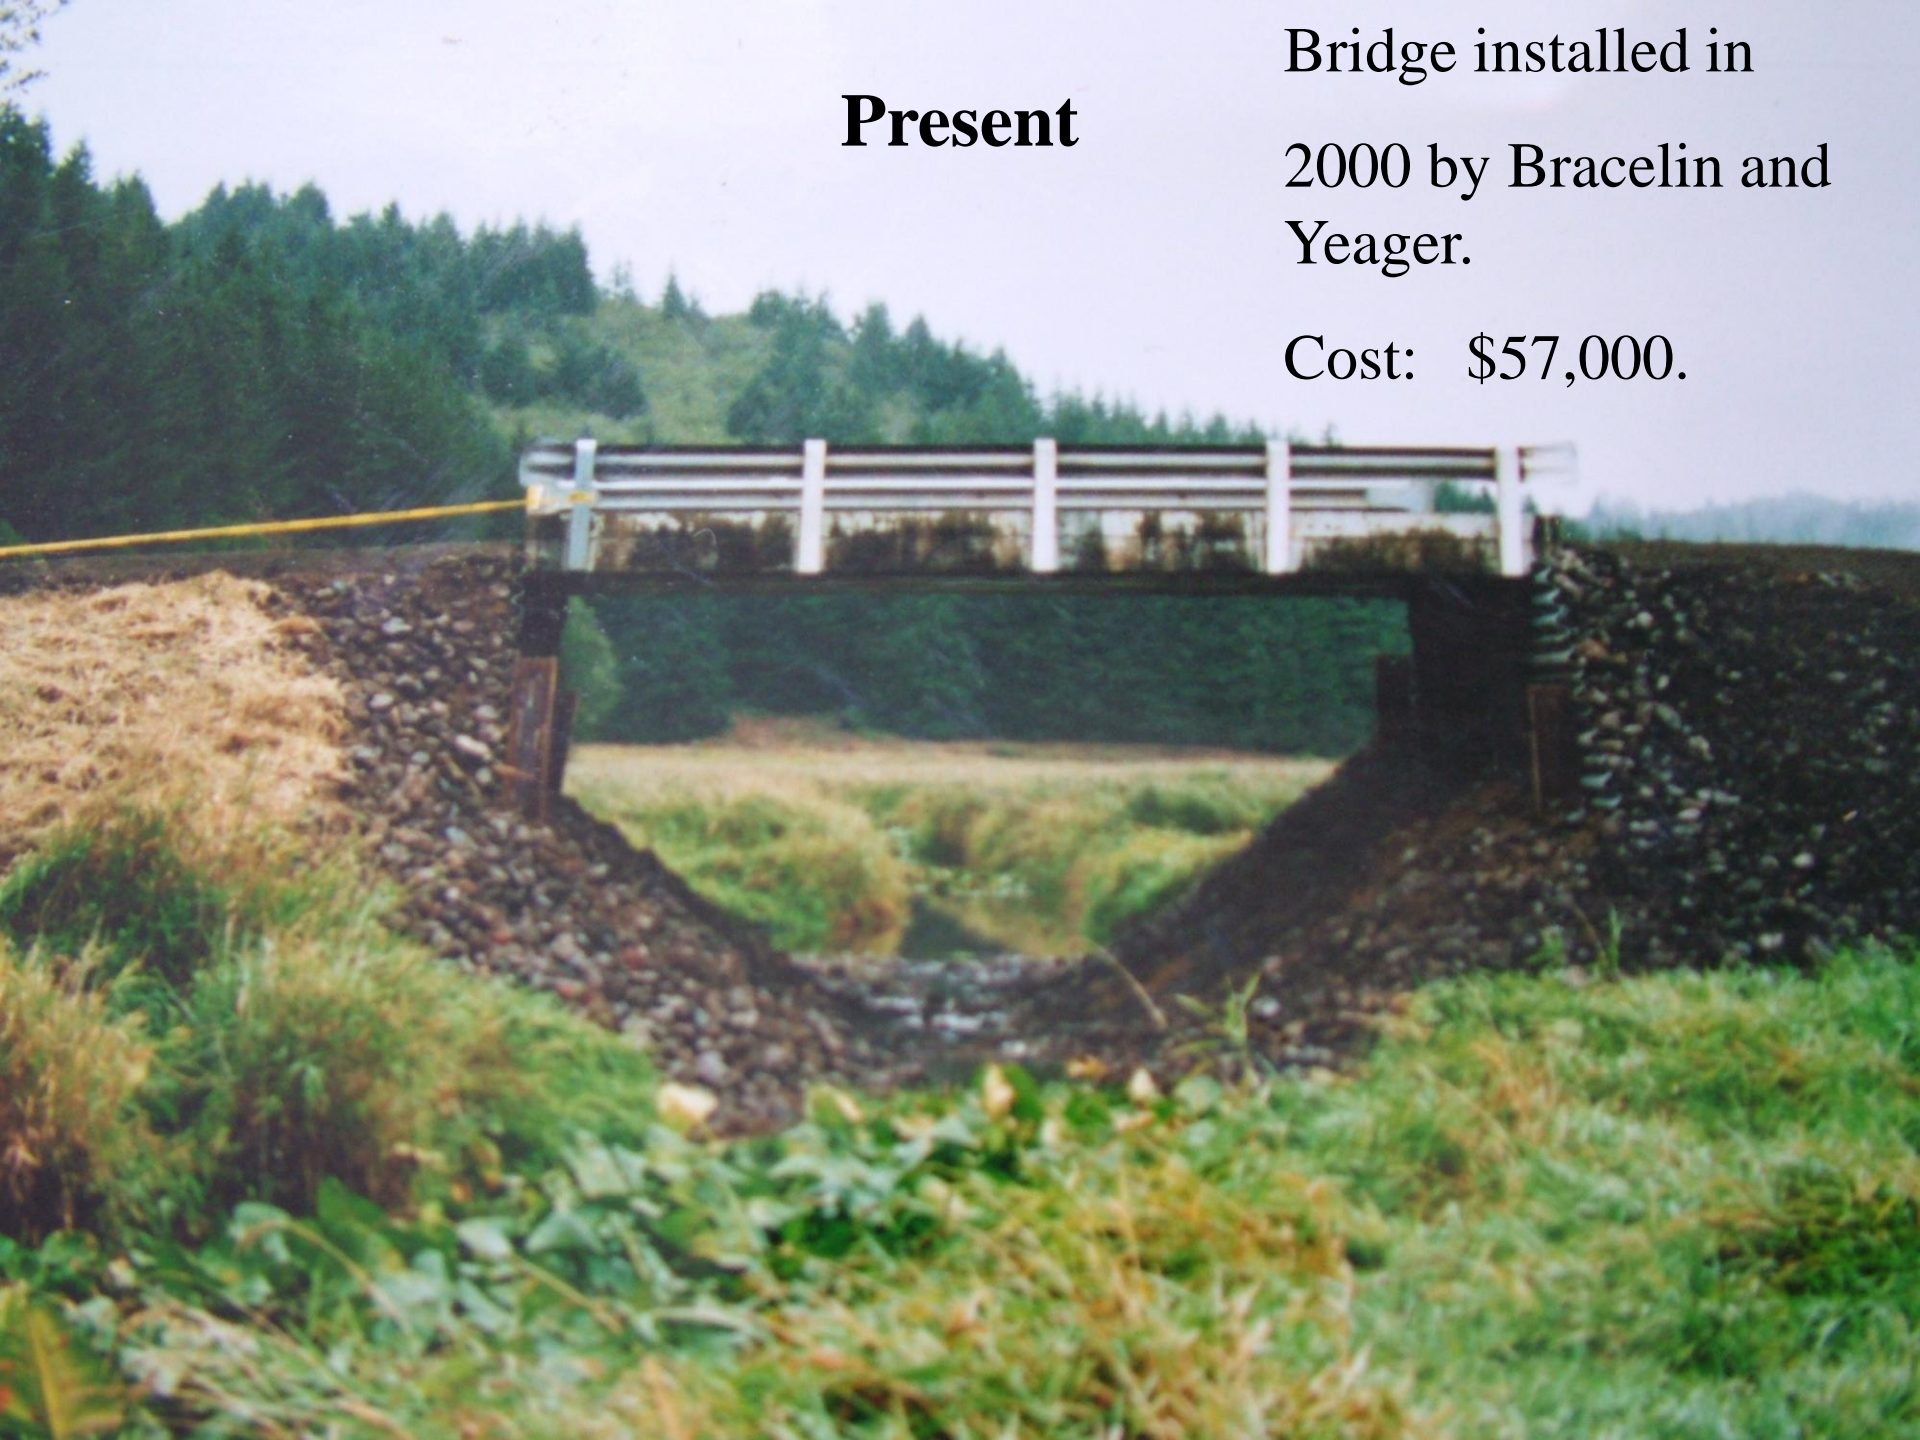
**Present**

Bridge installed in  
2000 by Bracelin and  
Yeager.

Cost: \$57,000.

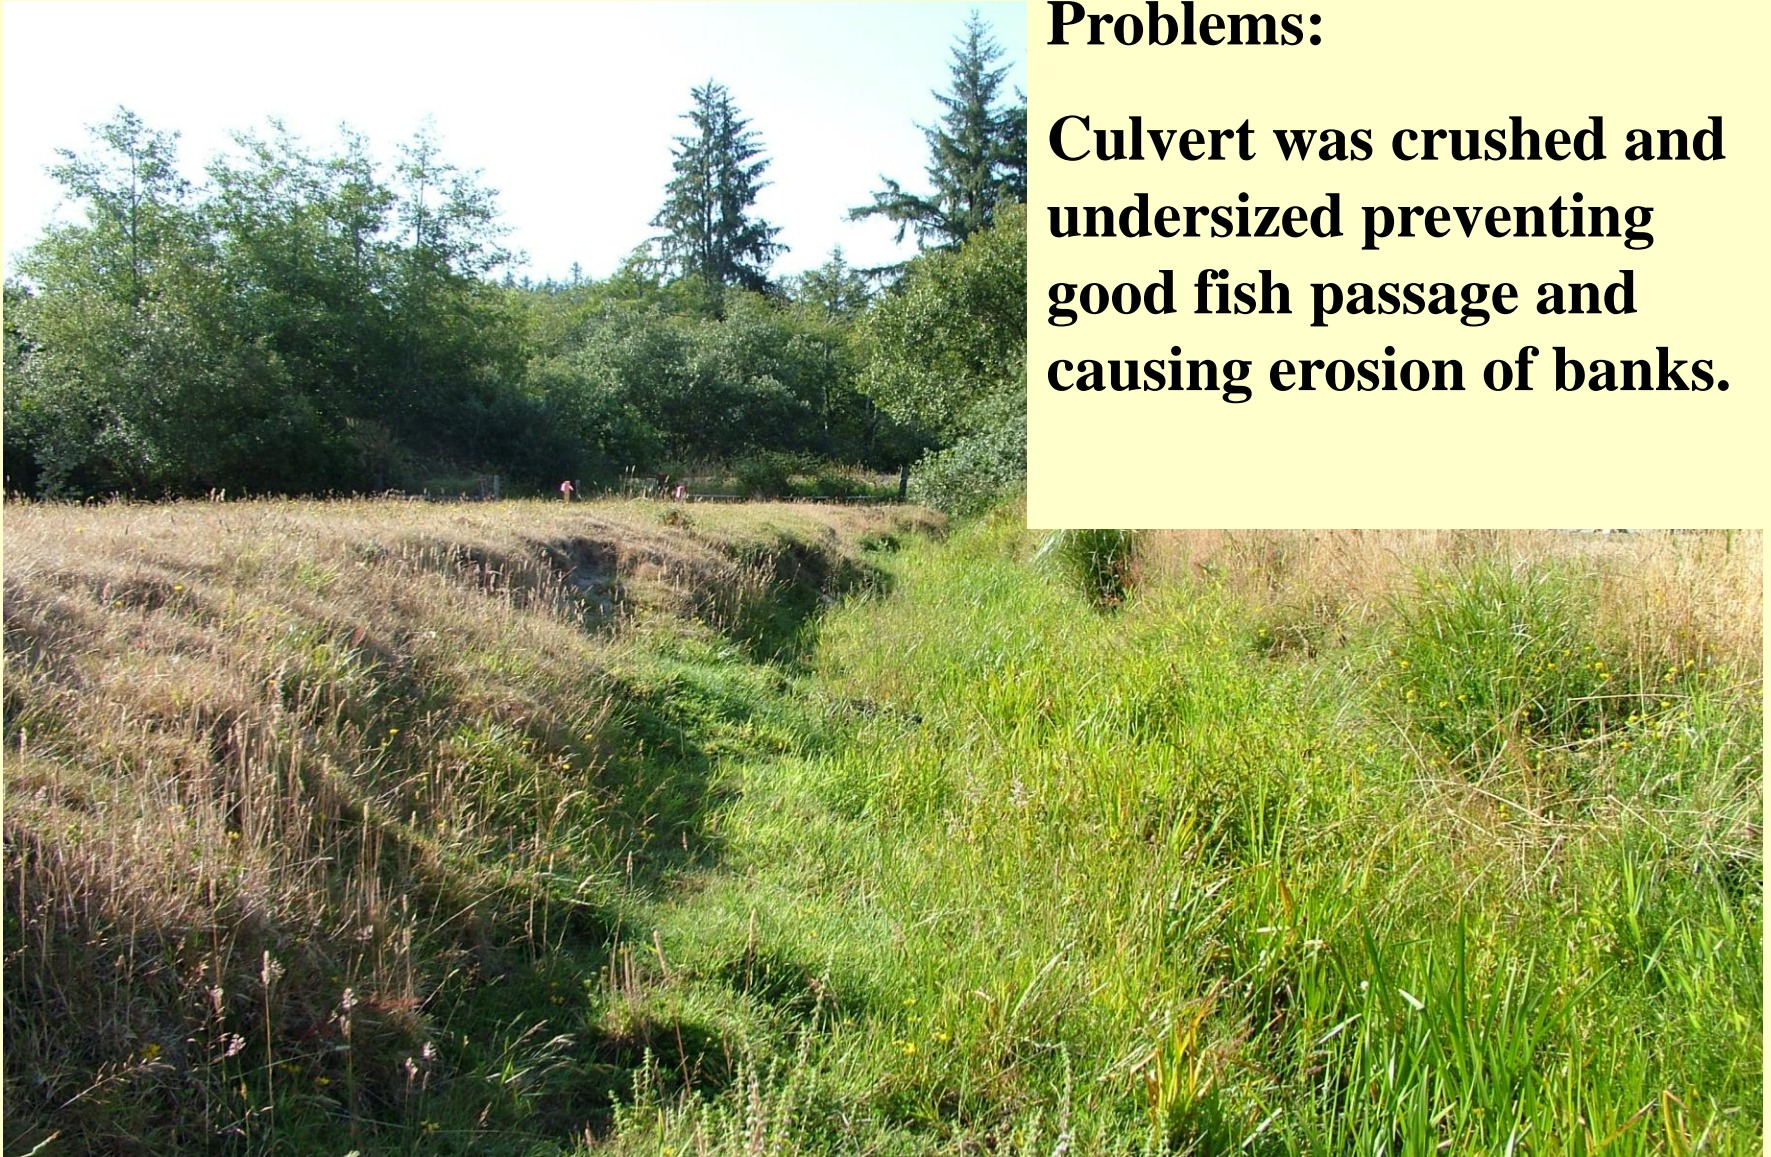
# Bowron Bridge

**Problems:**

**Culvert was crushed and undersized preventing good fish passage and causing erosion of banks.**

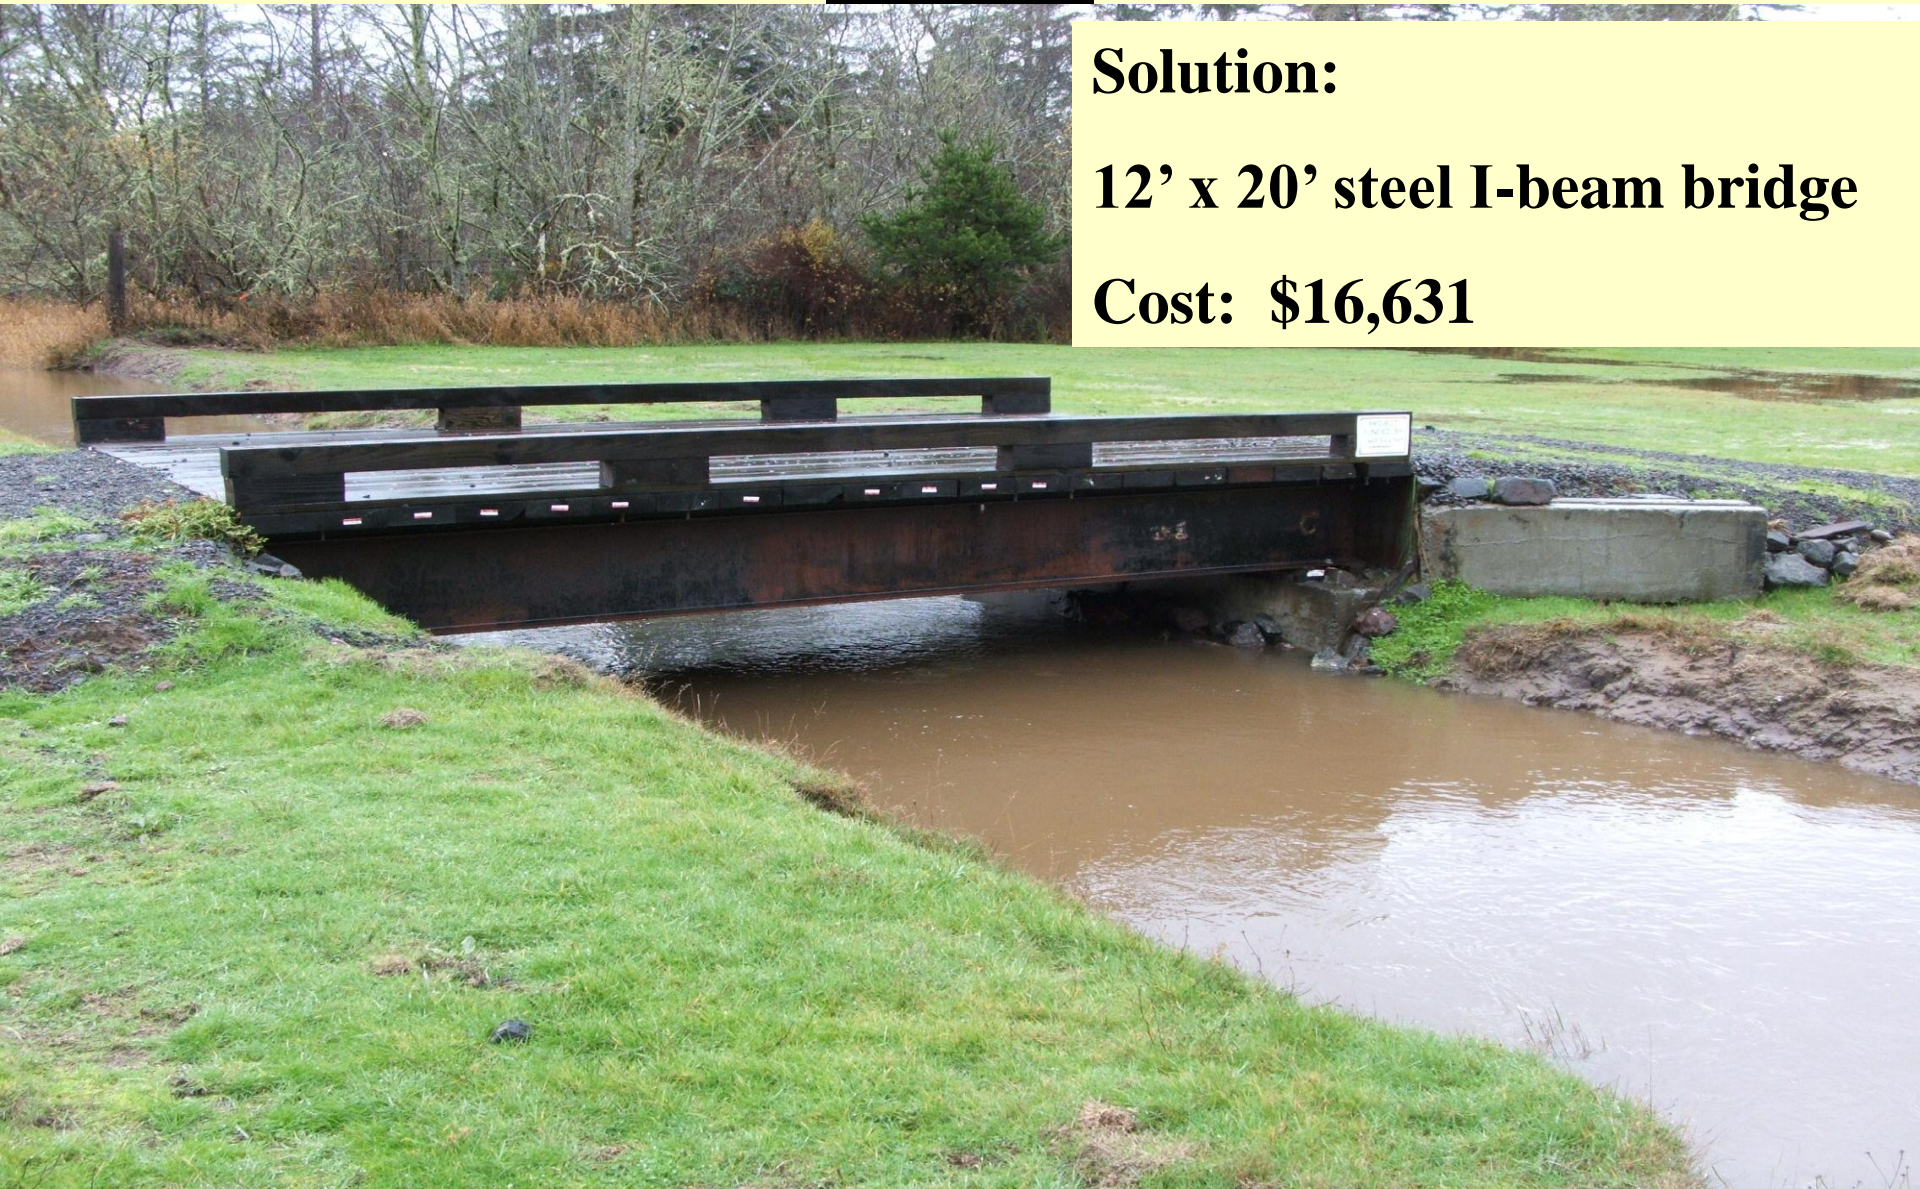
# Bowron Bridge

**Solution:**

**12' x 20' steel I-beam bridge**

**Cost: \$16,631**

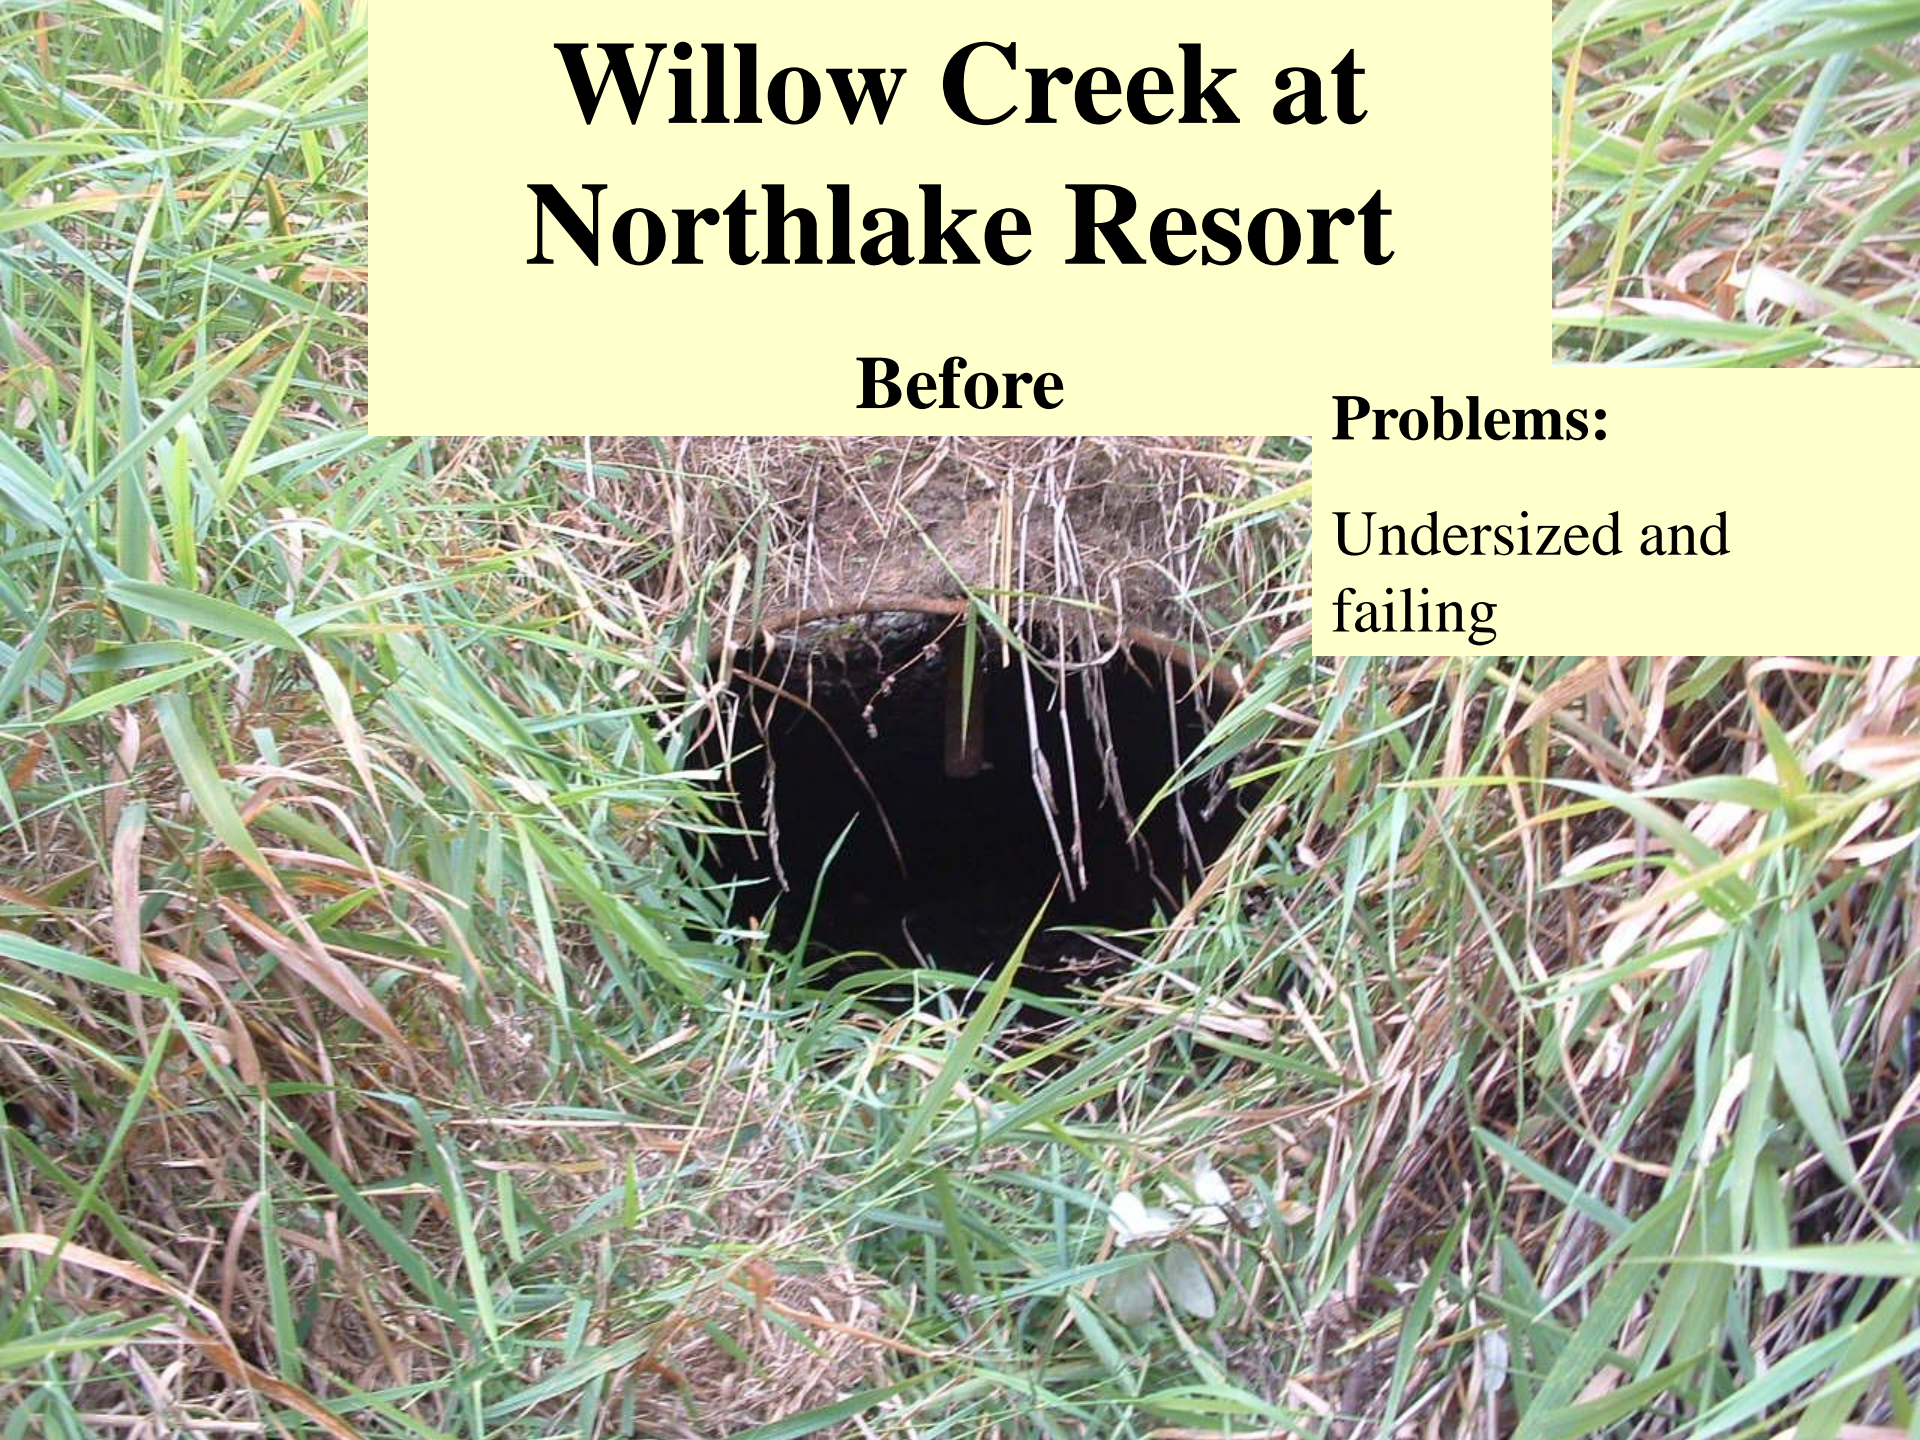
# Willow Creek at Northlake Resort

**Problems:**

Undersized and  
failing

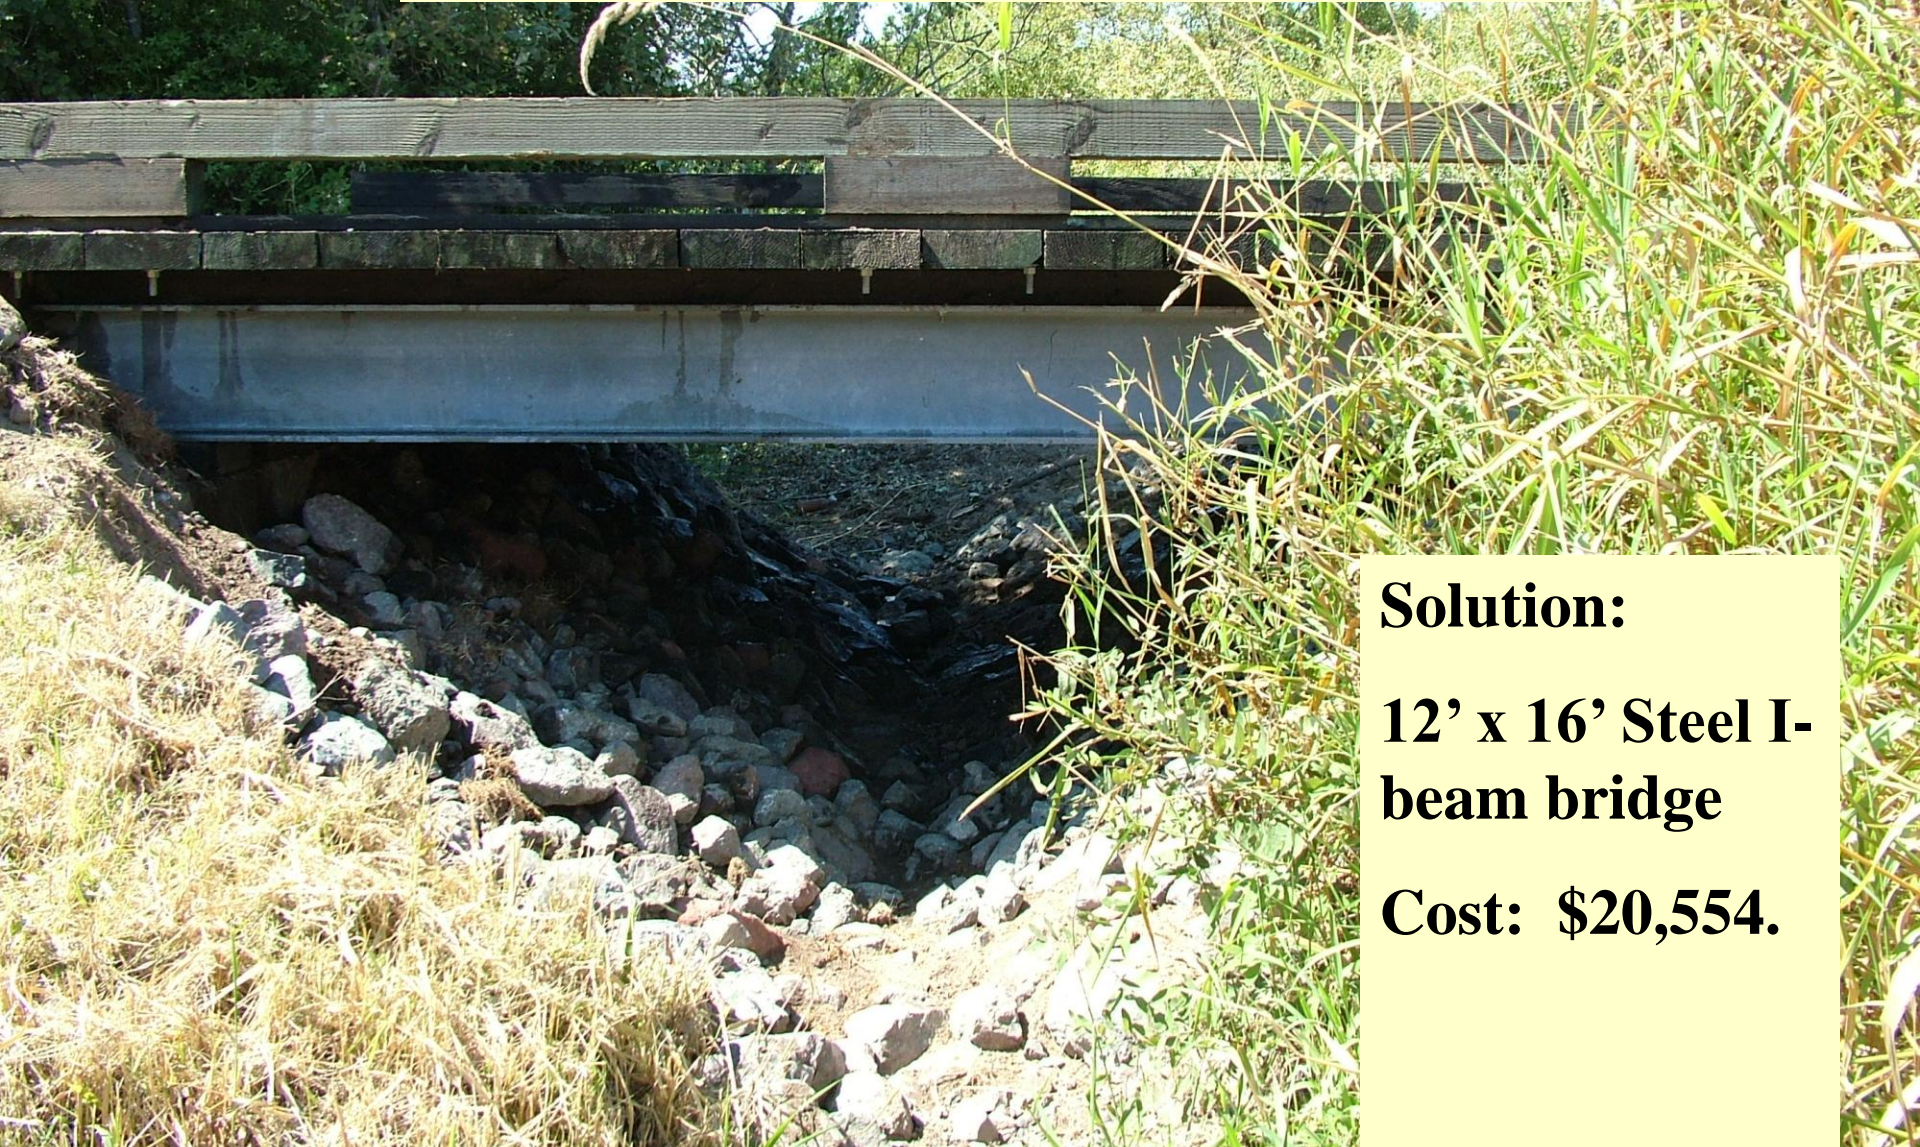
# Willow Creek Bridge

**Solution:**

**12' x 16' Steel I-beam bridge**

**Cost: \$20,554.**
