# Tenmile Lakes Basin Partnership

## 2006 Project Presentation

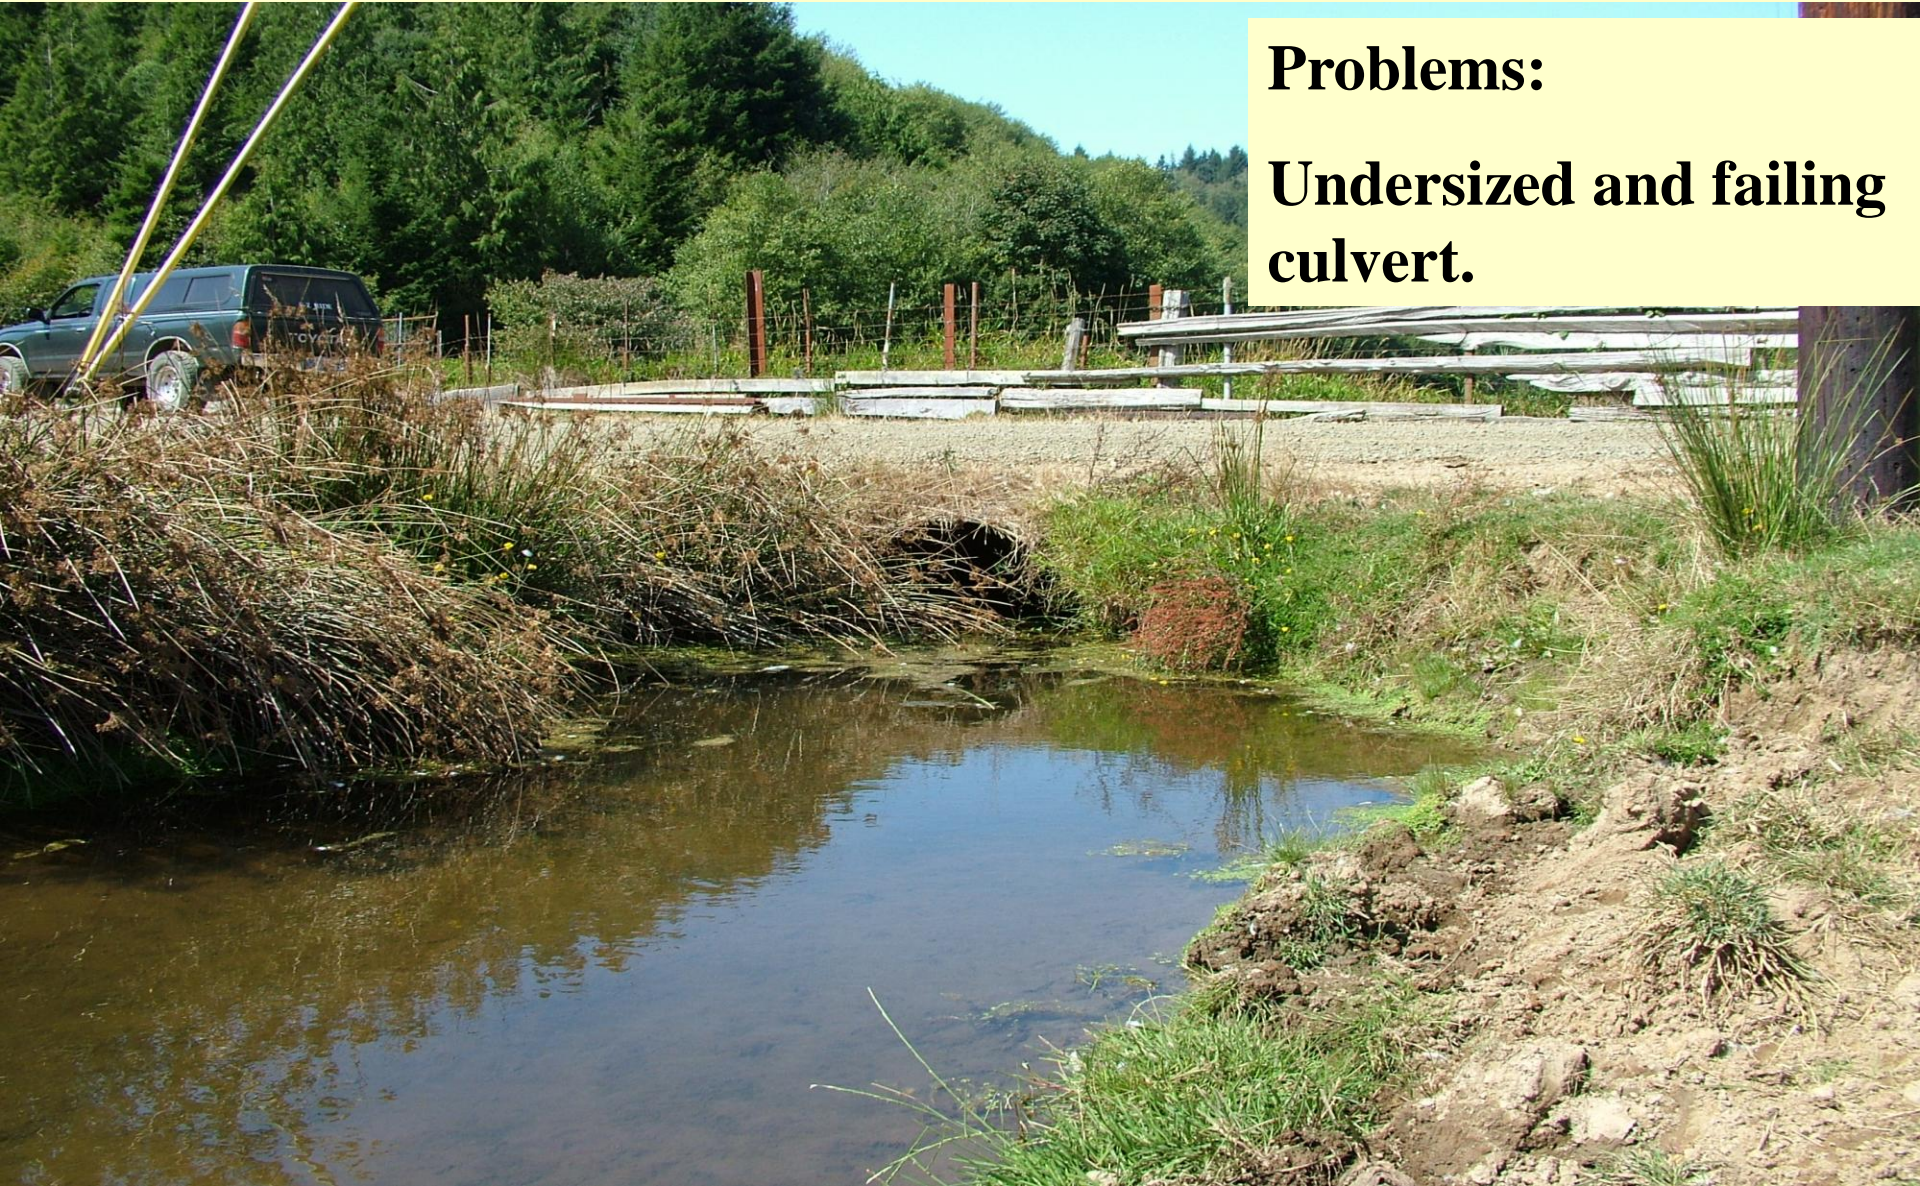
# Shutters Bridge #3

**Problems:**

**Undersized and failing  
culvert.**

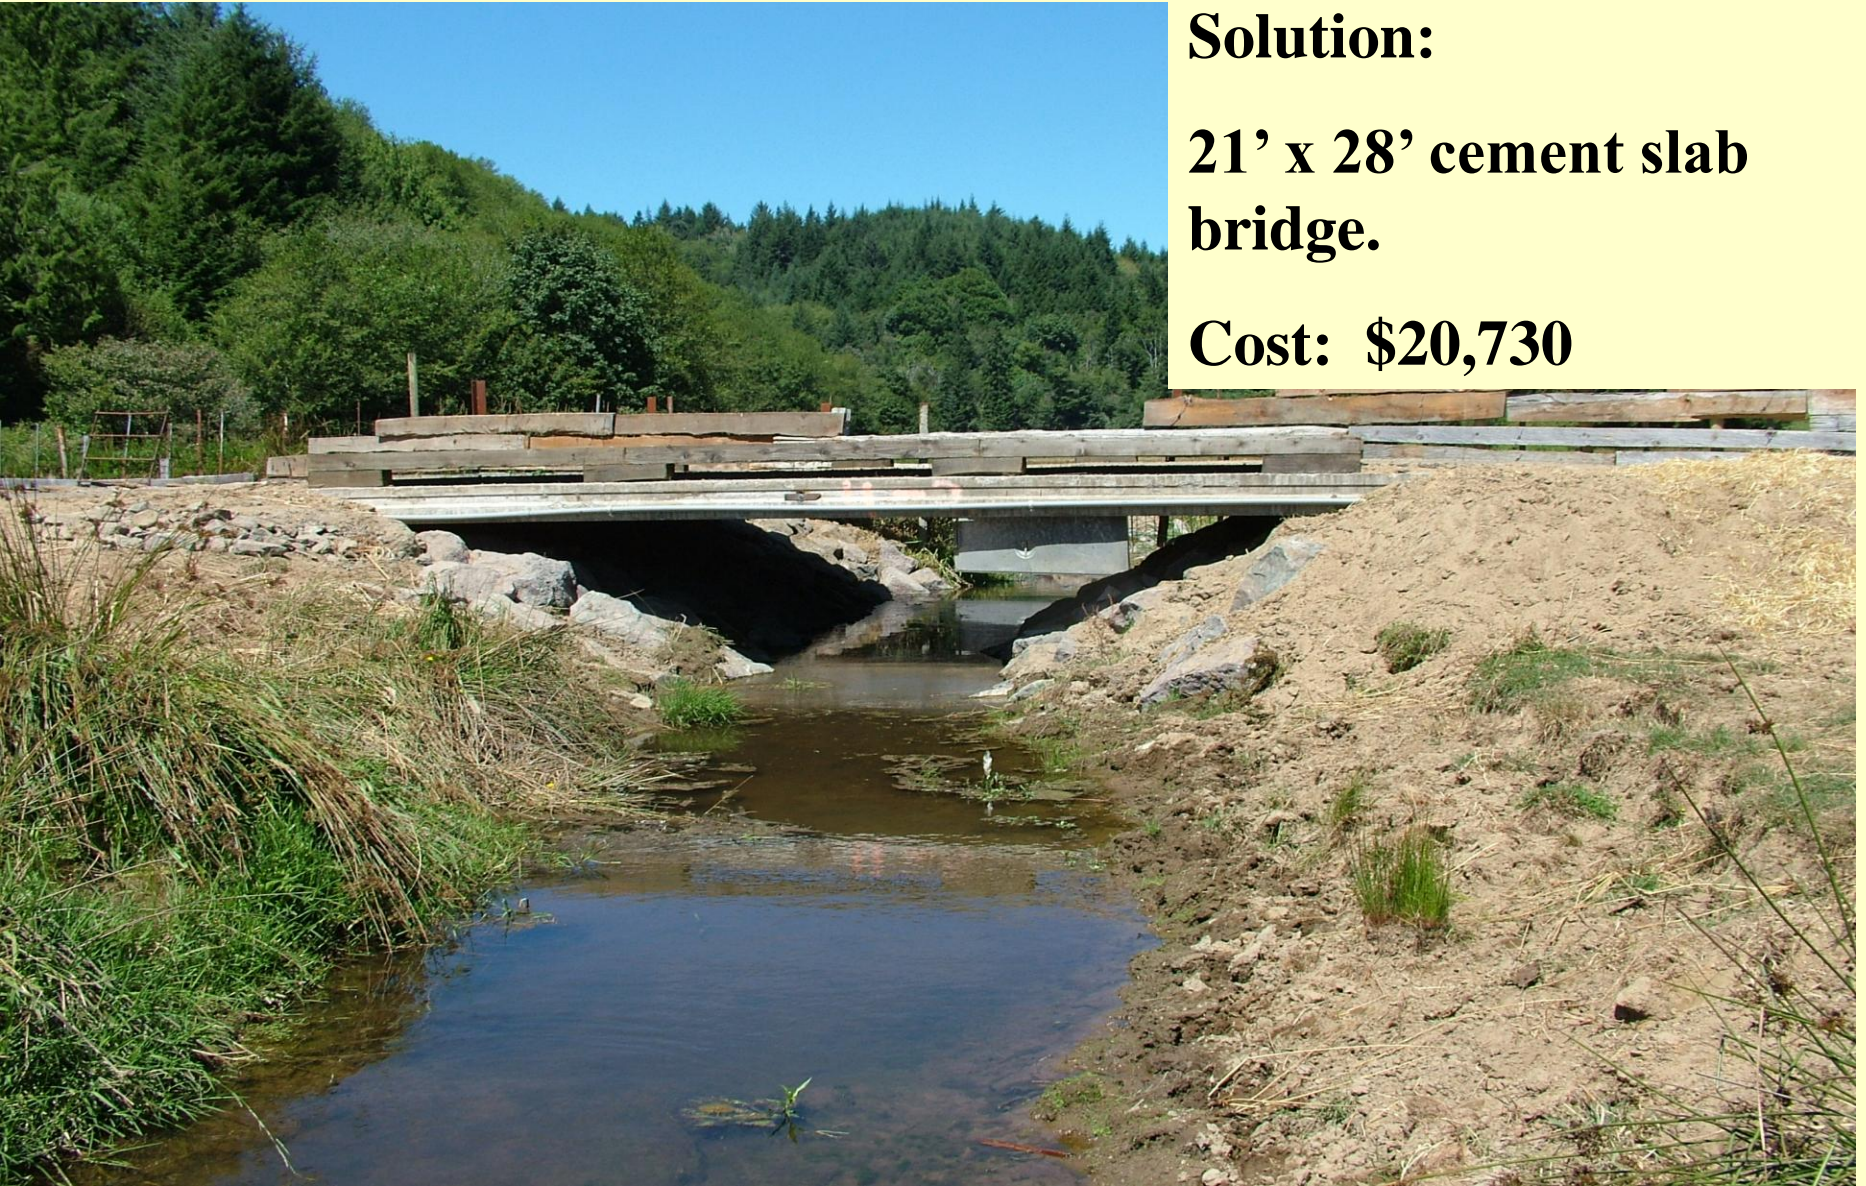
# Shutters Creek Bridge #3

**Solution:**

**21' x 28' cement slab  
bridge.**

**Cost: \$20,730**

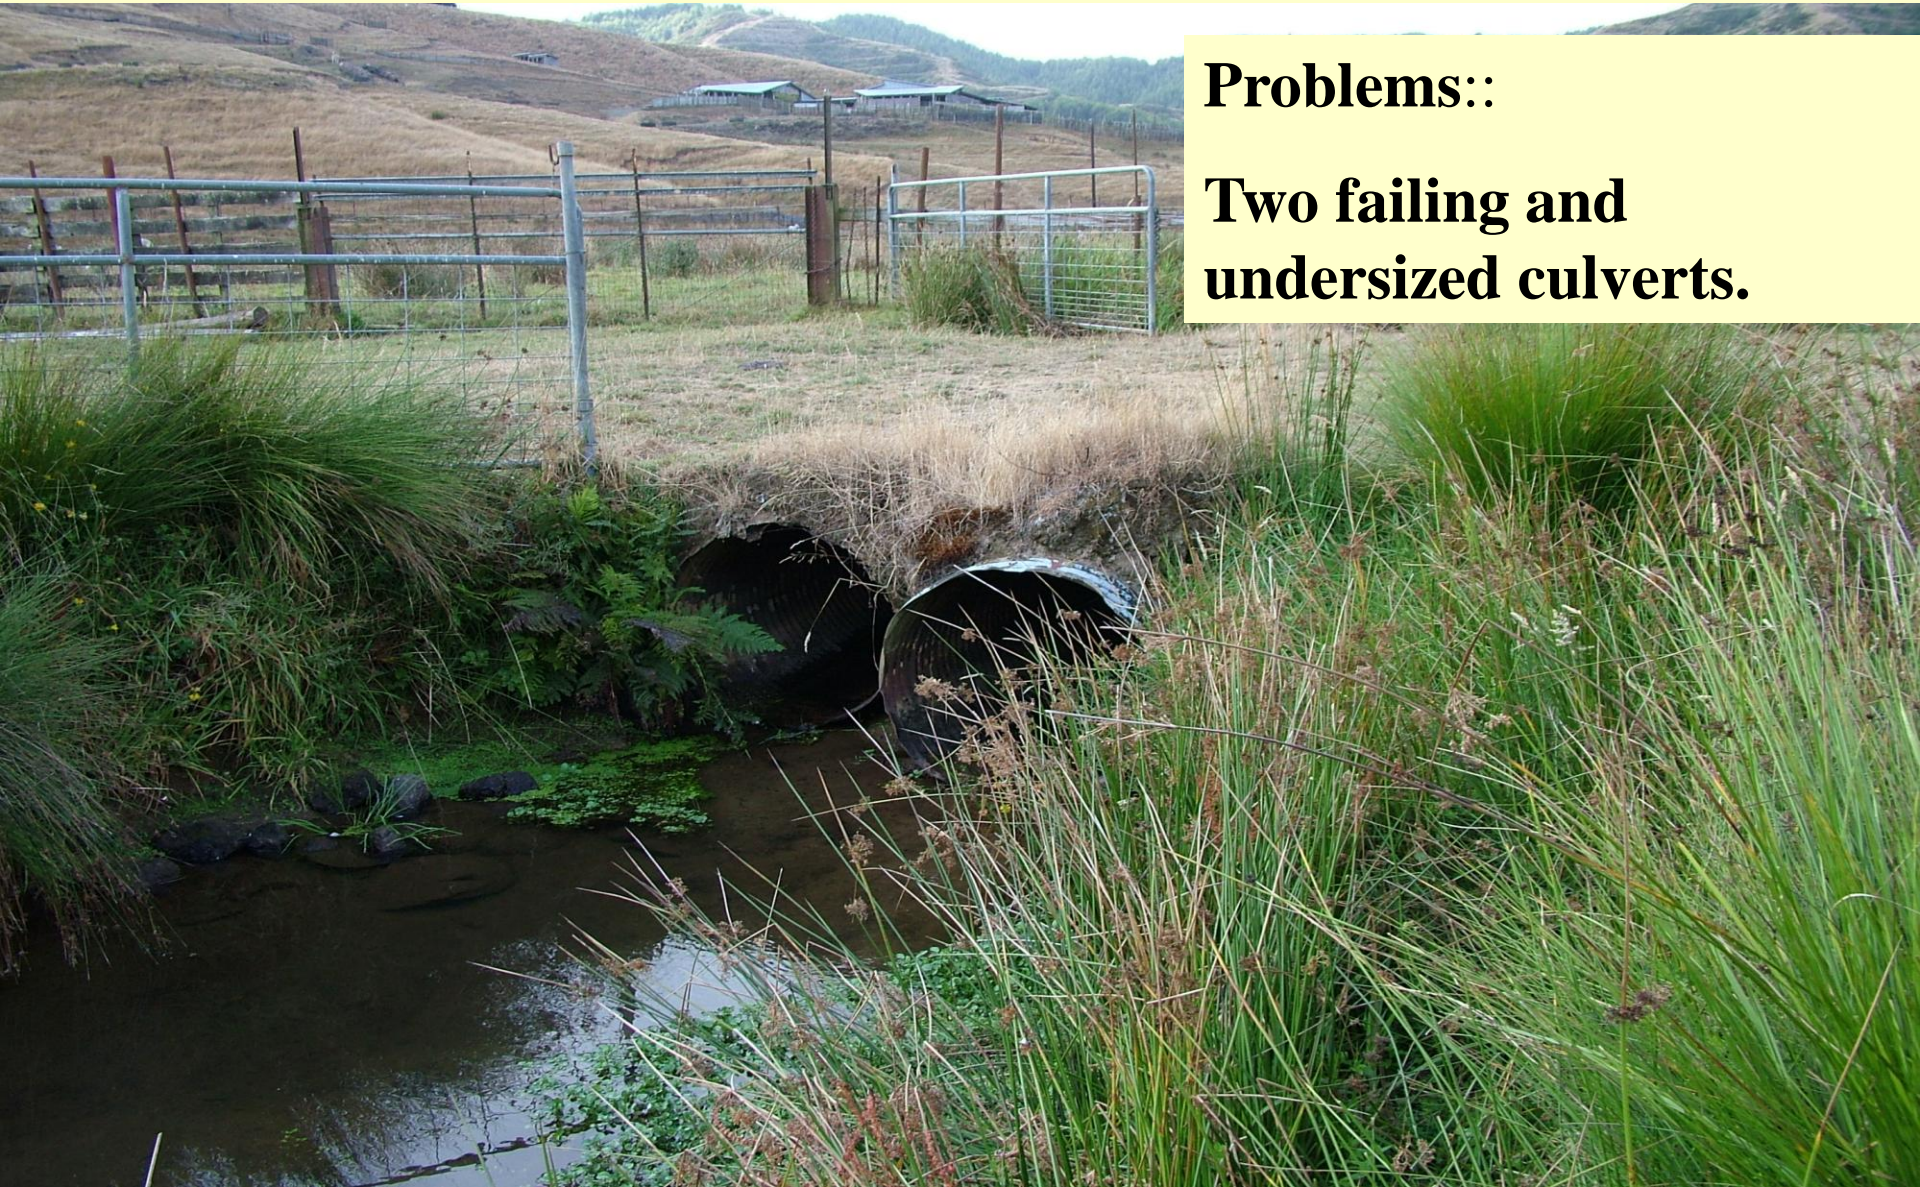
# Shutters Creek Bridge #4

**Problems::**

**Two failing and  
undersized culverts.**

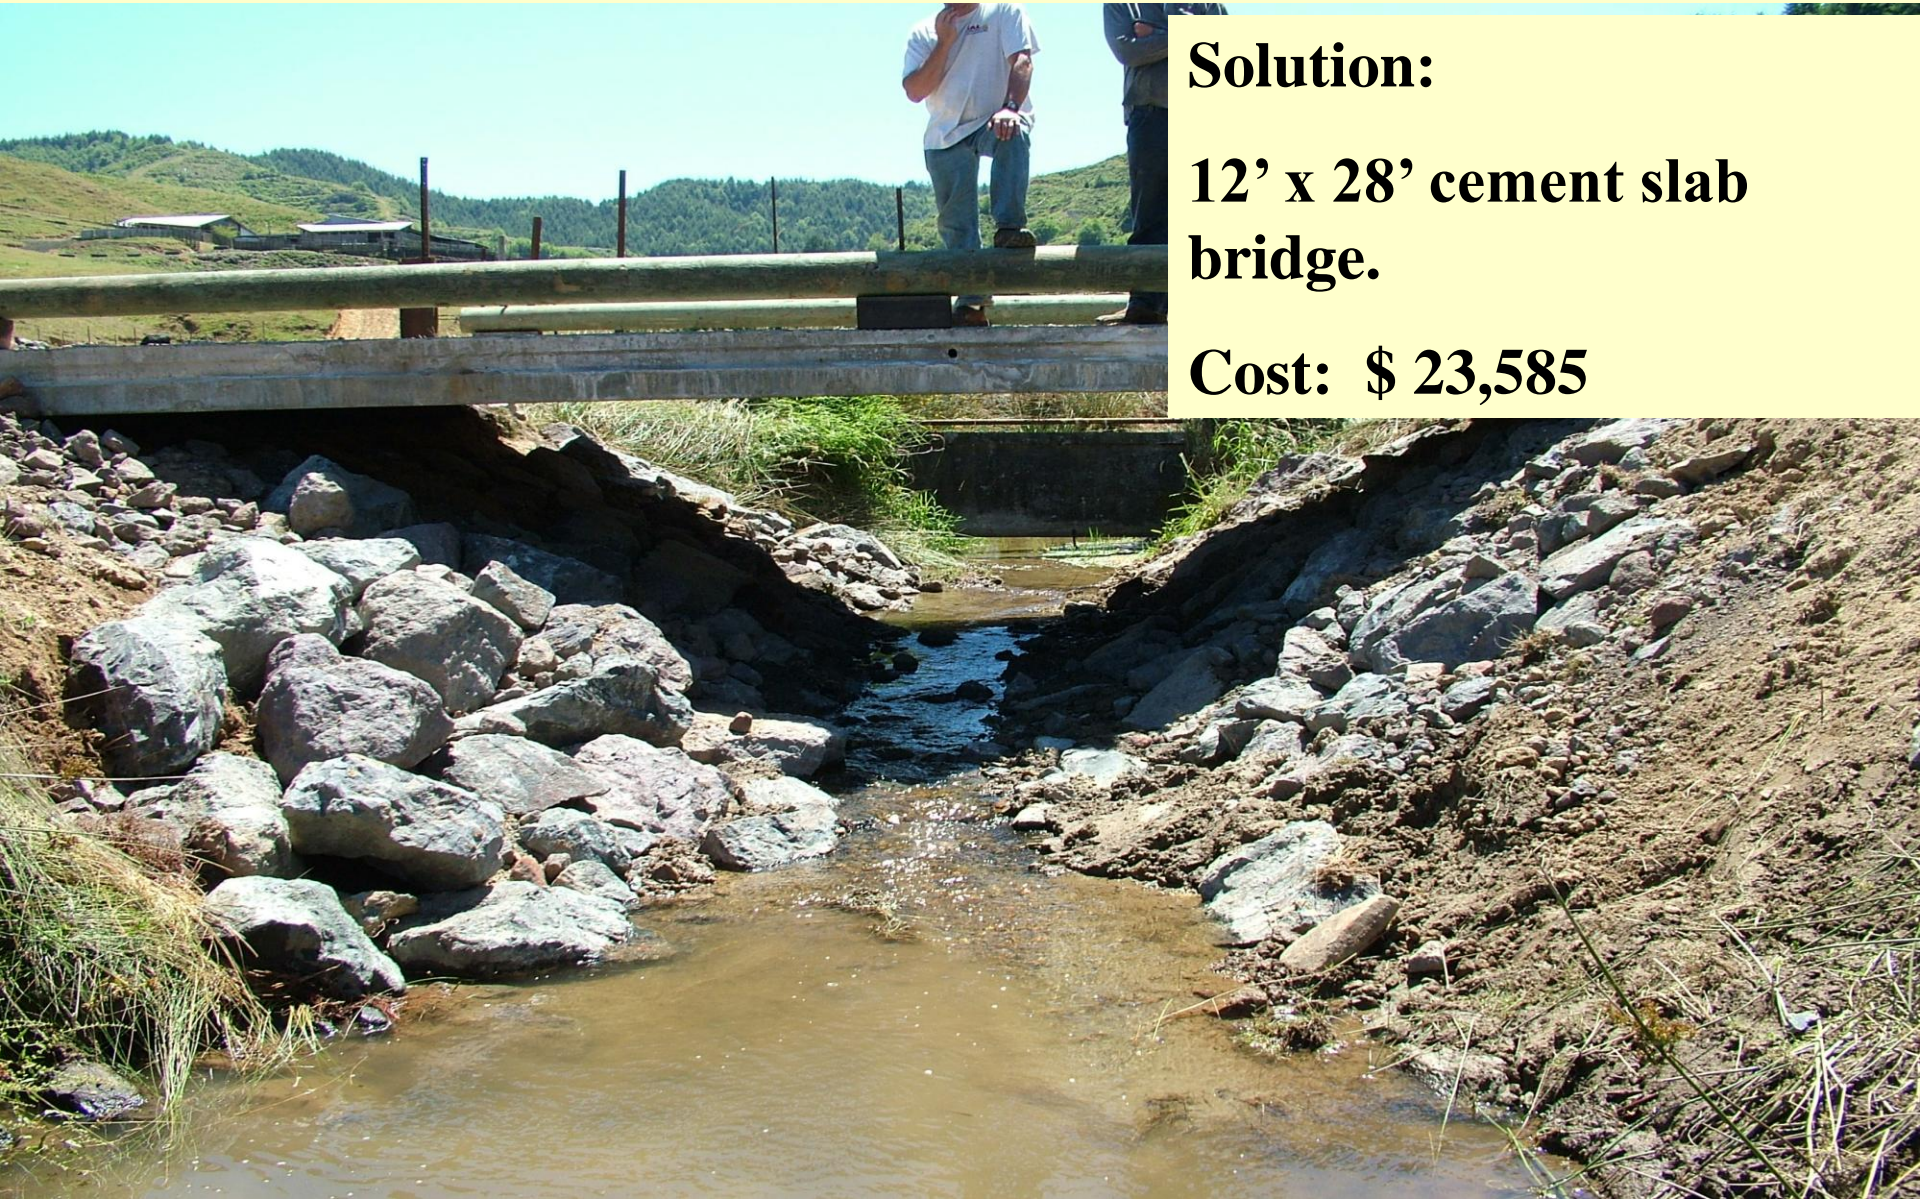
# Shutters Creek Bridge #4

**Solution:**

**12' x 28' cement slab  
bridge.**

**Cost: \$ 23,585**

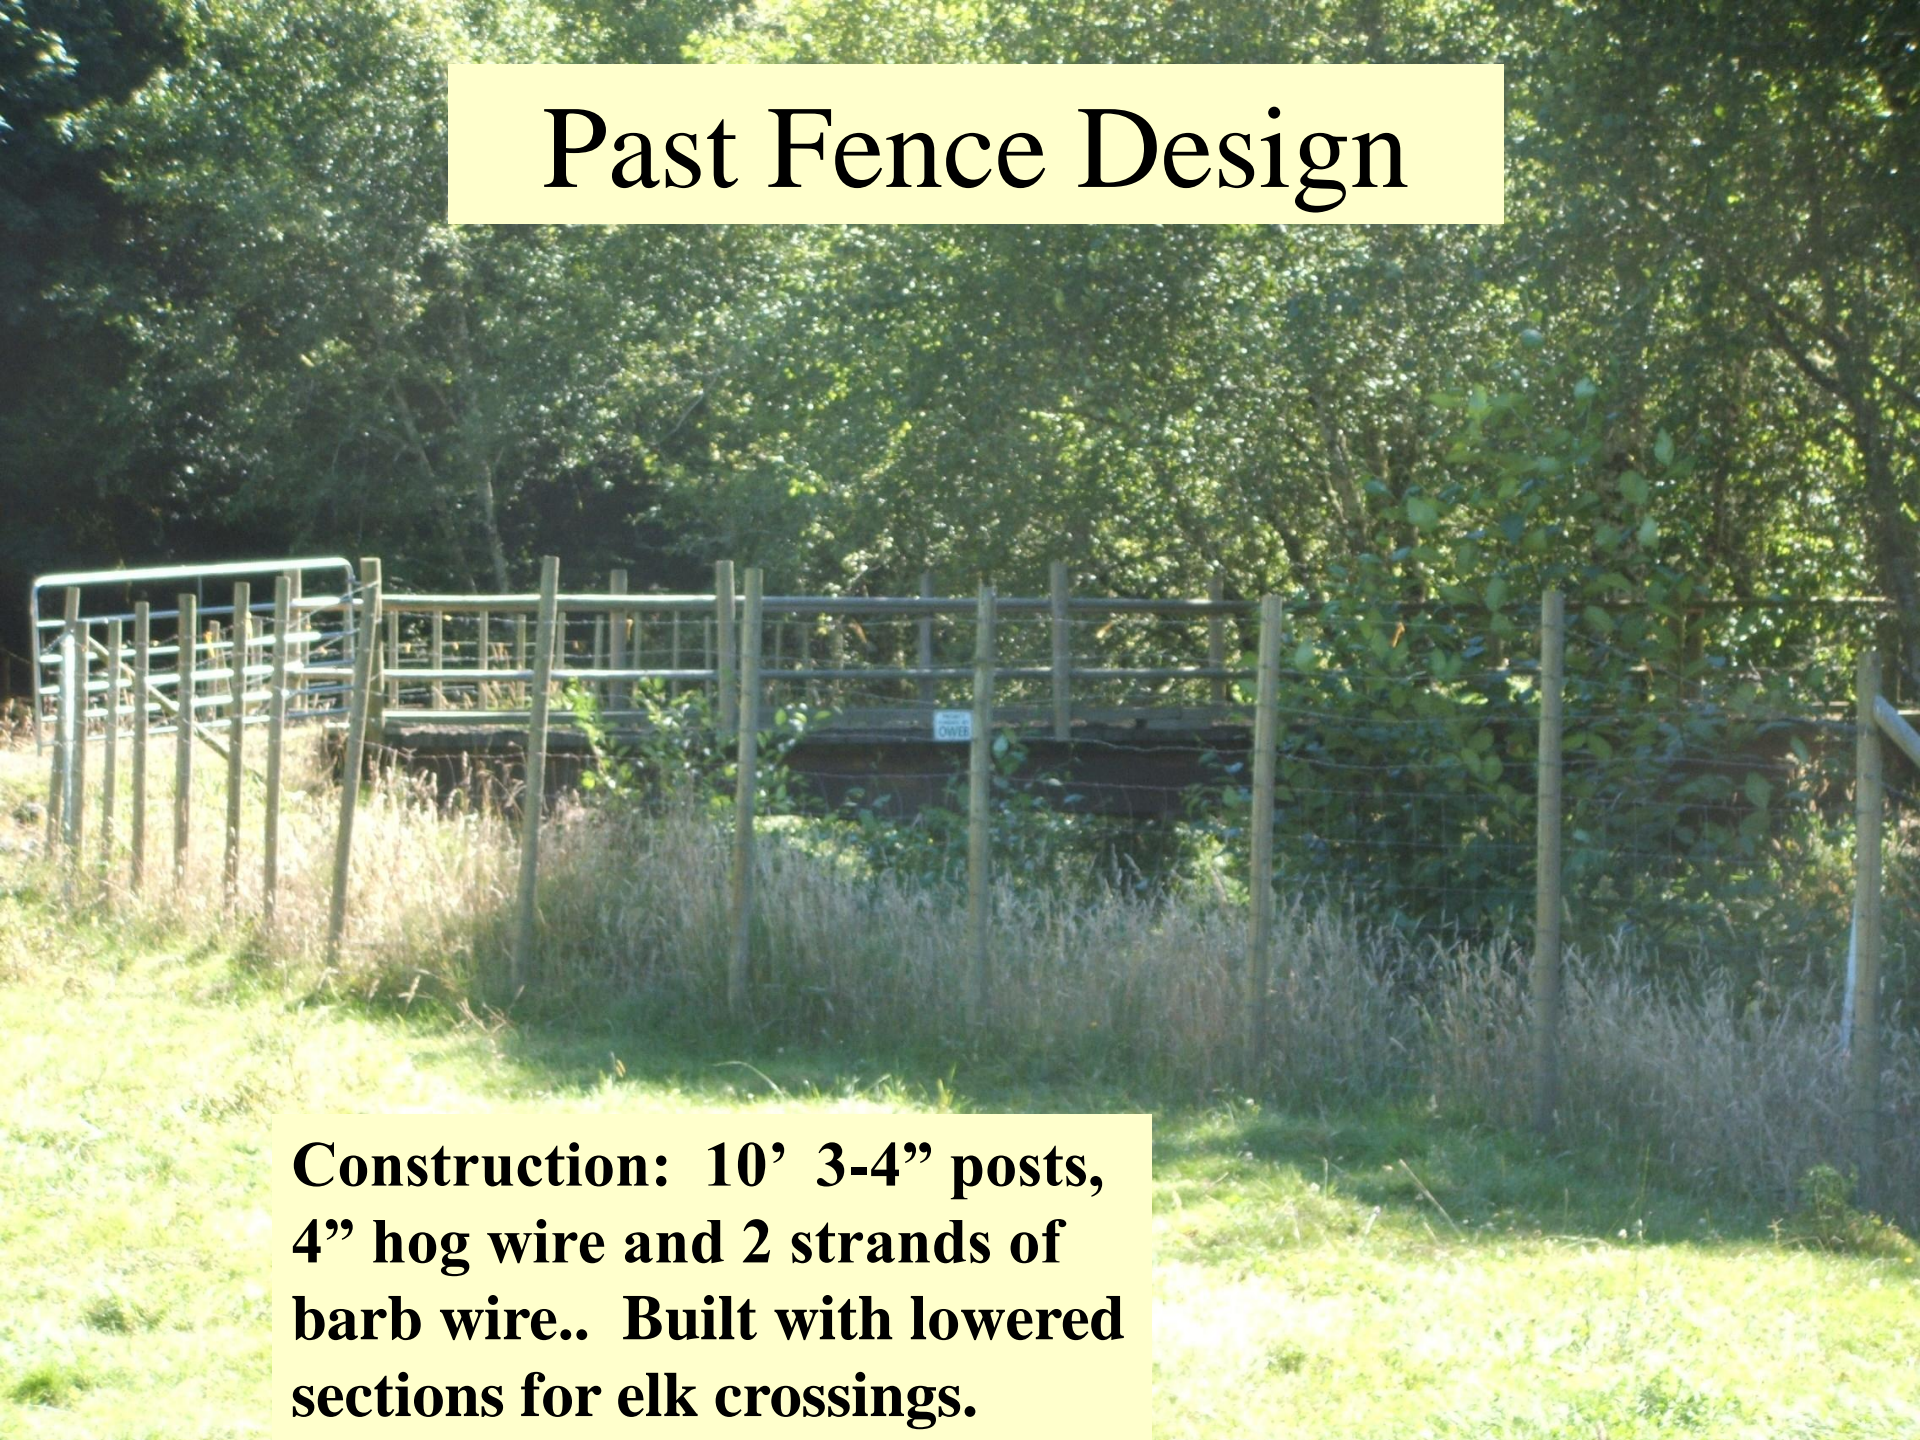
# Past Fence Design

**Construction: 10' 3-4" posts, 4" hog wire and 2 strands of barb wire.. Built with lowered sections for elk crossings.**

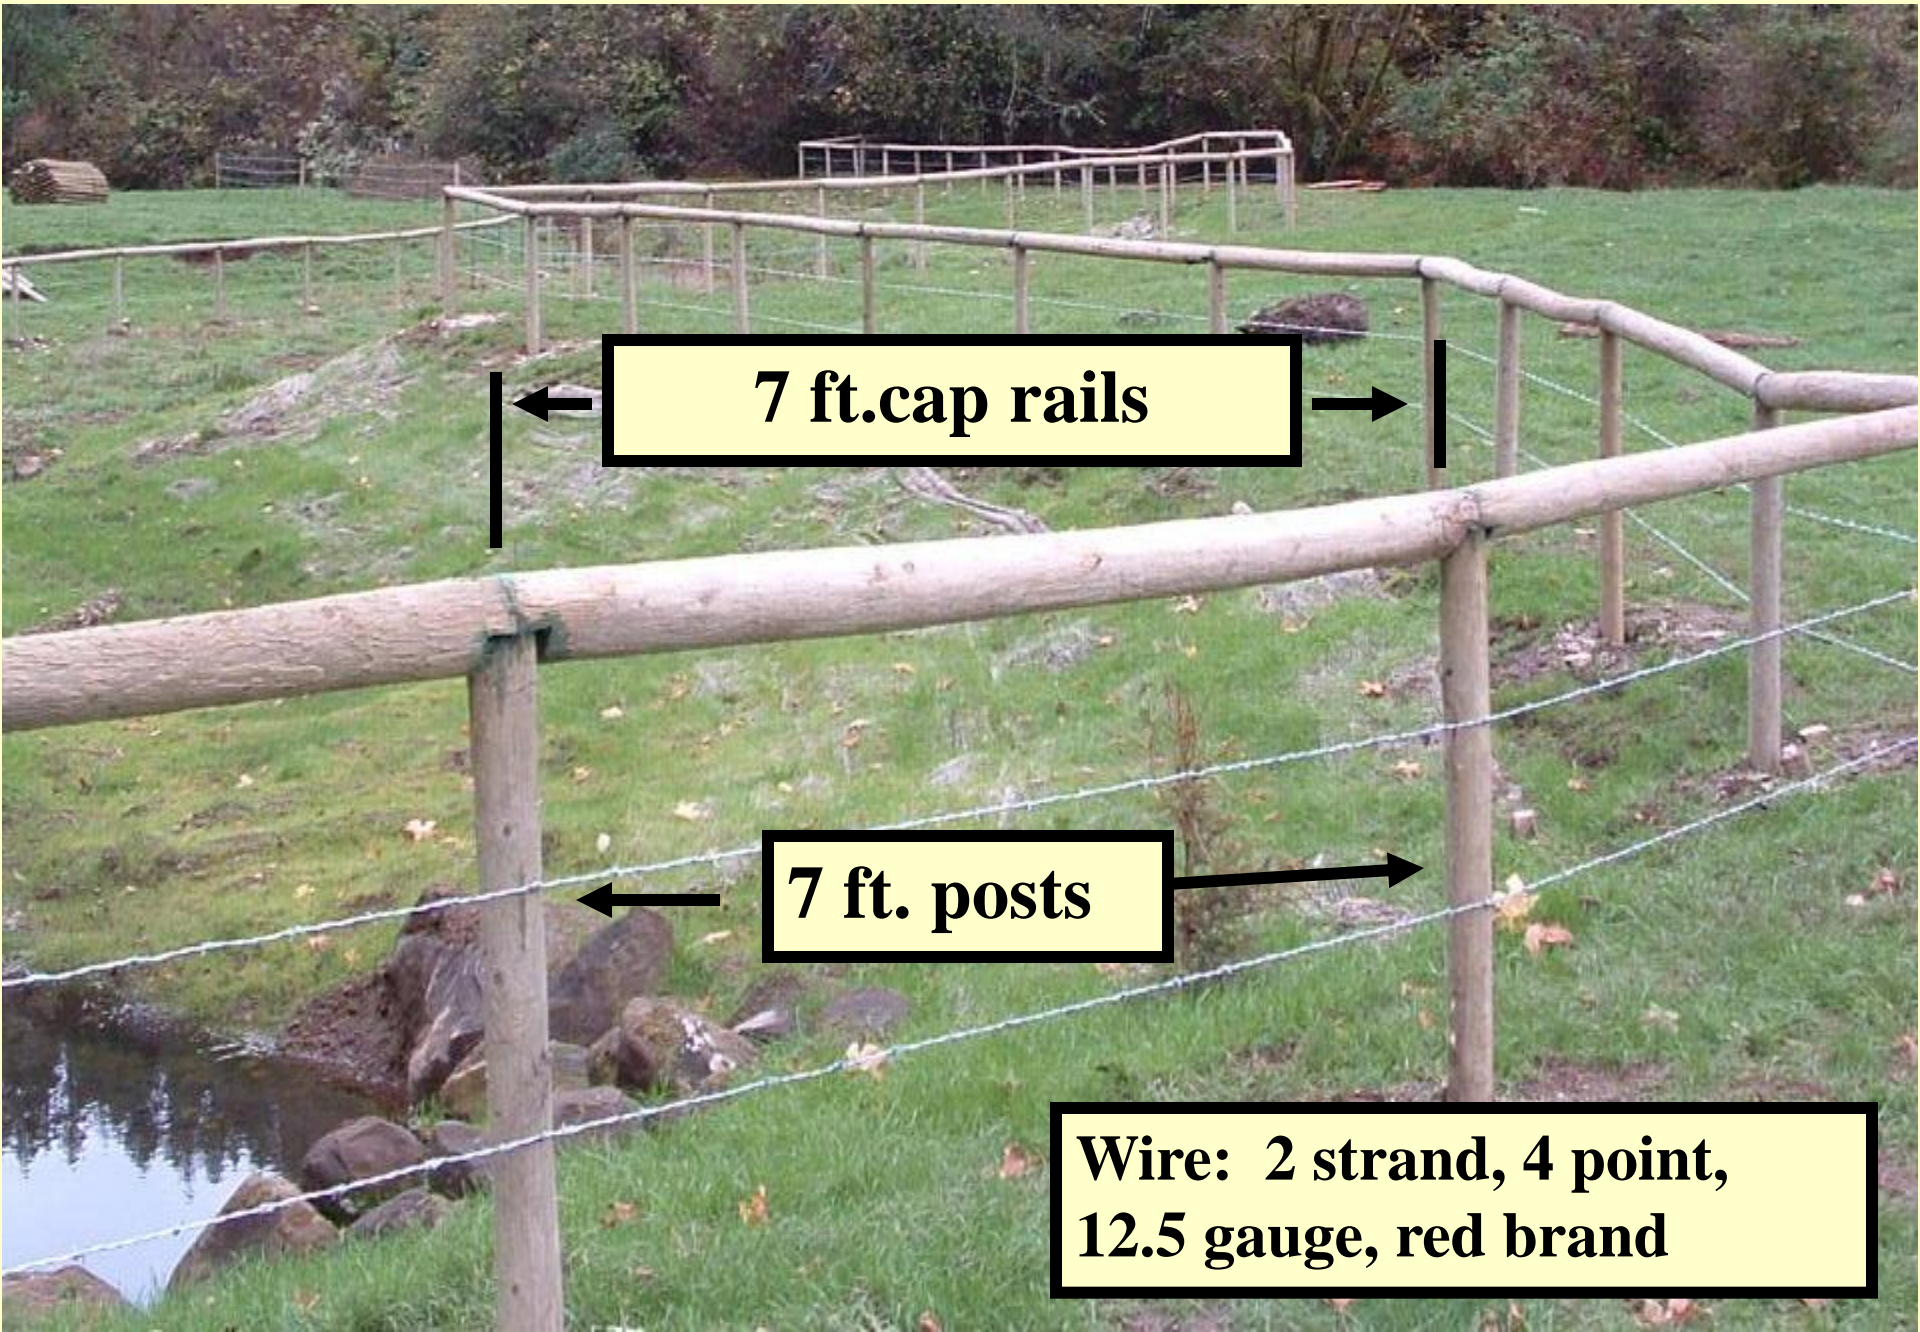
# Cattle Exclusion Fence Design

**7 ft. cap rails**

**7 ft. posts**

**Wire: 2 strand, 4 point,  
12.5 gauge, red brand**

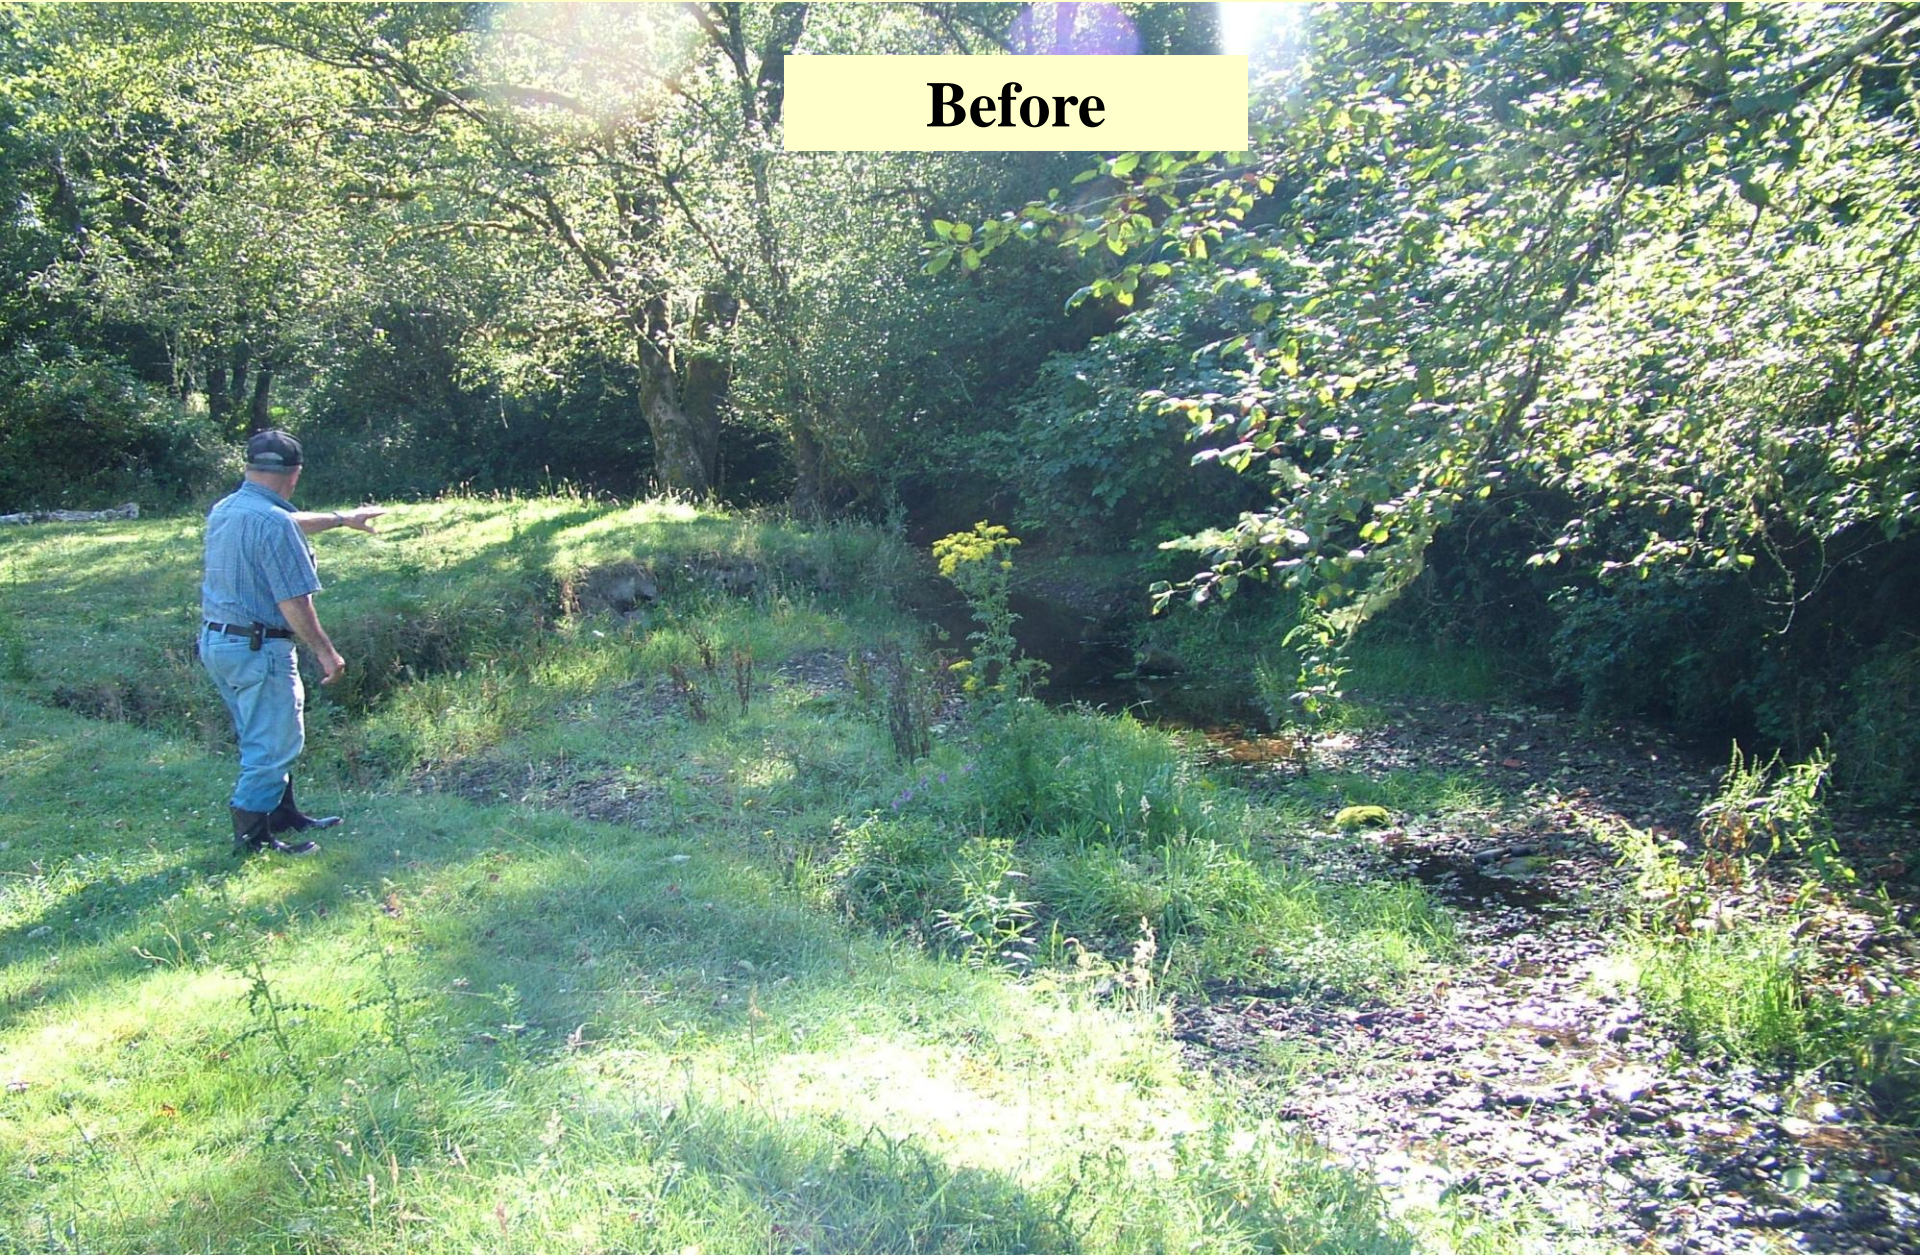
# Noble Creek Bank Stabilization

**Before**

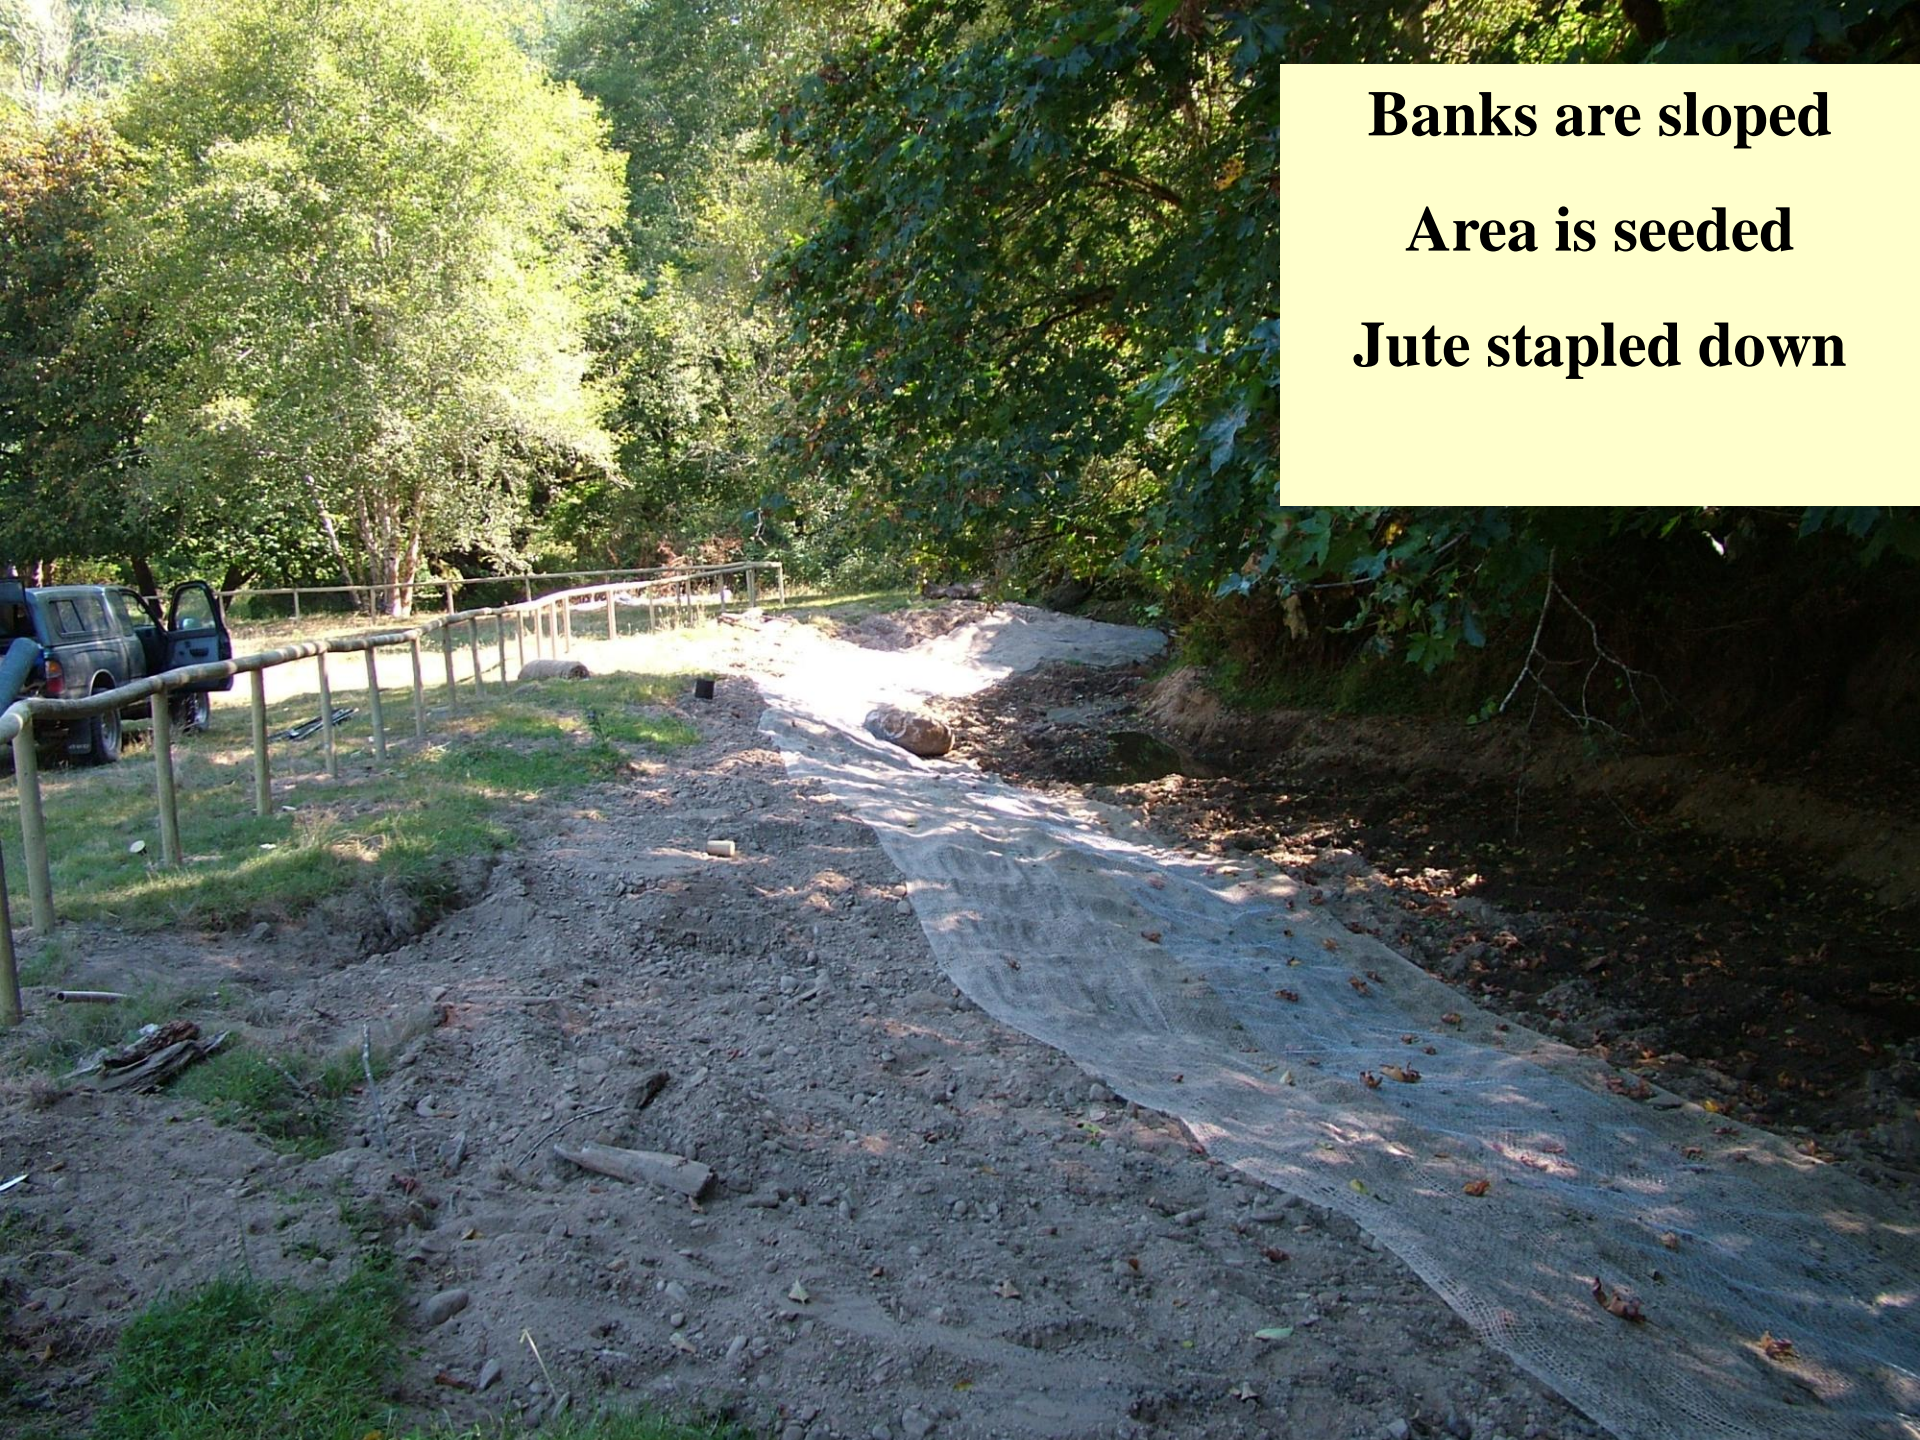
**Banks are sloped**  
**Area is seeded**  
**Jute stapled down**

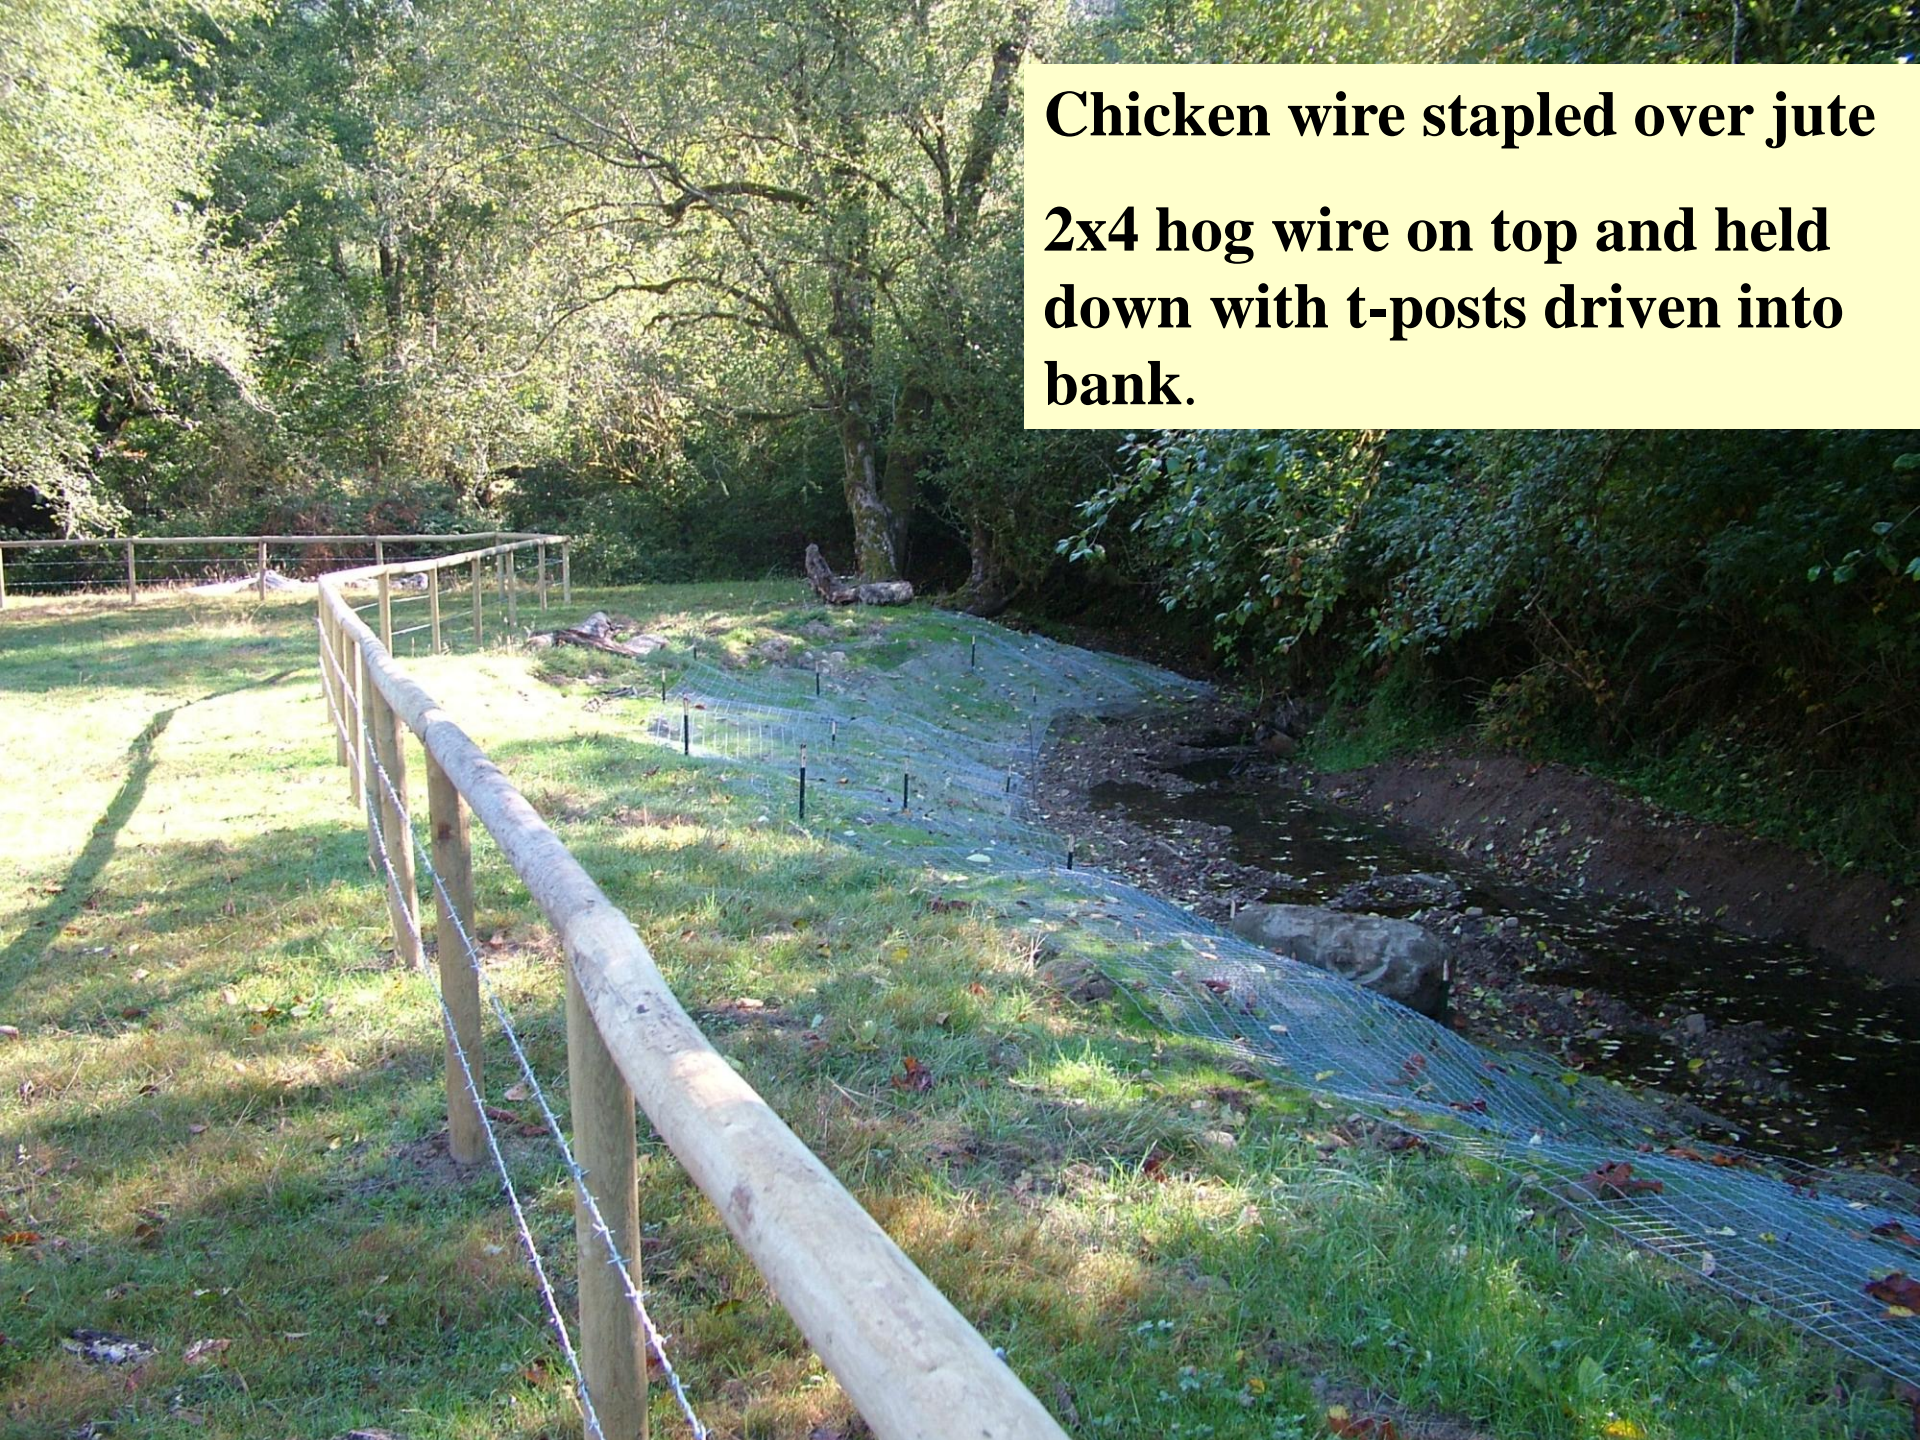
**Chicken wire stapled over jute  
2x4 hog wire on top and held  
down with t-posts driven into  
bank.**
