# Tenmile Lakes Basin Partnership

## 2006 Project Presentation

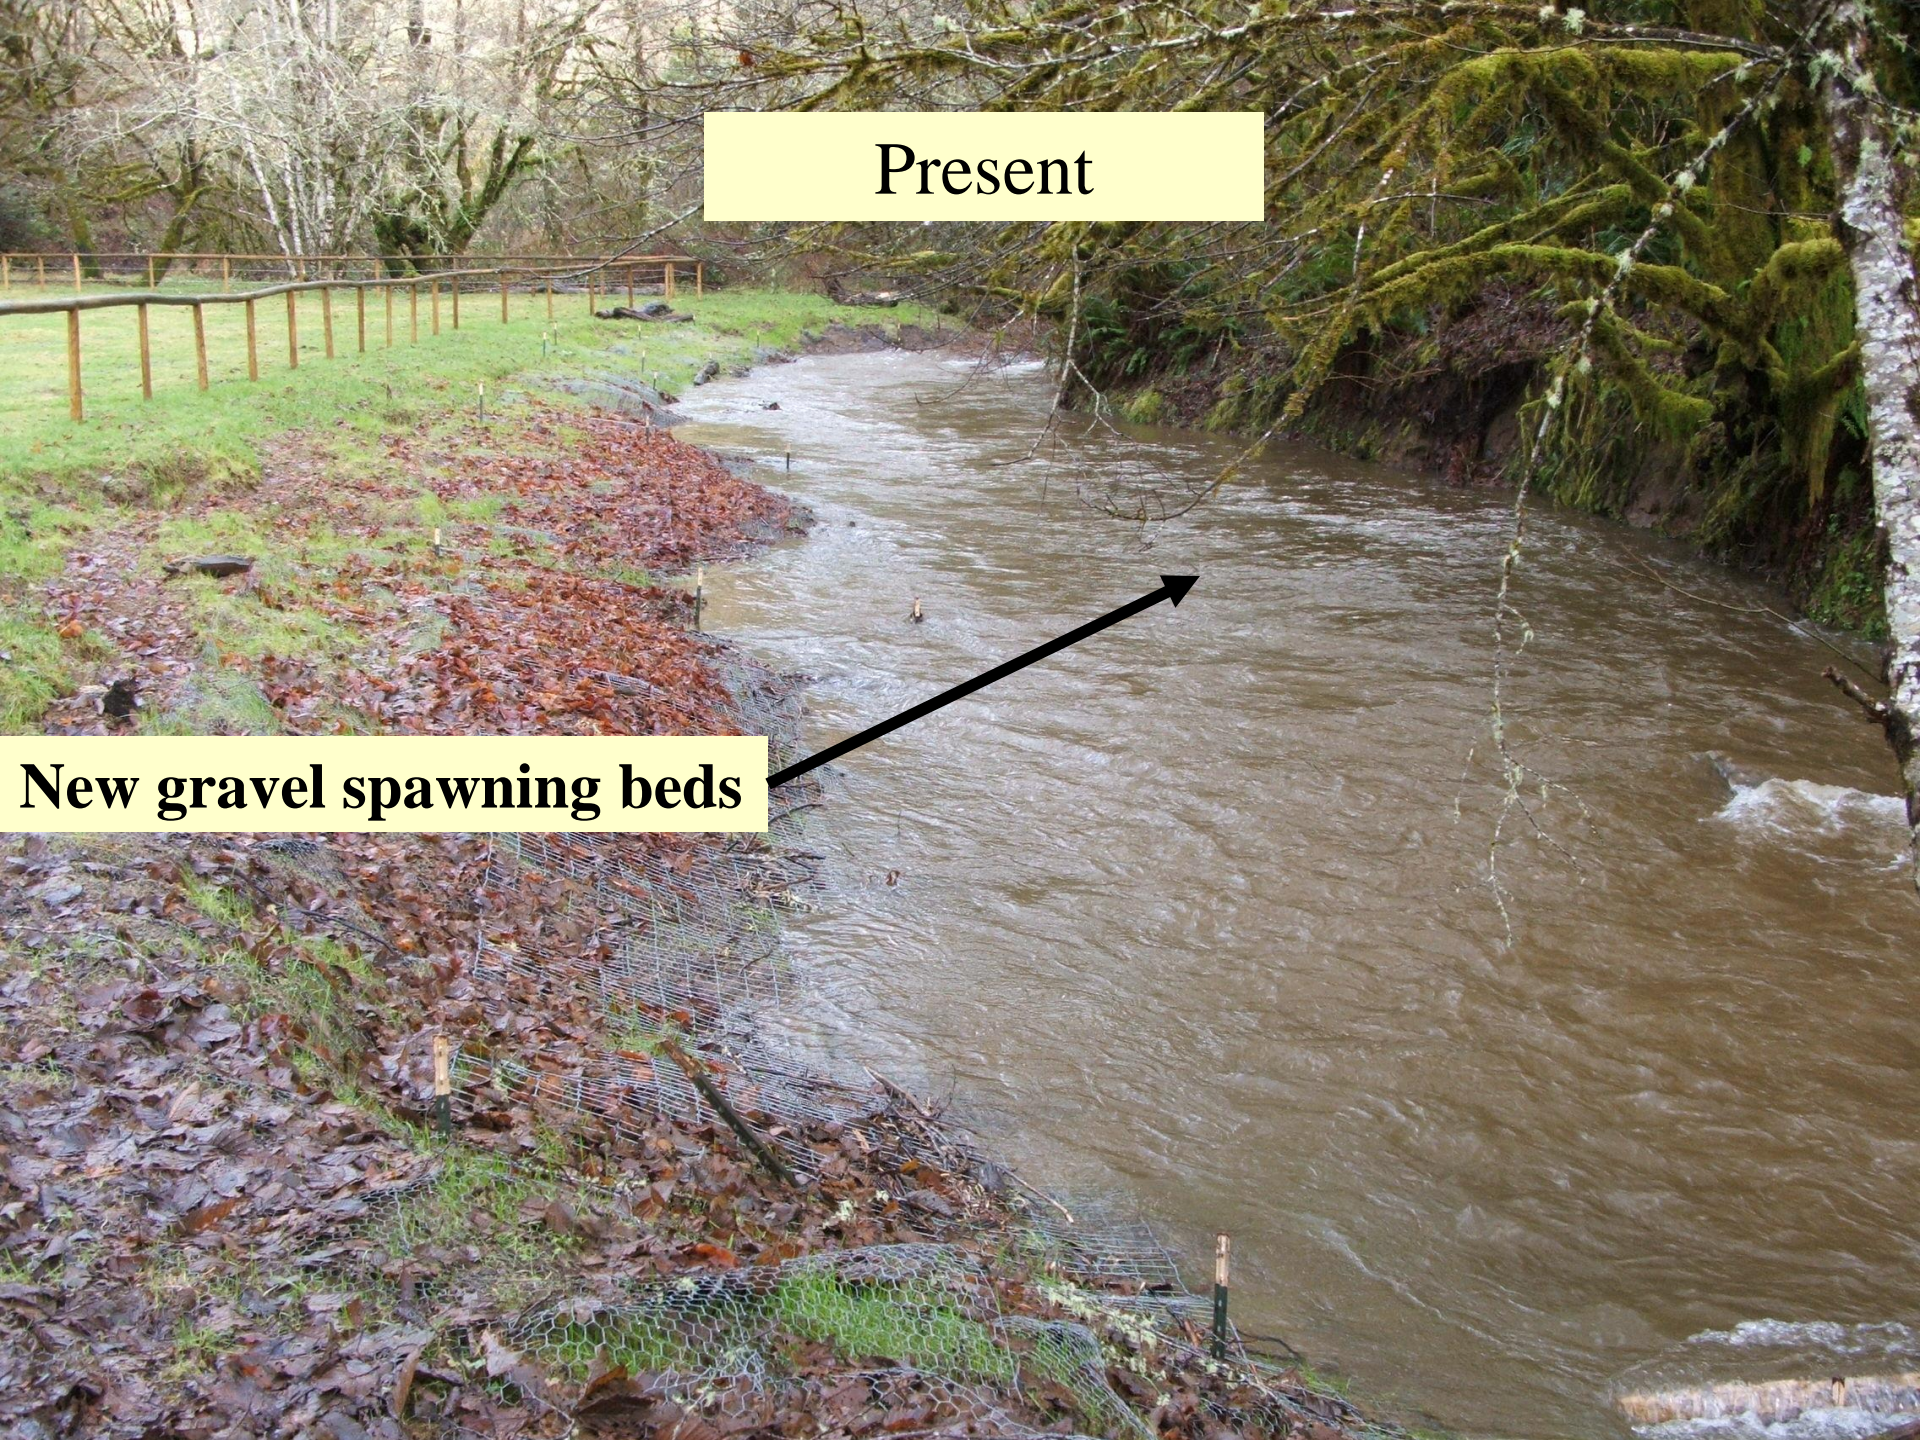
Present

**New gravel spawning beds**
