# State of the Lakes

# OVERVIEW

# Tenmile Lakes Watershed

Tennessee Lakes Basin Partnership  
2006 Project Presentation

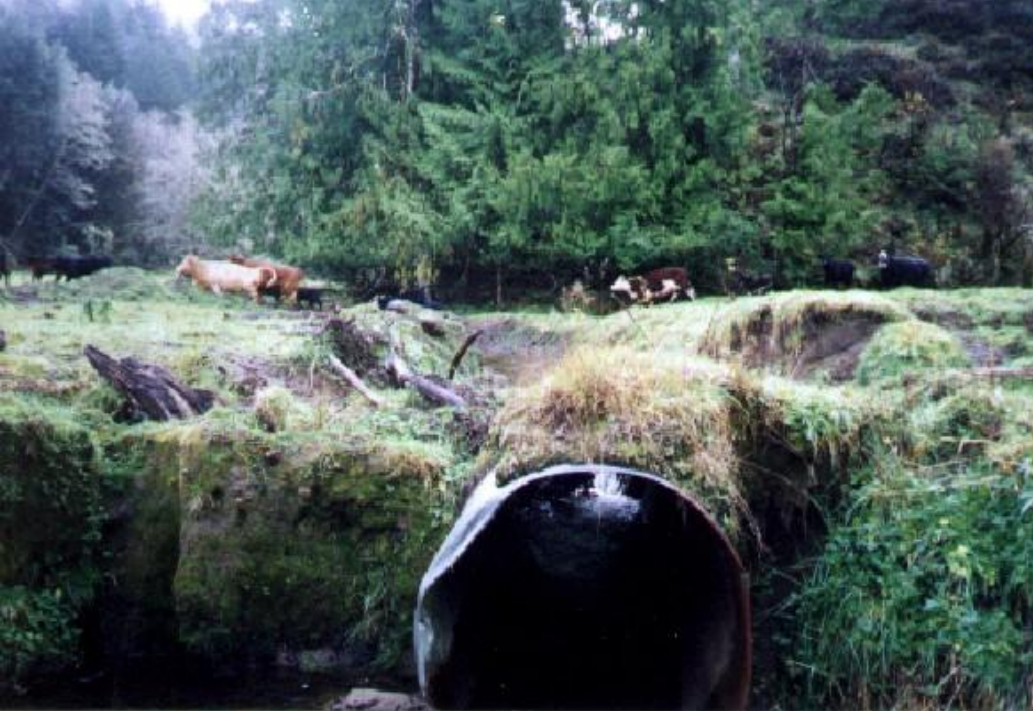
A culvert in Robertson Cr.  
Identified in 1999 as  
juvenile fish barrier and  
high risk sediment source

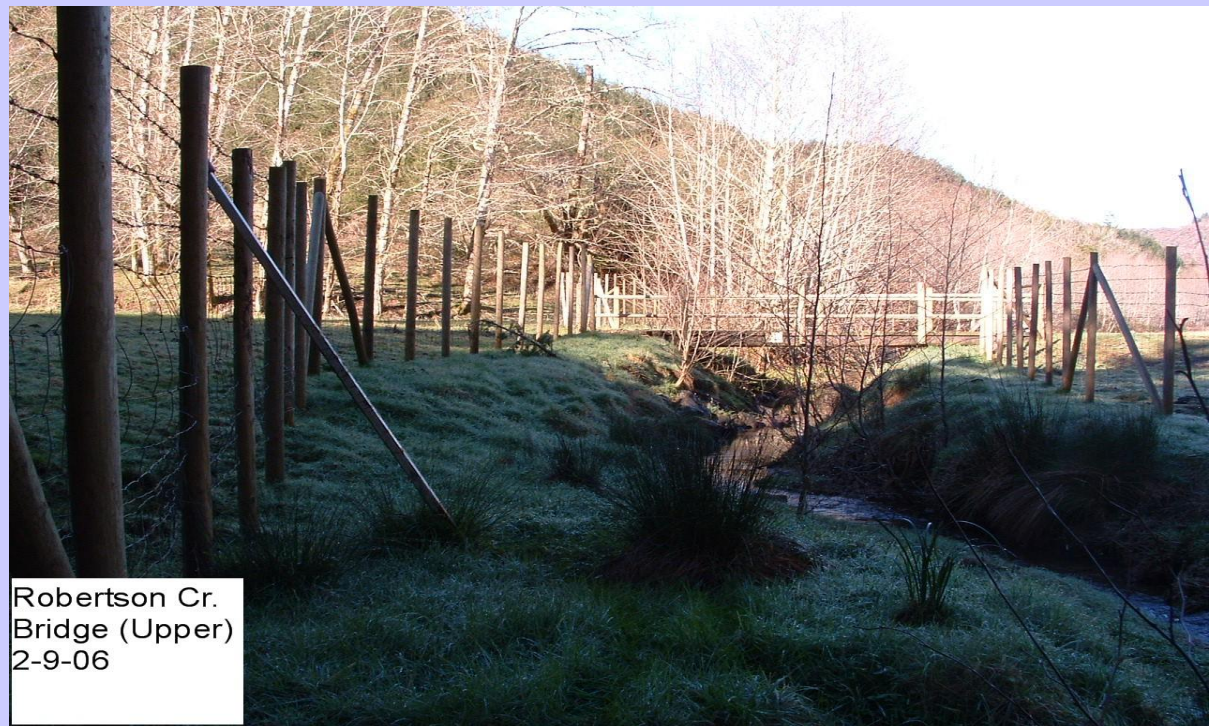
Robertson Cr. Bridge  
and Fencing project  
implemented in 2000.

Robertson Cr.  
Bridge (Upper)  
2-9-06

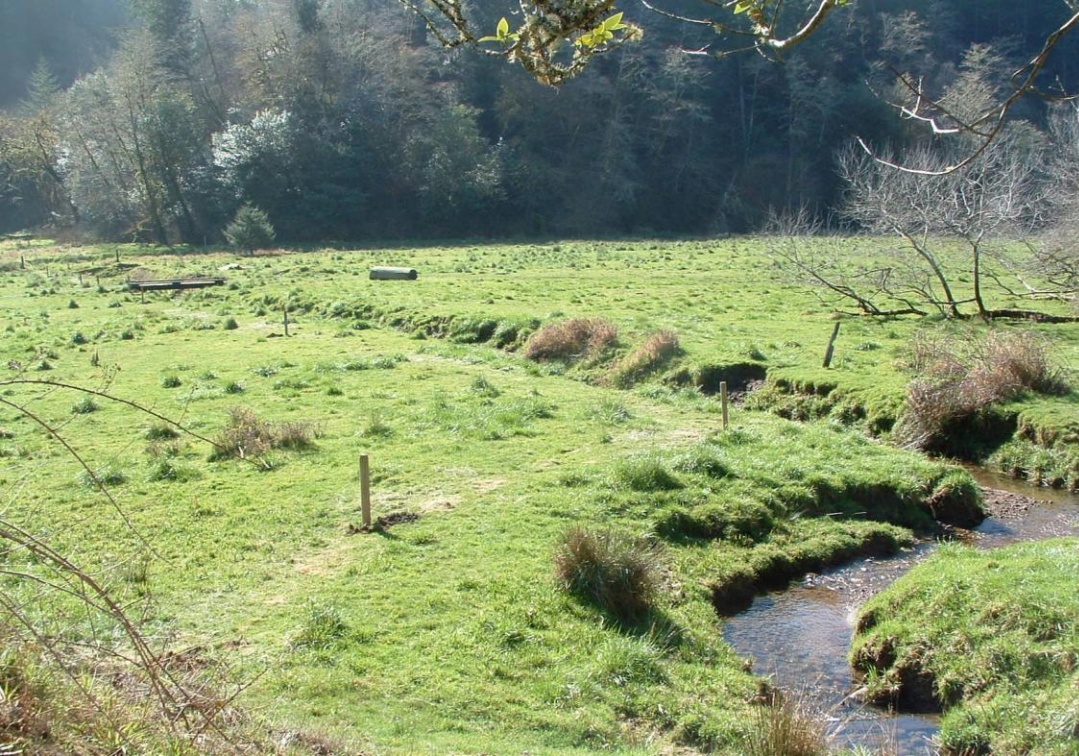
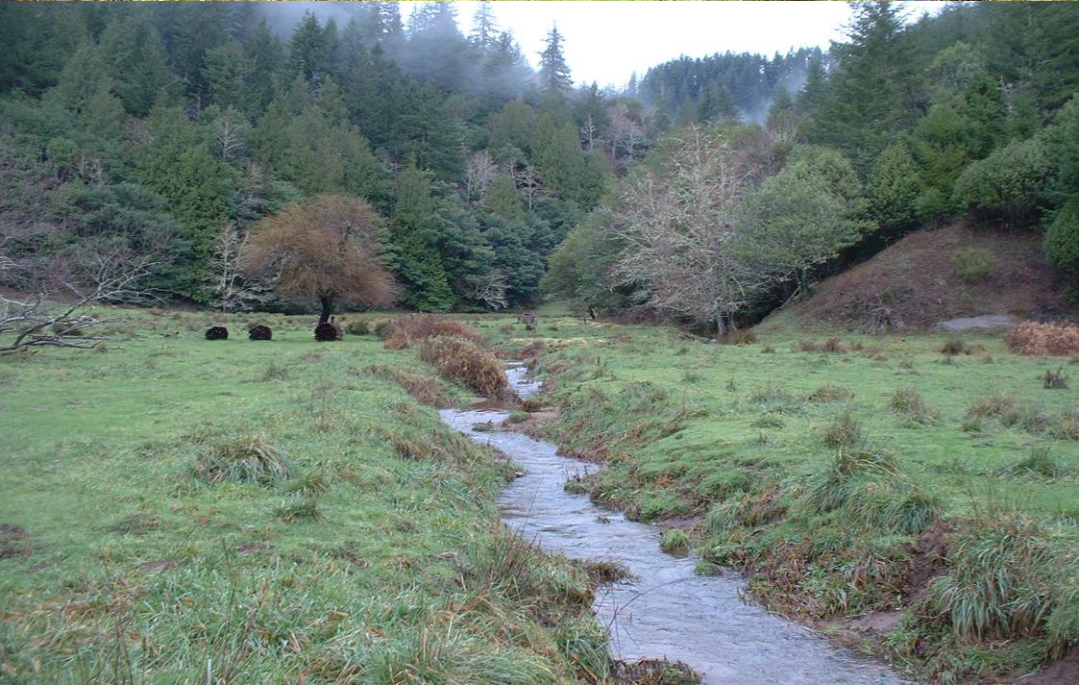
# House Gulch Fencing

Before

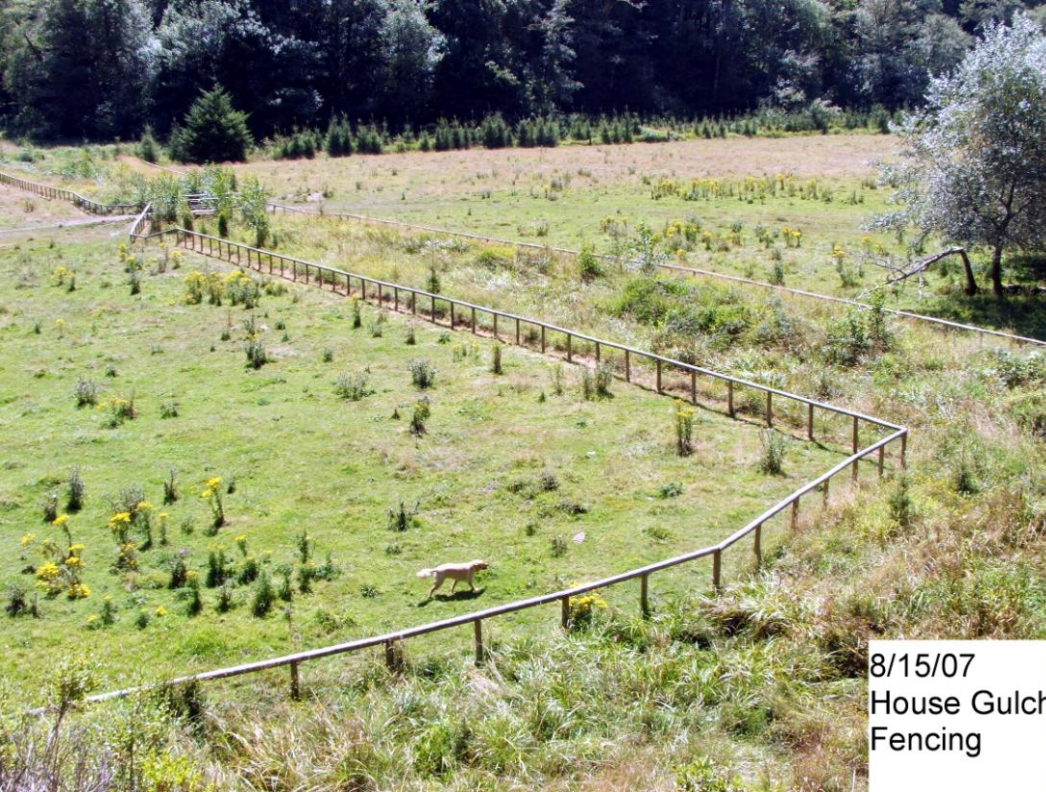
# House Gulch Fencing

After

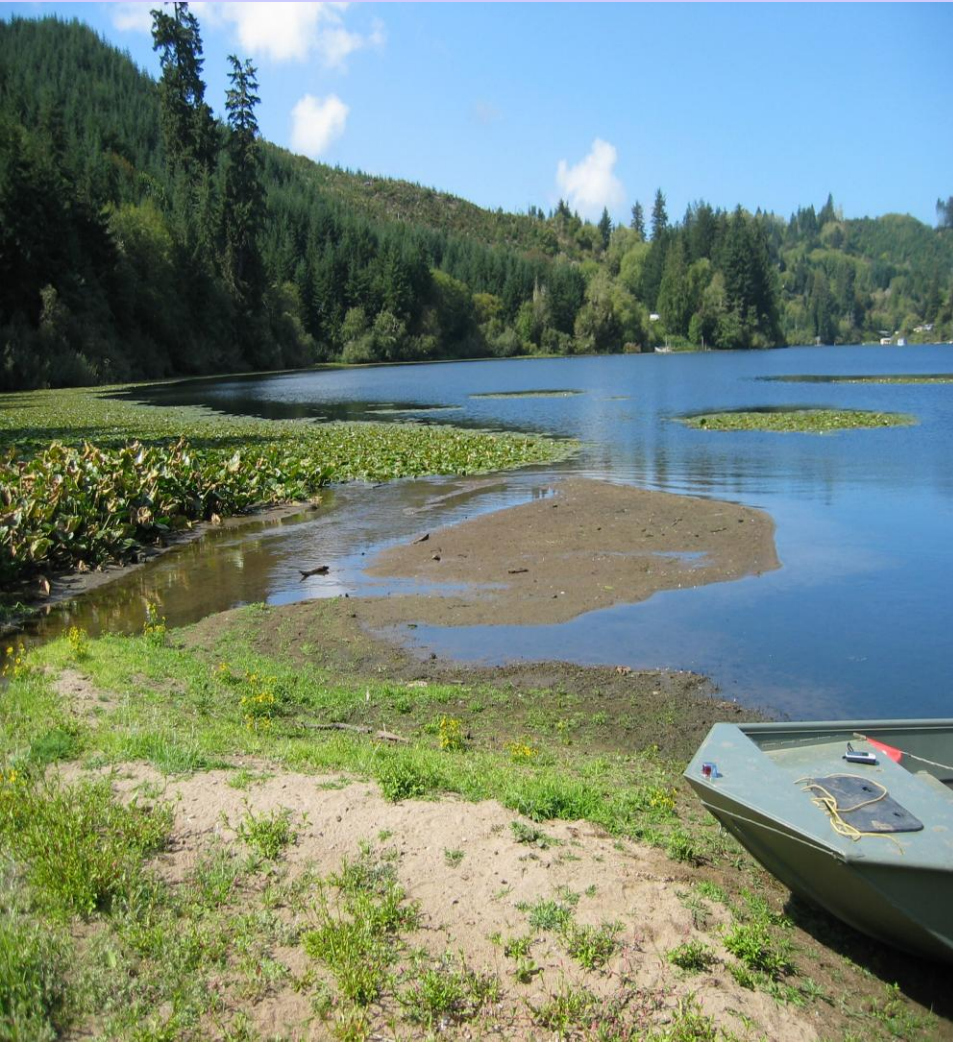
# Benson Cr.

2004

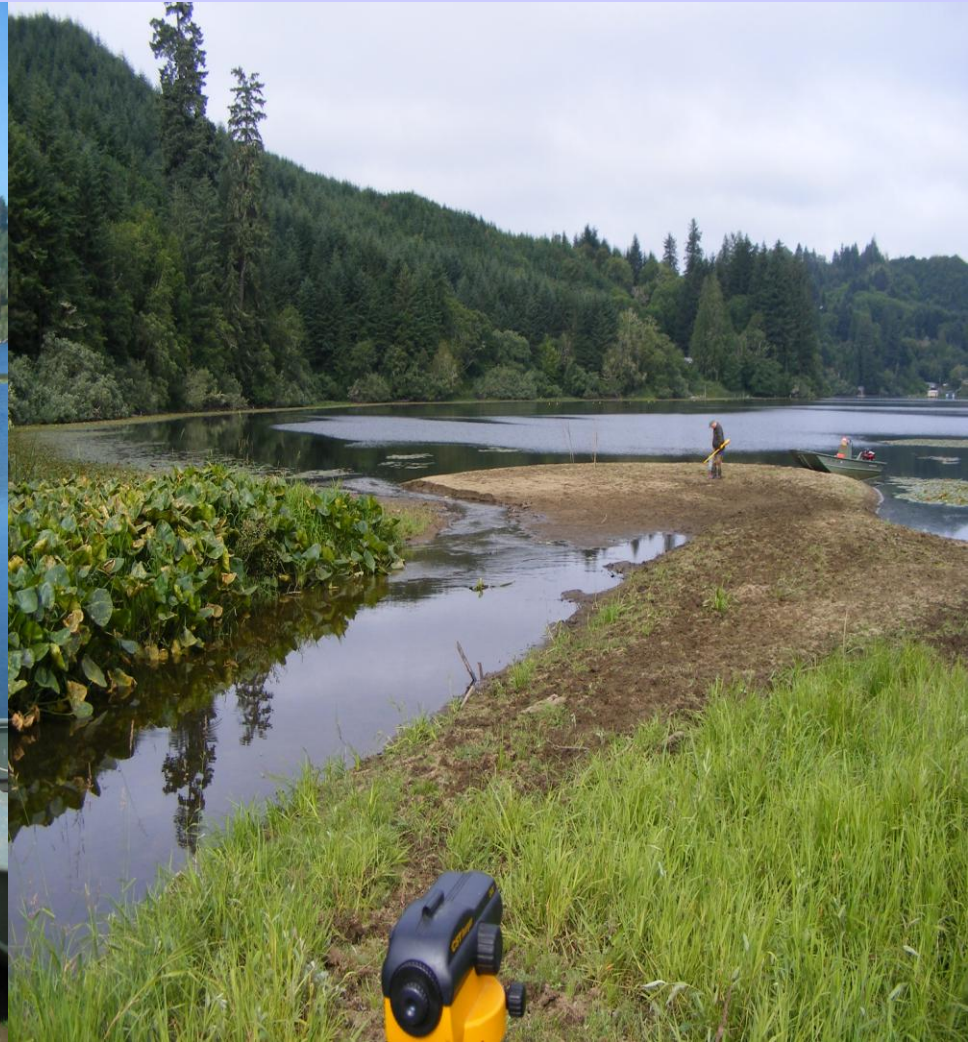
2008

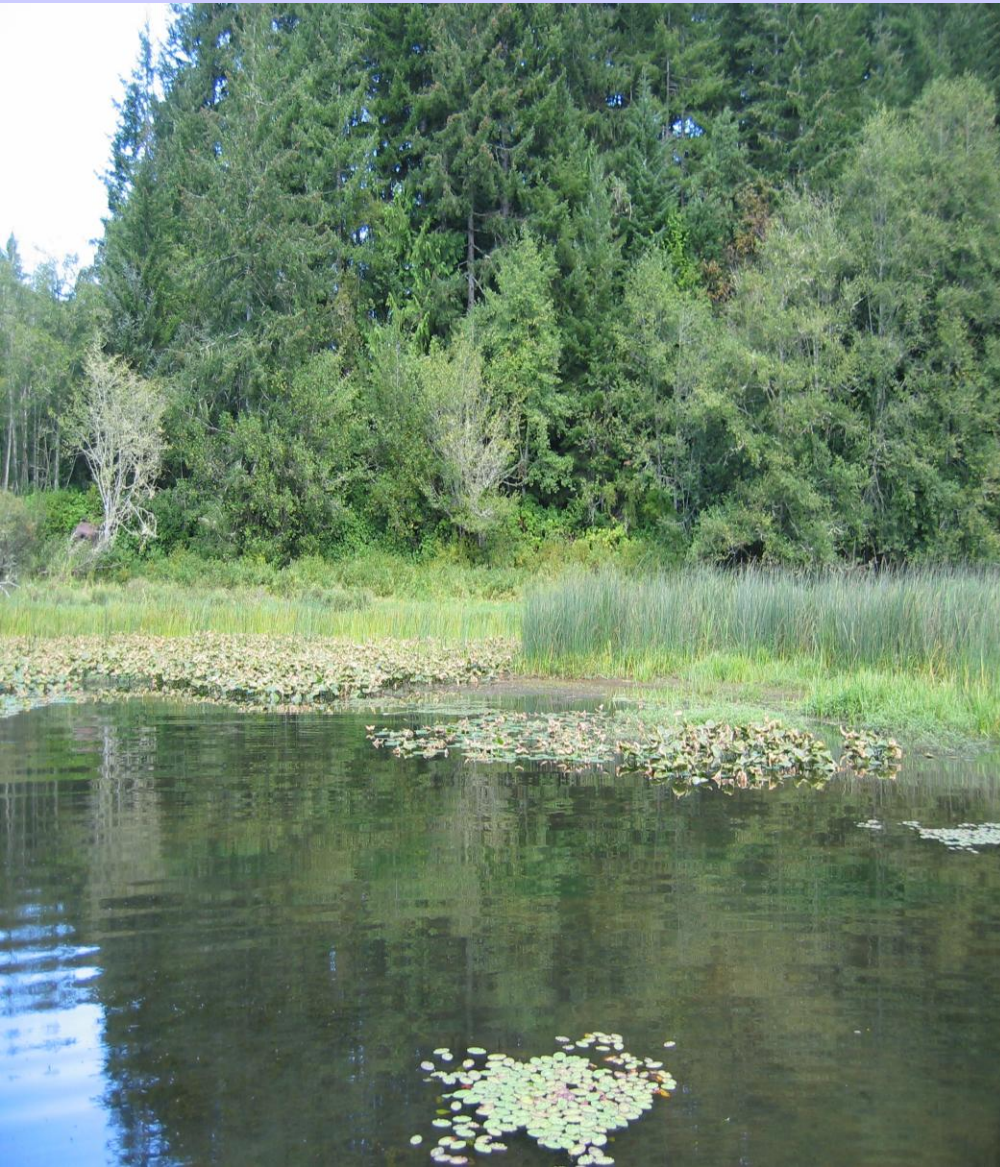
# Murphy

2004

2004

No land mass to  
measure

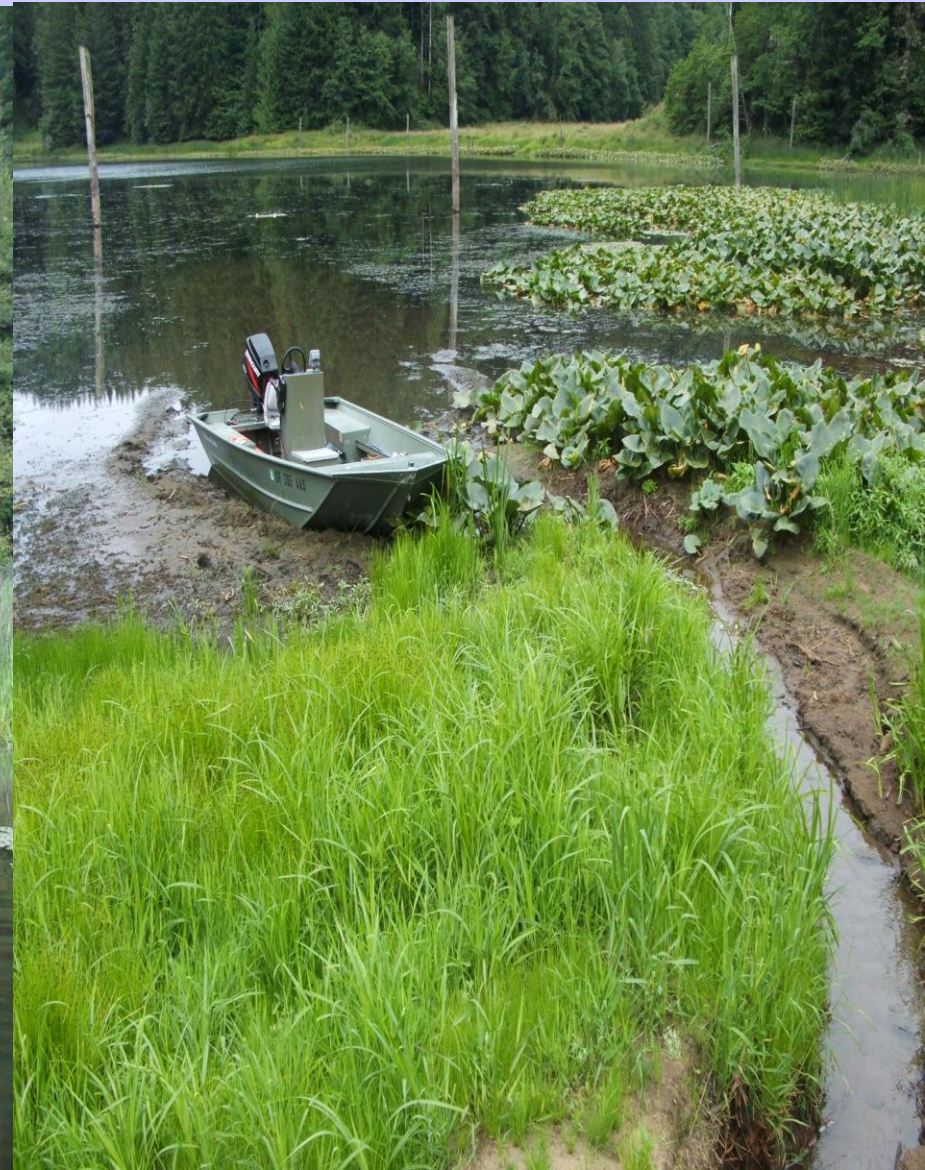
2007

Length-63' 2"

•1:width- 17'5"

•2:width- 14'6"

•3:width- 9'

•4:width- 4' 10"
