# State of the Lakes

# OVERVIEW

- BREIF LAKE HISTORY
- ALGAE SAMPLING
- NUTRIENT MONITORING
- SEDIMENTATION
- SHORELINE DEVELOPMENT
- SEPTIC TANKS
- WATER AVAILABILITY
- NON-NATIVE WEEDS & FISH
- VOLUNTEER OPPORTUNITIES

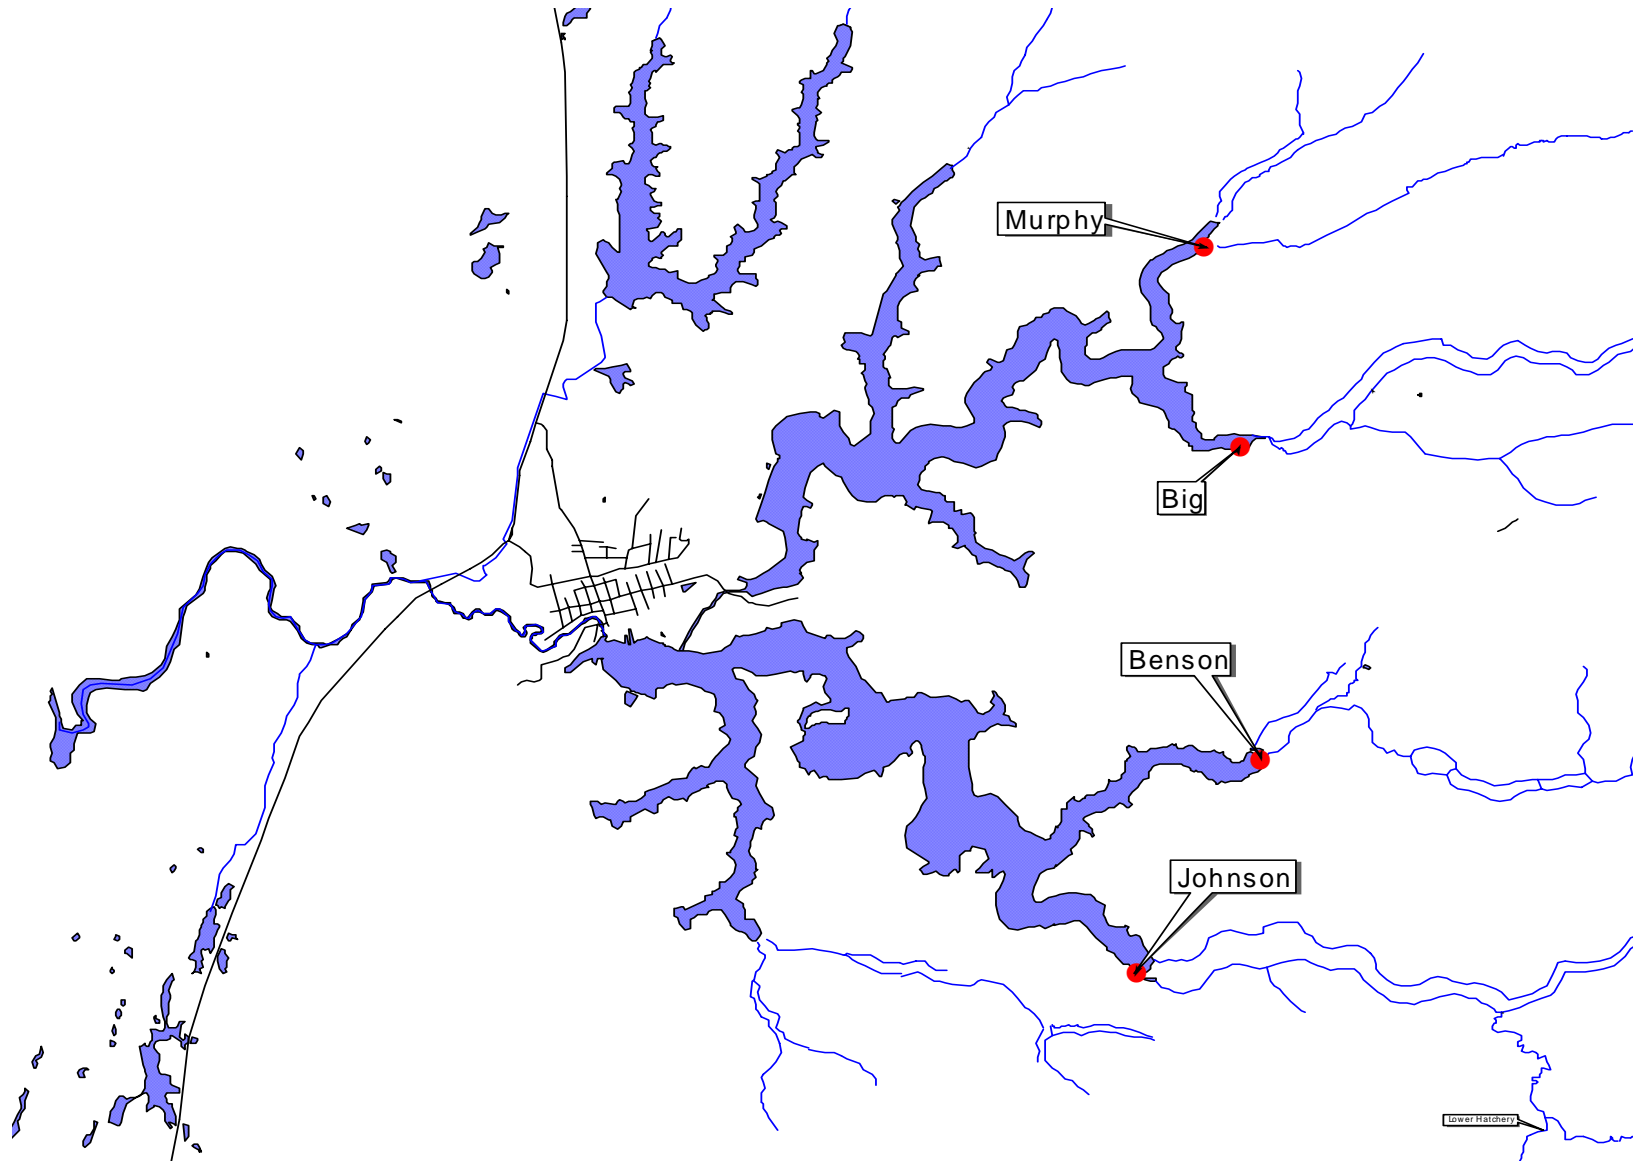
# Delta Building Sites

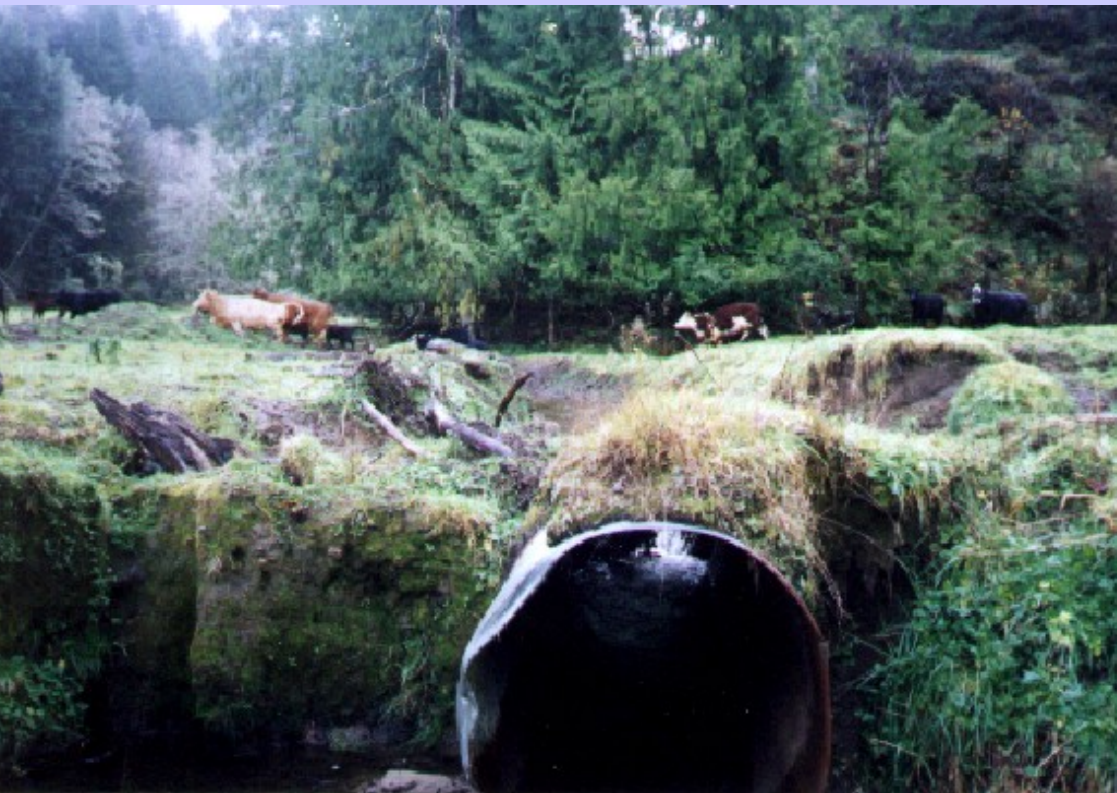
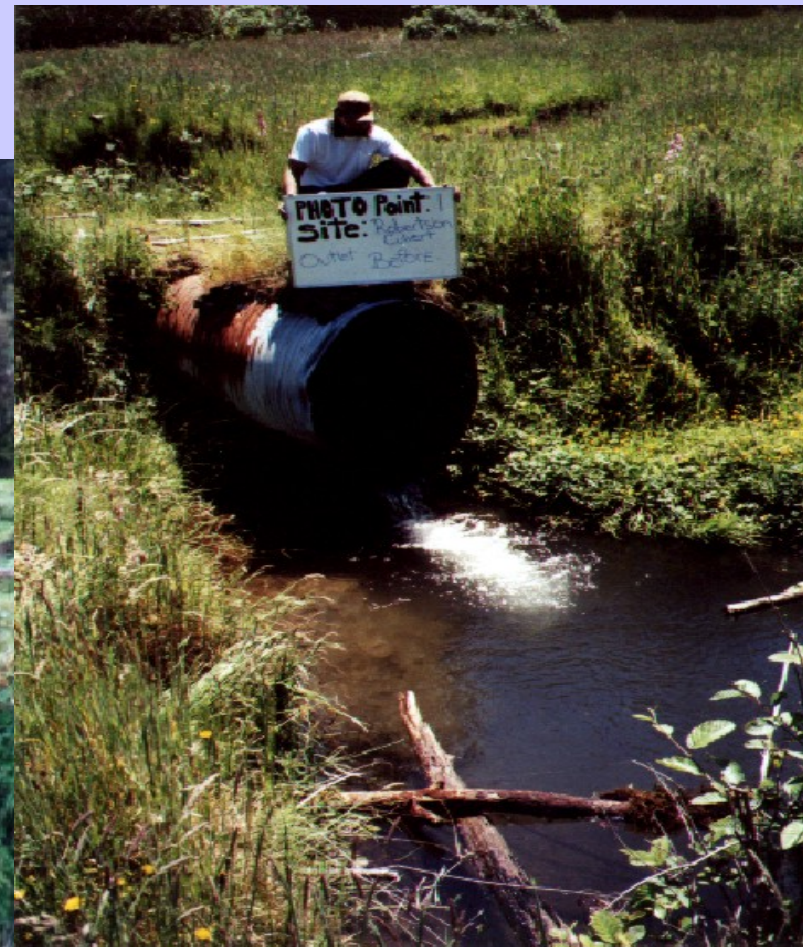
# Robertson Cr. Failed Culvert Replacement

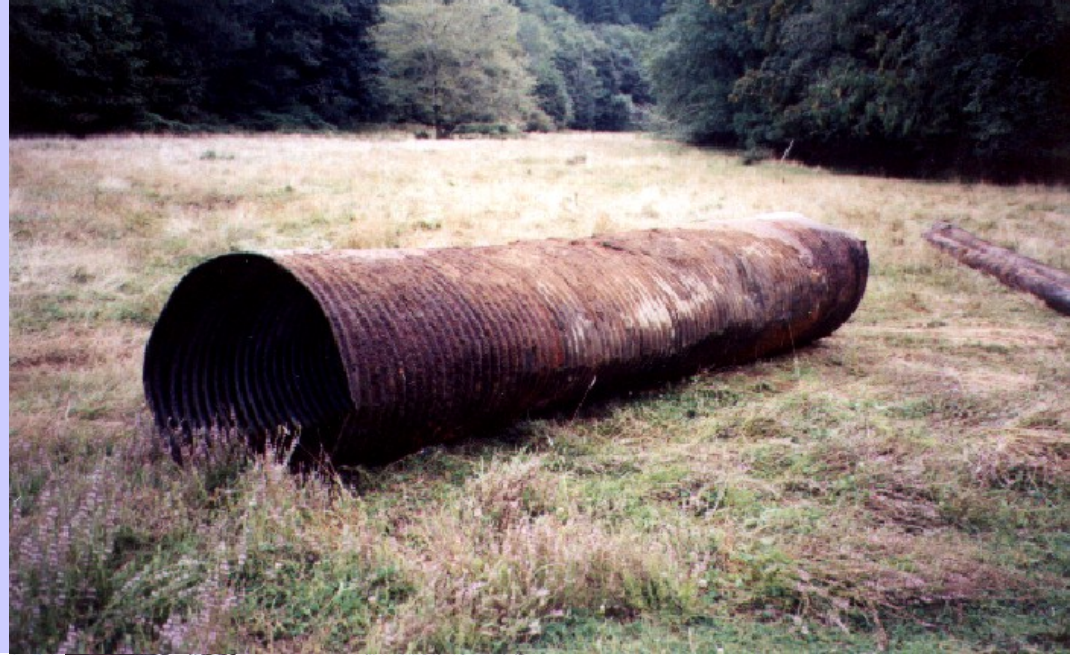
2/13/08  
Robertson Cr.  
Bridge

# Robertson Cr. Culvert replaced with a log stringer bridge

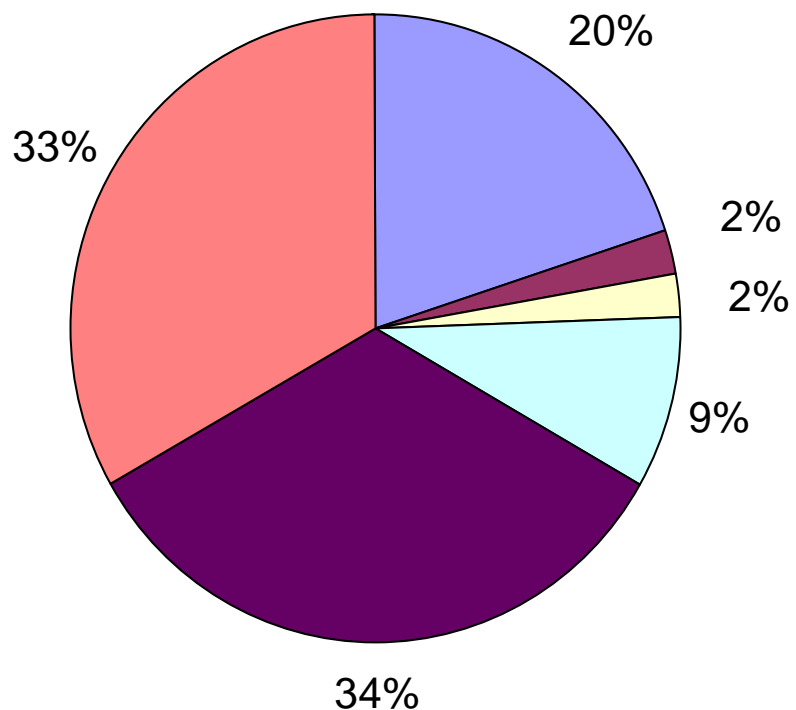
## Results of Tenmile Lakes Septic Survey

- Apparent properly functioning systems.
- Sites with untreated gray water discharge.
- System failures with evidence of sewage discharge into lake or ground water.
- Bottomless tanks identified.
- Systems in need of repair (not including gray water).
- Owners with systems in need of repair.

# Pre-1974 Septic System Survey

Worked with county health department to inspect 26 lakefront homes in 2006 and 2007.

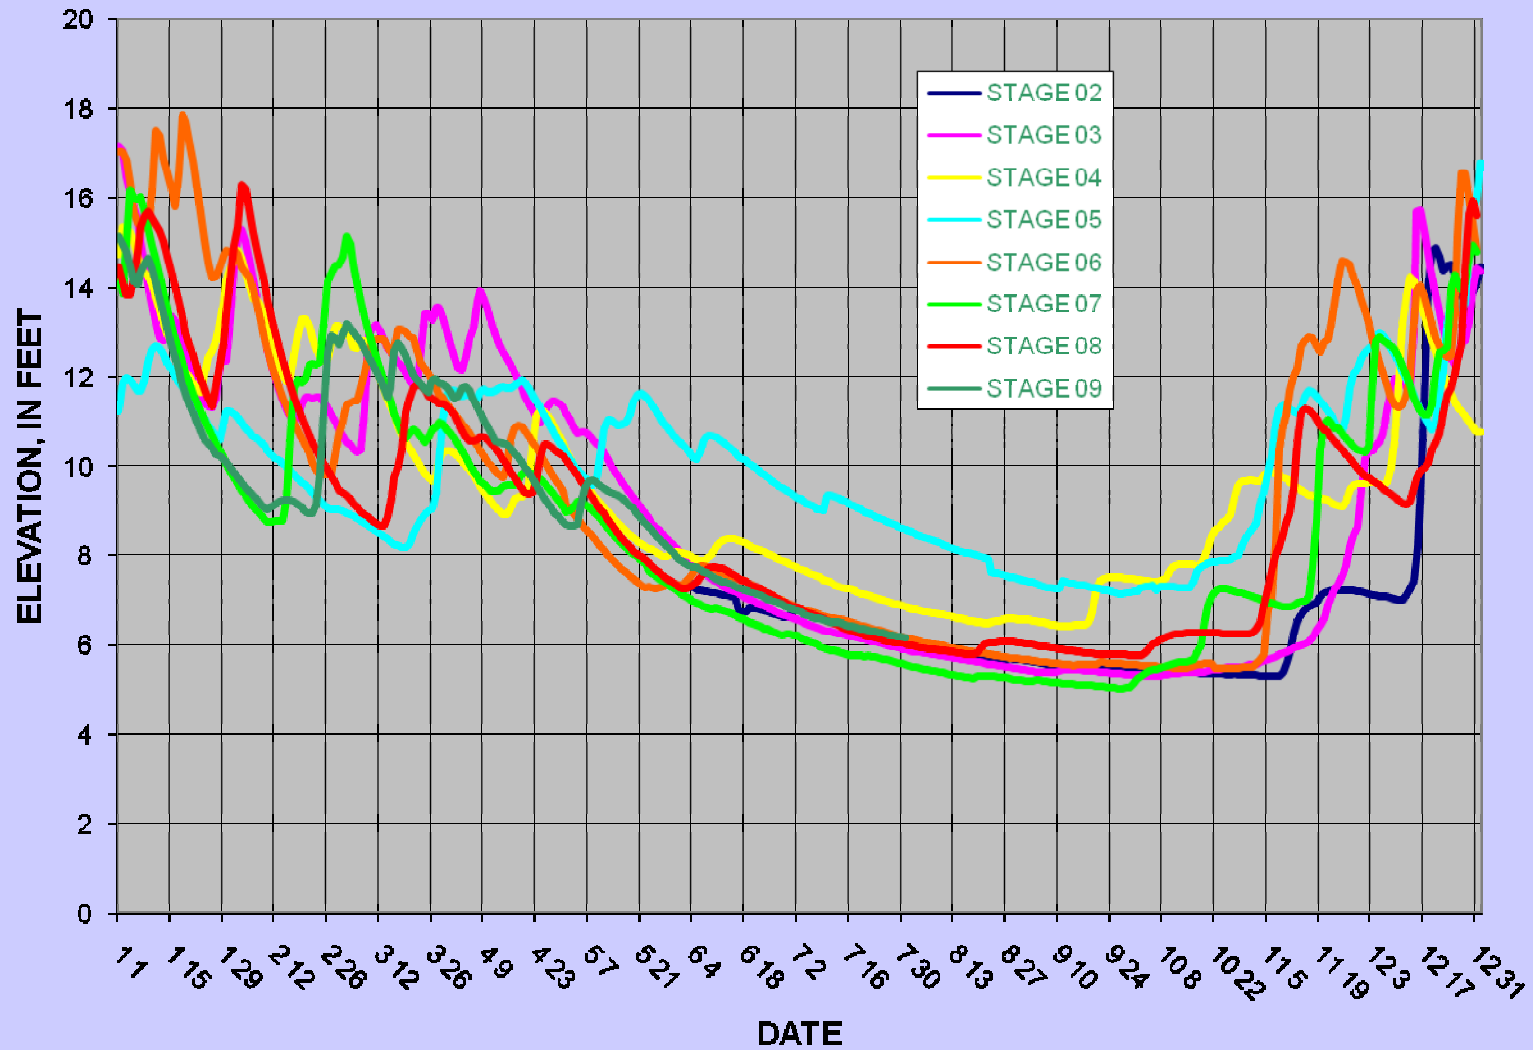
## TENMILE LAKE DAILY MEAN ELEVATIONS, CALENDAR YEARS

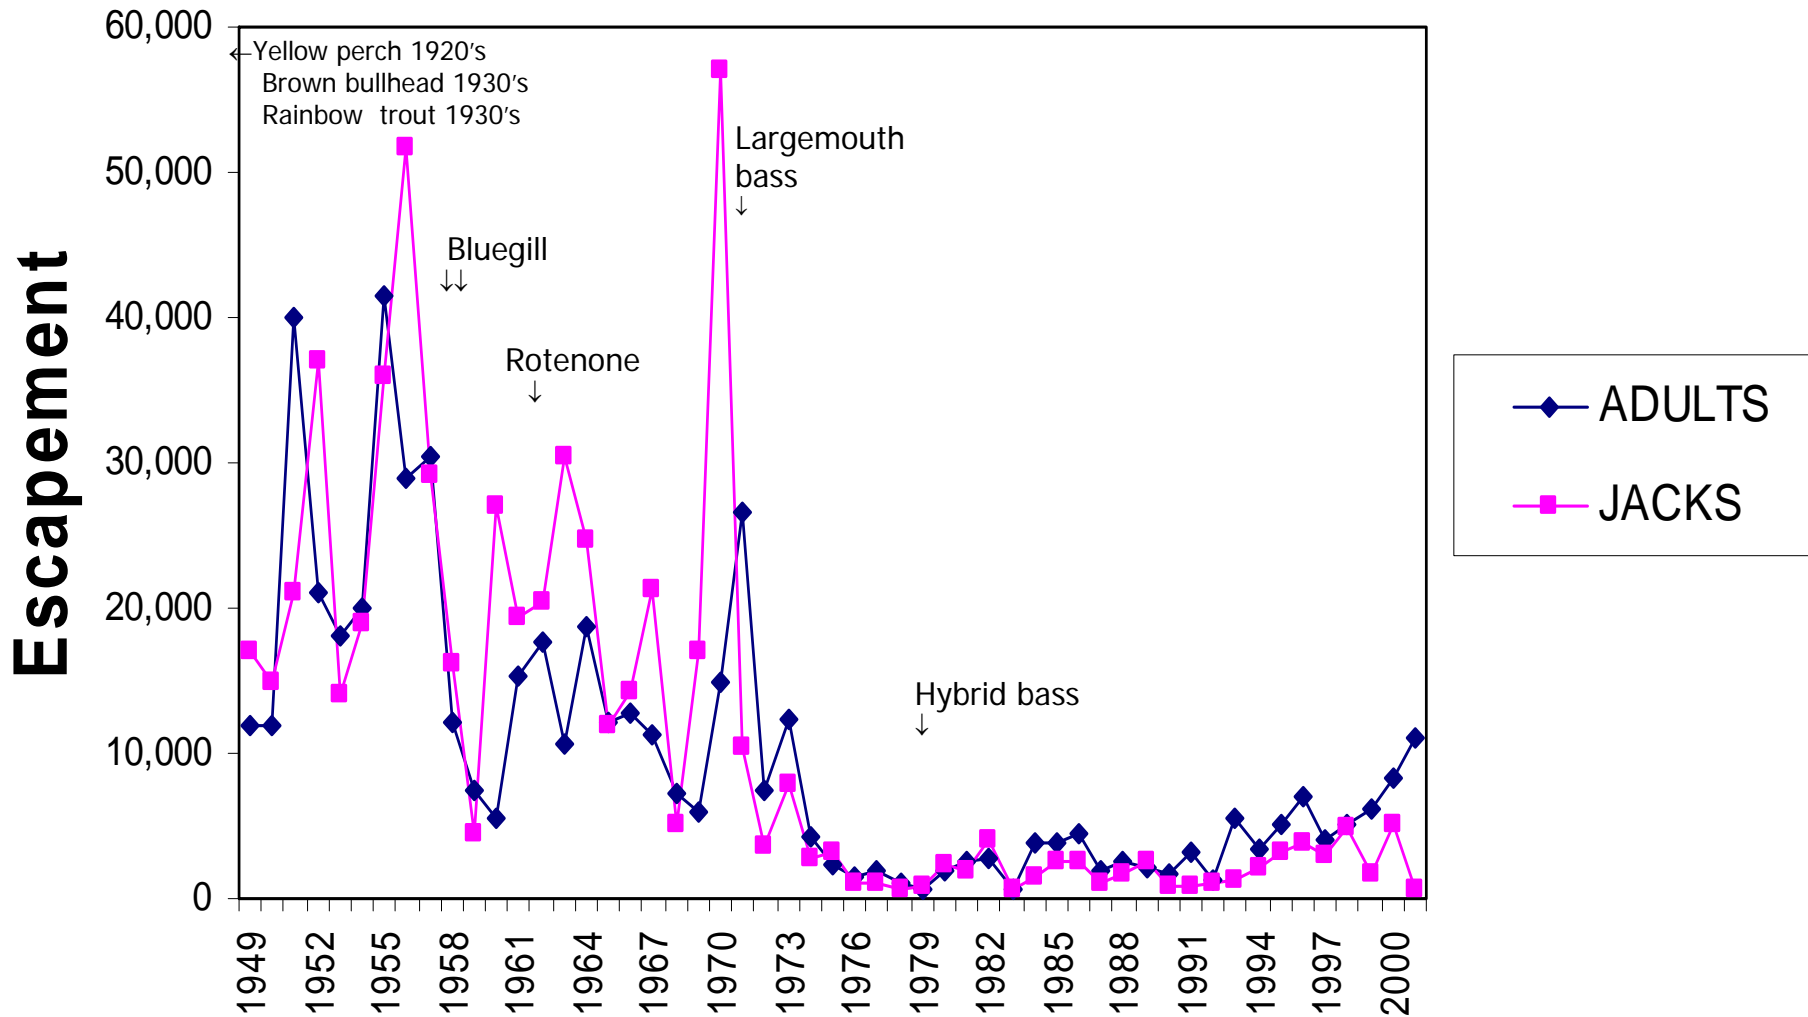
# Tenmile Lakes Coho Escapement Estimates
