# State of the Lakes

# OVERVIEW

- BRIEF LAKE HISTORY
- ALGAE SAMPLING
- NUTRIENT MONITORING
- SEDIMENTATION
- SHORELINE DEVELOPMENT
- SEPTIC TANKS
- NON-NATIVE SPECIES
- VOLUNTEER OPPORTUNITIES

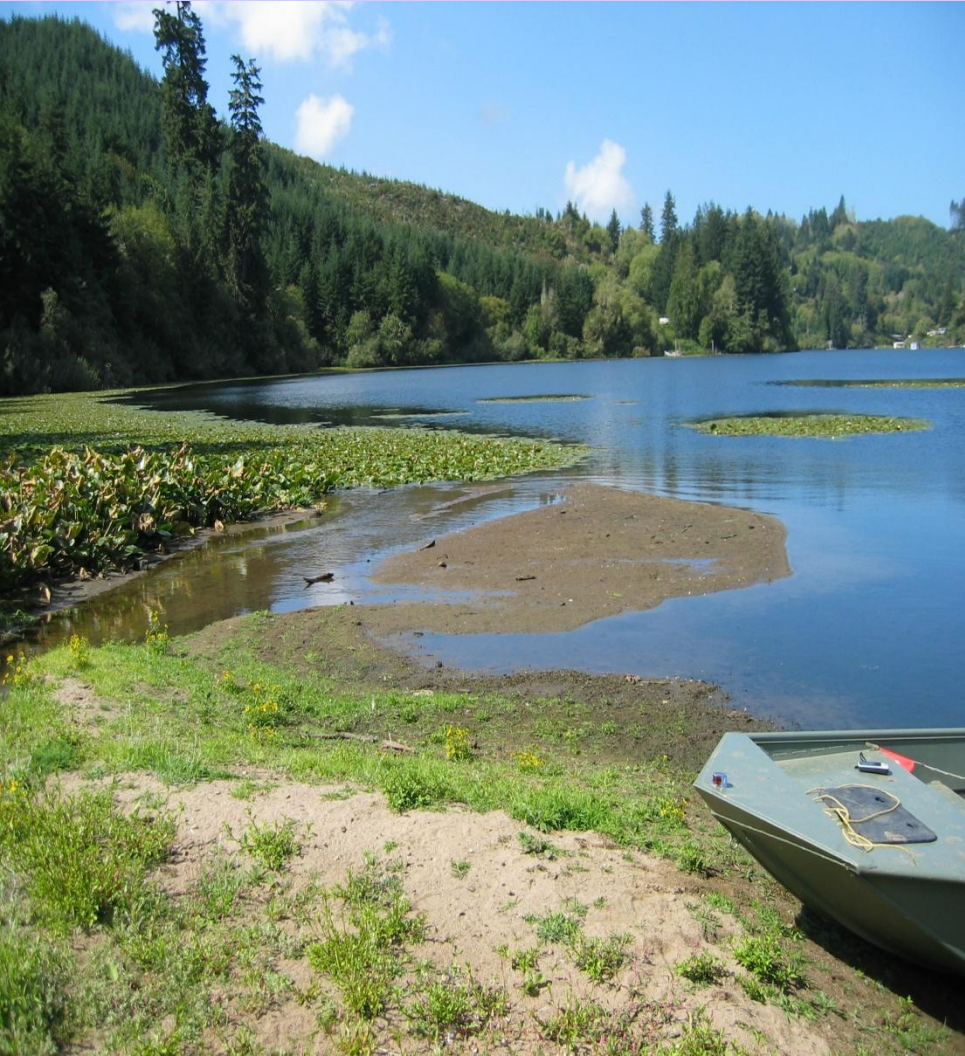
2004

# Benson Cr.

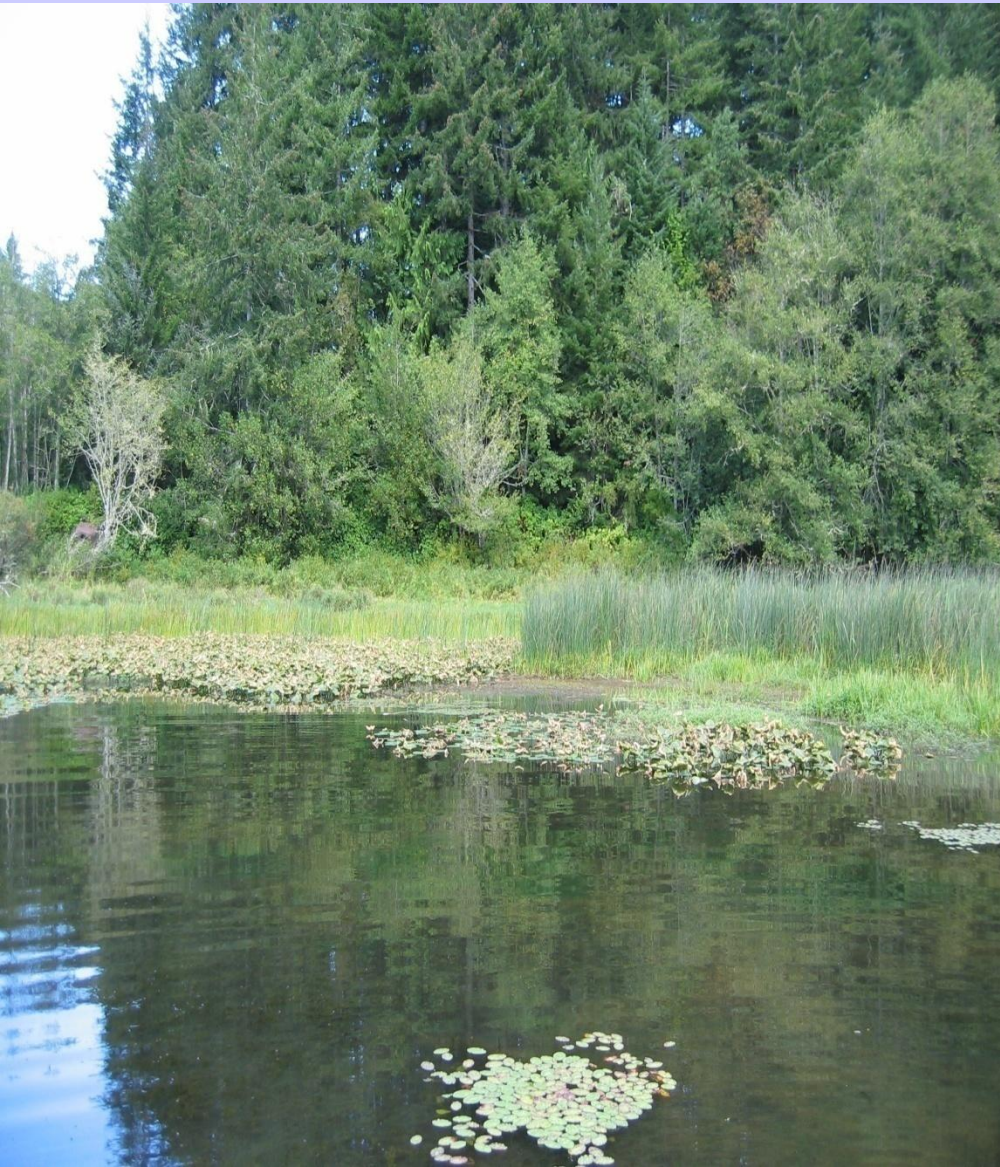
# Murphy

2004

No land mass to  
measure

Lake Height-  
6.43ft

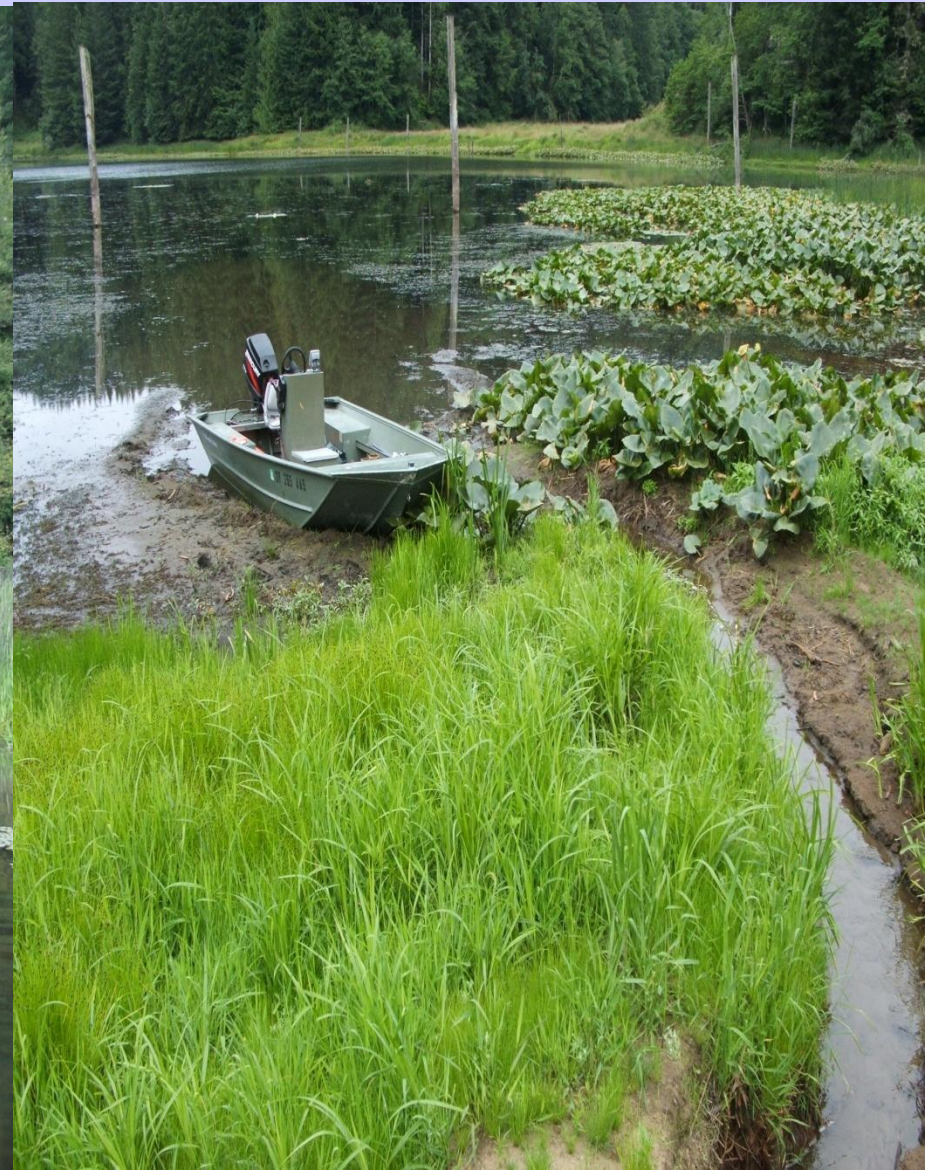
2007

Length-63' 2"

•1:width- 17'5"

•2:width- 14'6"

•3:width- 9'

•4:width- 4' 10"

•5: no width

5.74ft

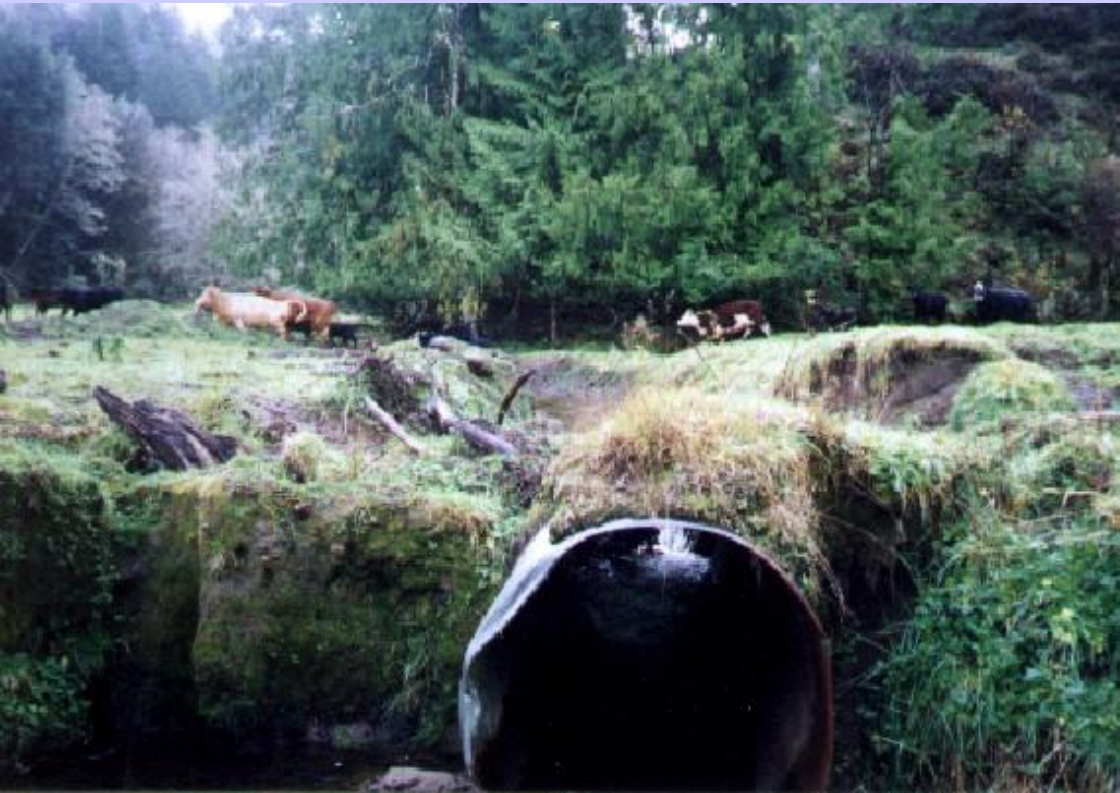
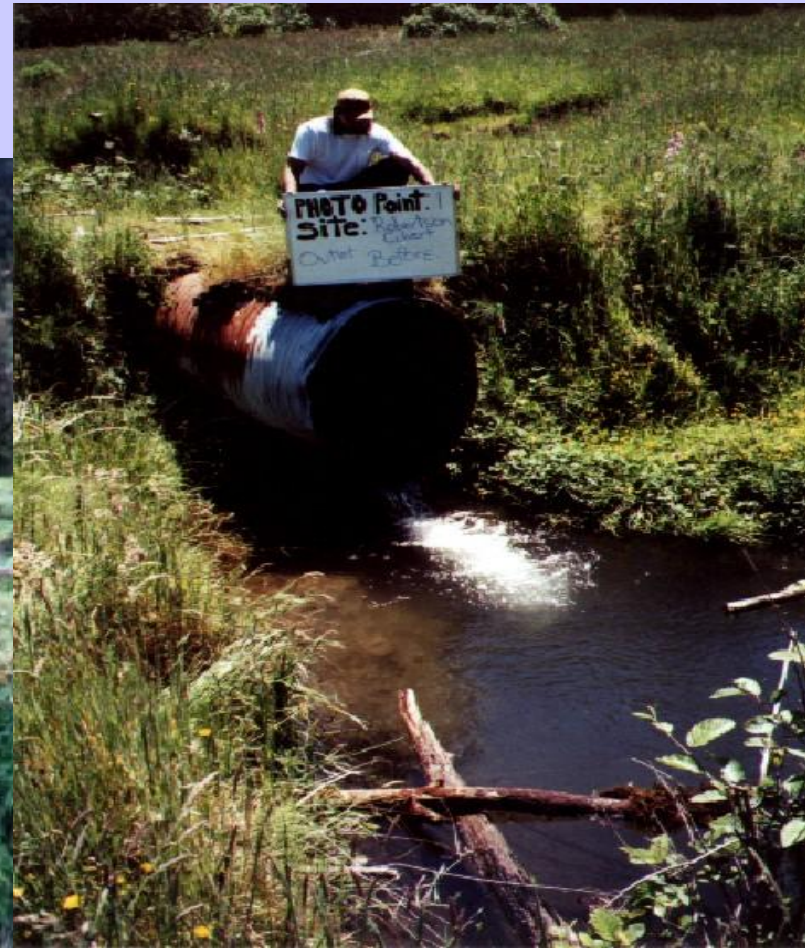
# Robertson Cr. Failed Culvert Replacement

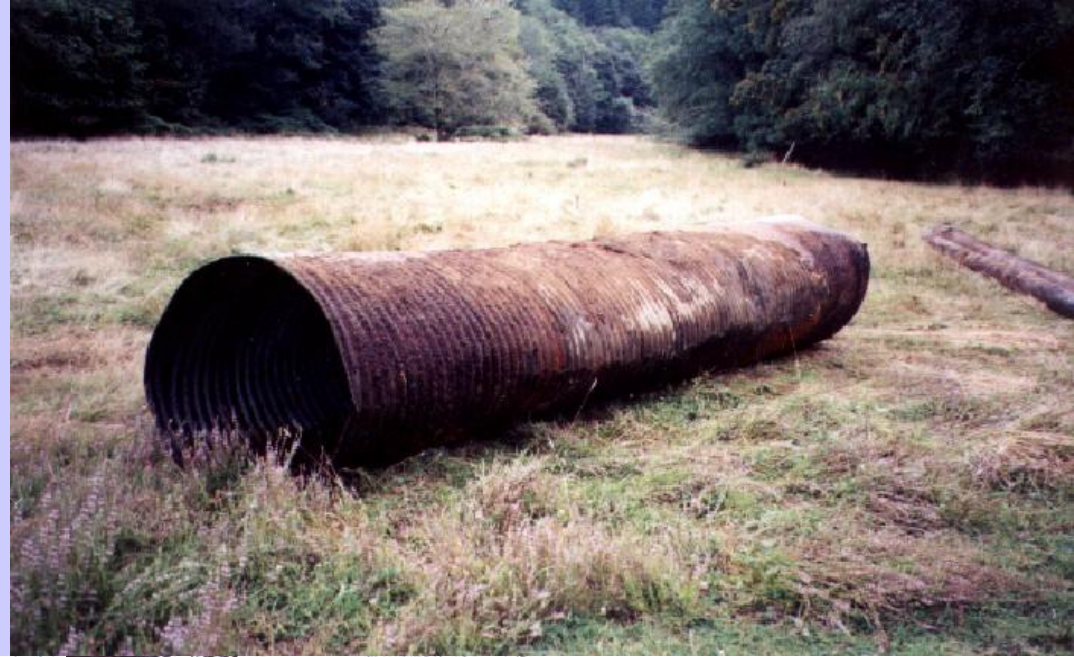
# Robertson Cr. Culvert replaced with a log stringer bridge

2/13/08  
Robertson Cr.  
Bridge
