# State of the Lakes

# OVERVIEW

# Tenmile Lakes Watershed

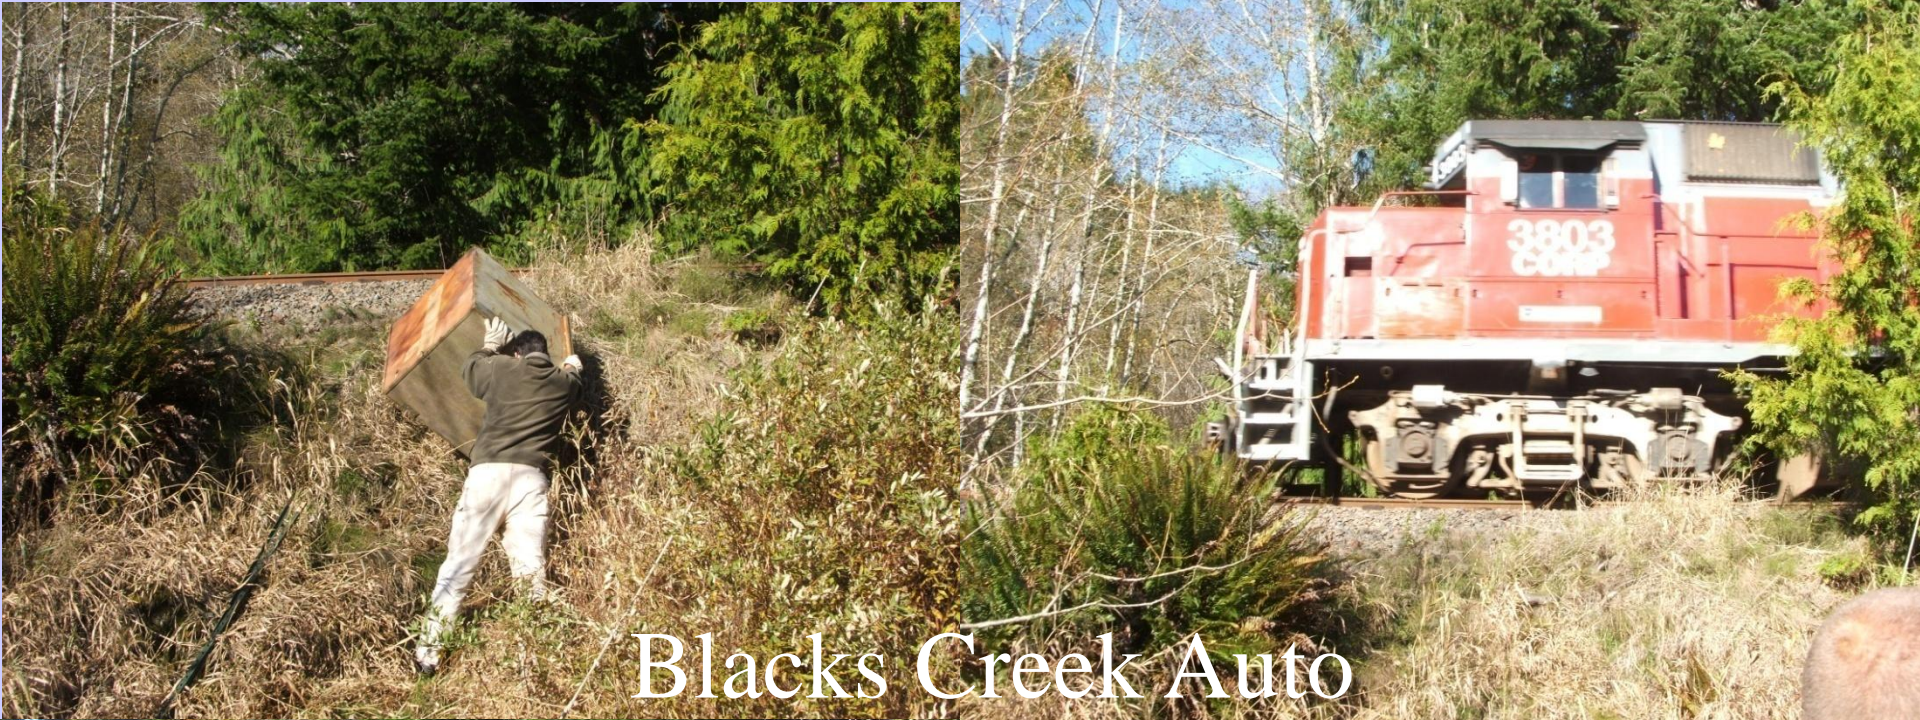
# Big Cr. Auto Sampler

Big Cr.

Avg. TSS- 64 mg/L

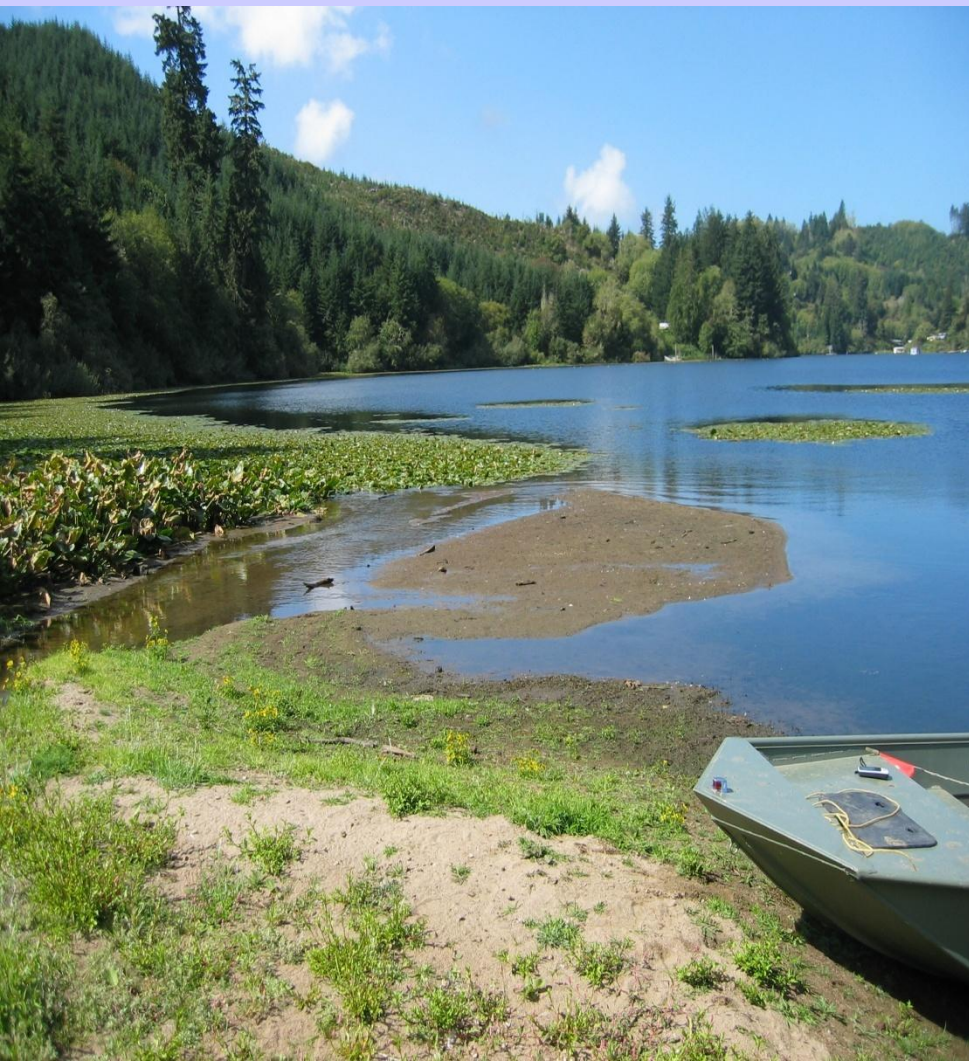
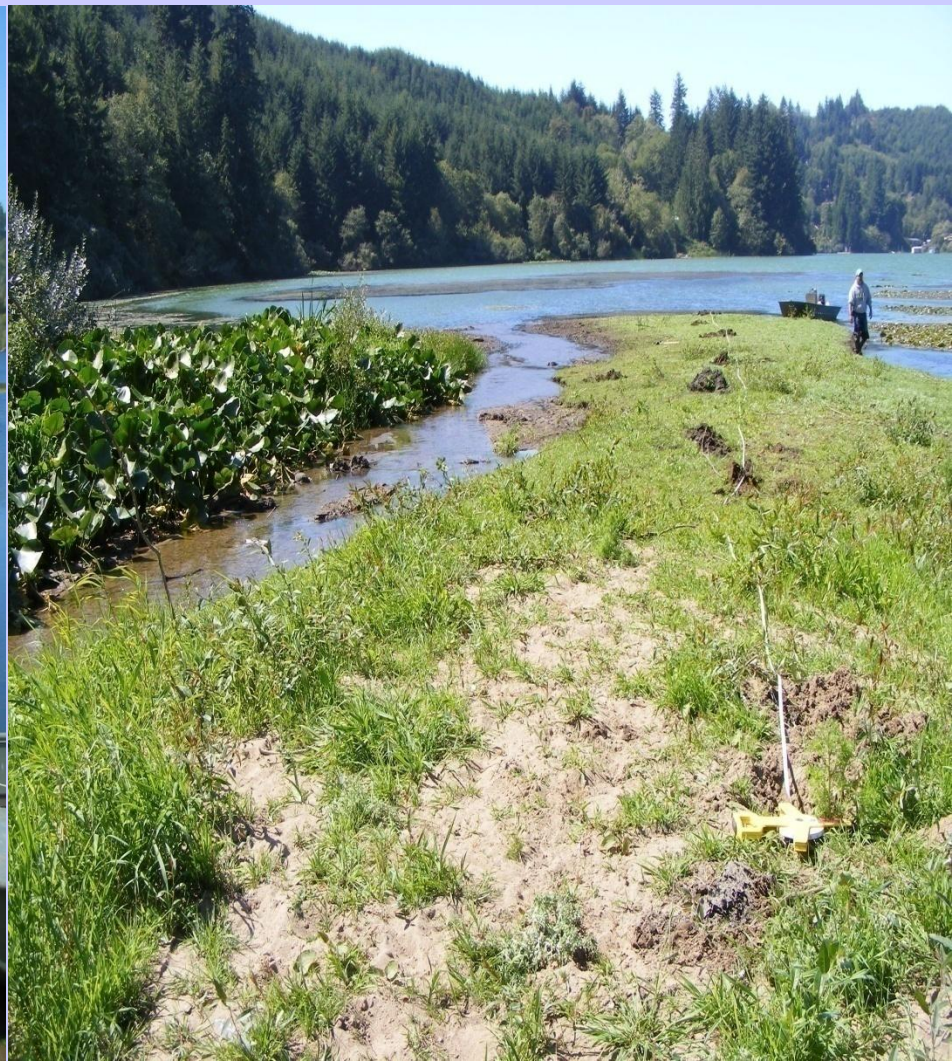
# Coleman Arm

- Length- 74' 11"
- 1: Width: 20' 7"
- 2: Width: 10' 2"
- 3: Width: 17' 19"
- 4: no width

Lake Height for  
2004 & 2010-  
6.43ft

- total delta length-172'2"
- 1: width-38'7" \*\*
- 2: width-43'4"\*
- 3: width-39'\*
- 4: width-30'6"\*
- 5: width-32'1"\*
- 6: width-63'4"\*\*\*
- 7: width-78'2"\*\*\*
- 8: width-55'7"\*
- 9: width-24'9"\*\*\*

\*Survey gained 7"-1' of sediment on top  
of survey marks

\*\* 3-5" of sediment on top of survey marks

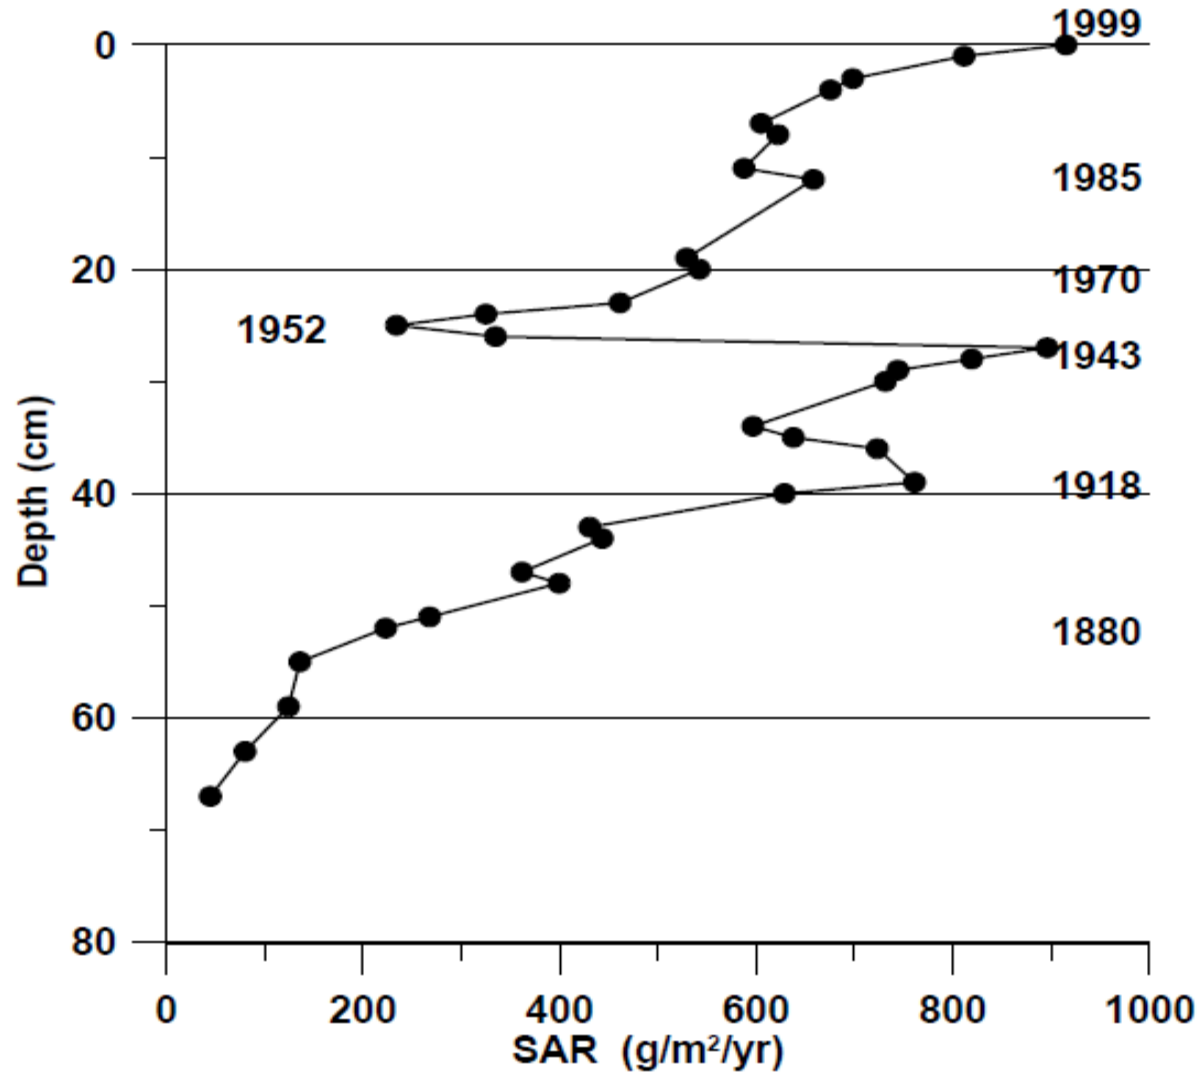
Figure 40. Sediment accumulation rates (SAR) for site STA, South Tenmile Lake.

# Analysis of South Tenmile Coring Samples

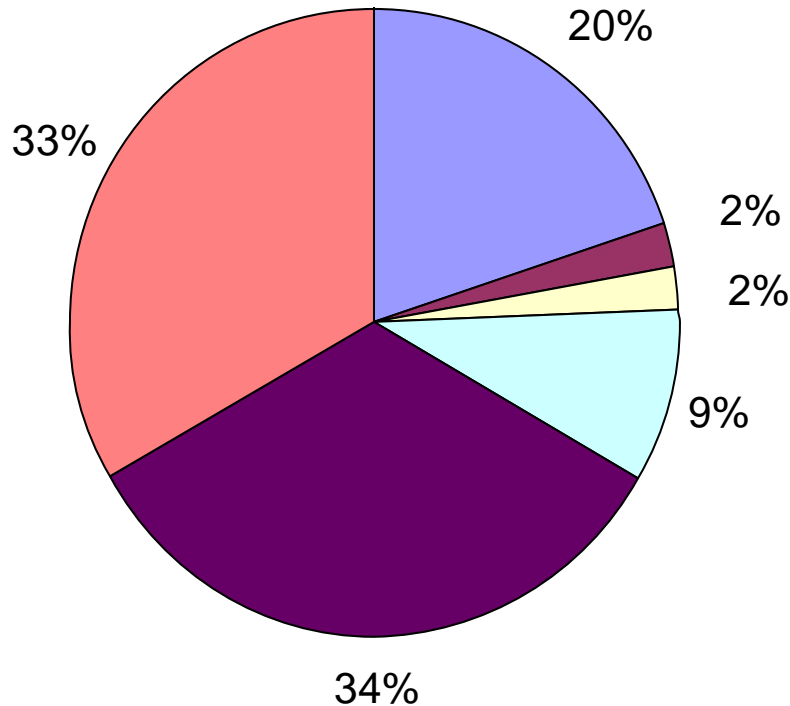
## Results of Tenmile Lakes Septic Survey

Worked with county health department to inspect 27 lakefront homes in 2006 and 2007.

- Apparent properly functioning systems.
- Sites with untreated gray water discharge.
- System failures with evidence of sewage discharge into lake or ground water.
- Bottomless tanks identified.
- Systems in need of repair (not including gray water).
- Owners with systems in need of repair.
