State of the Lakes 2015

I'm Richard Litts Watershed Monitoring Coordinator

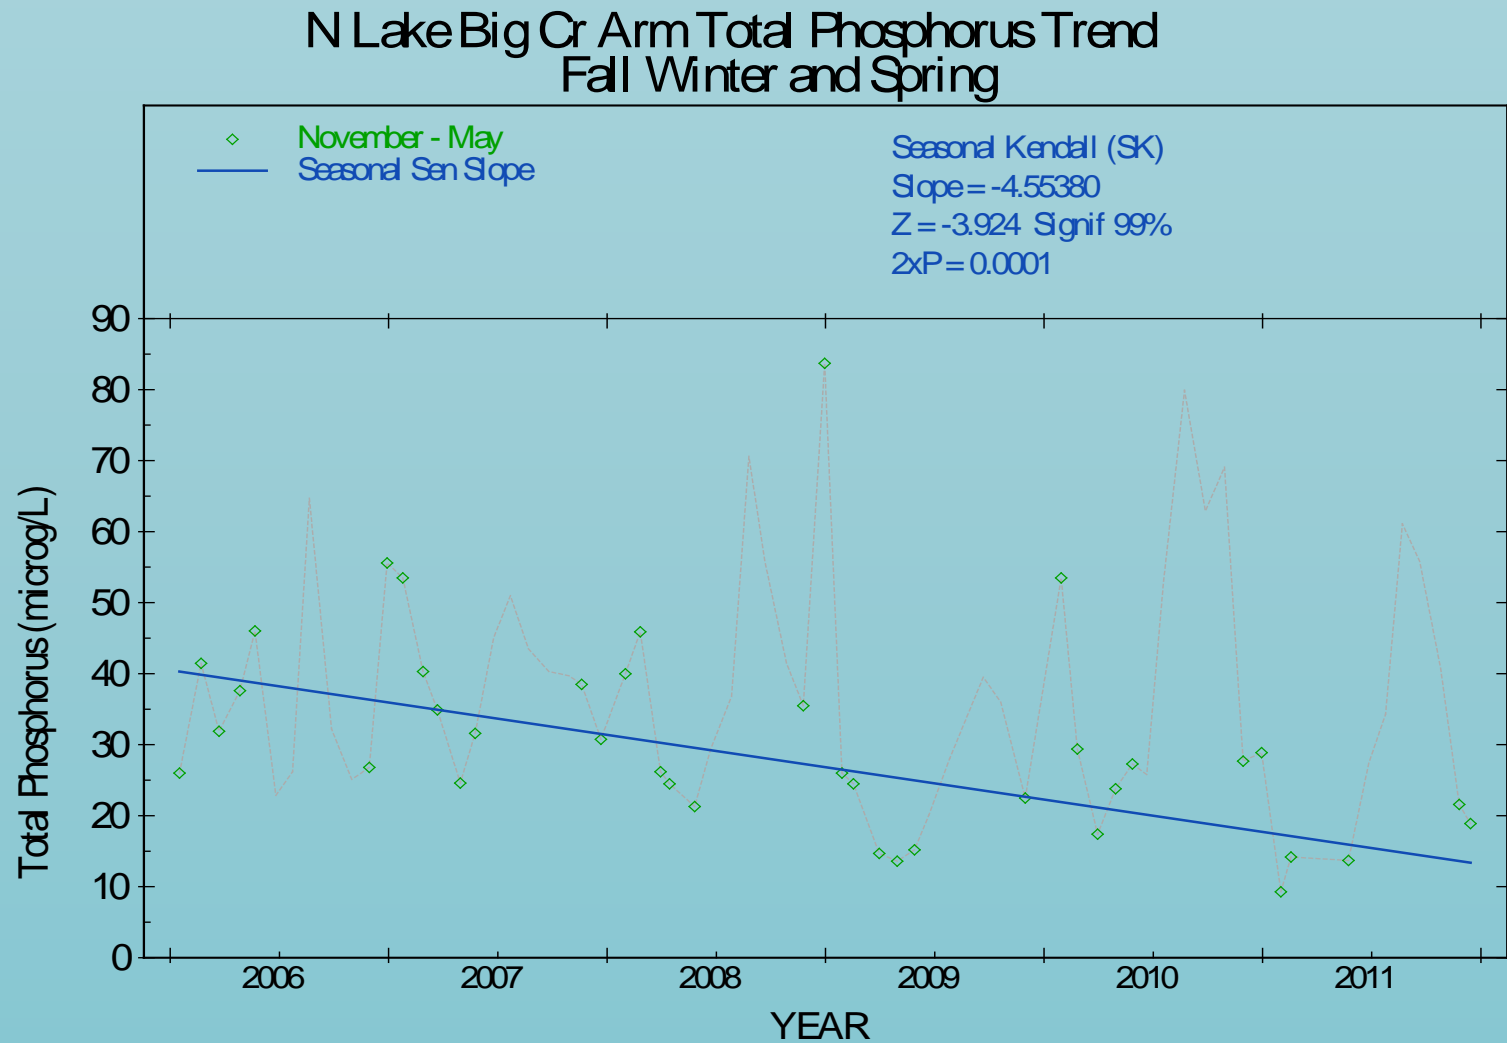
Fall, Winter & Spring have good downward trend

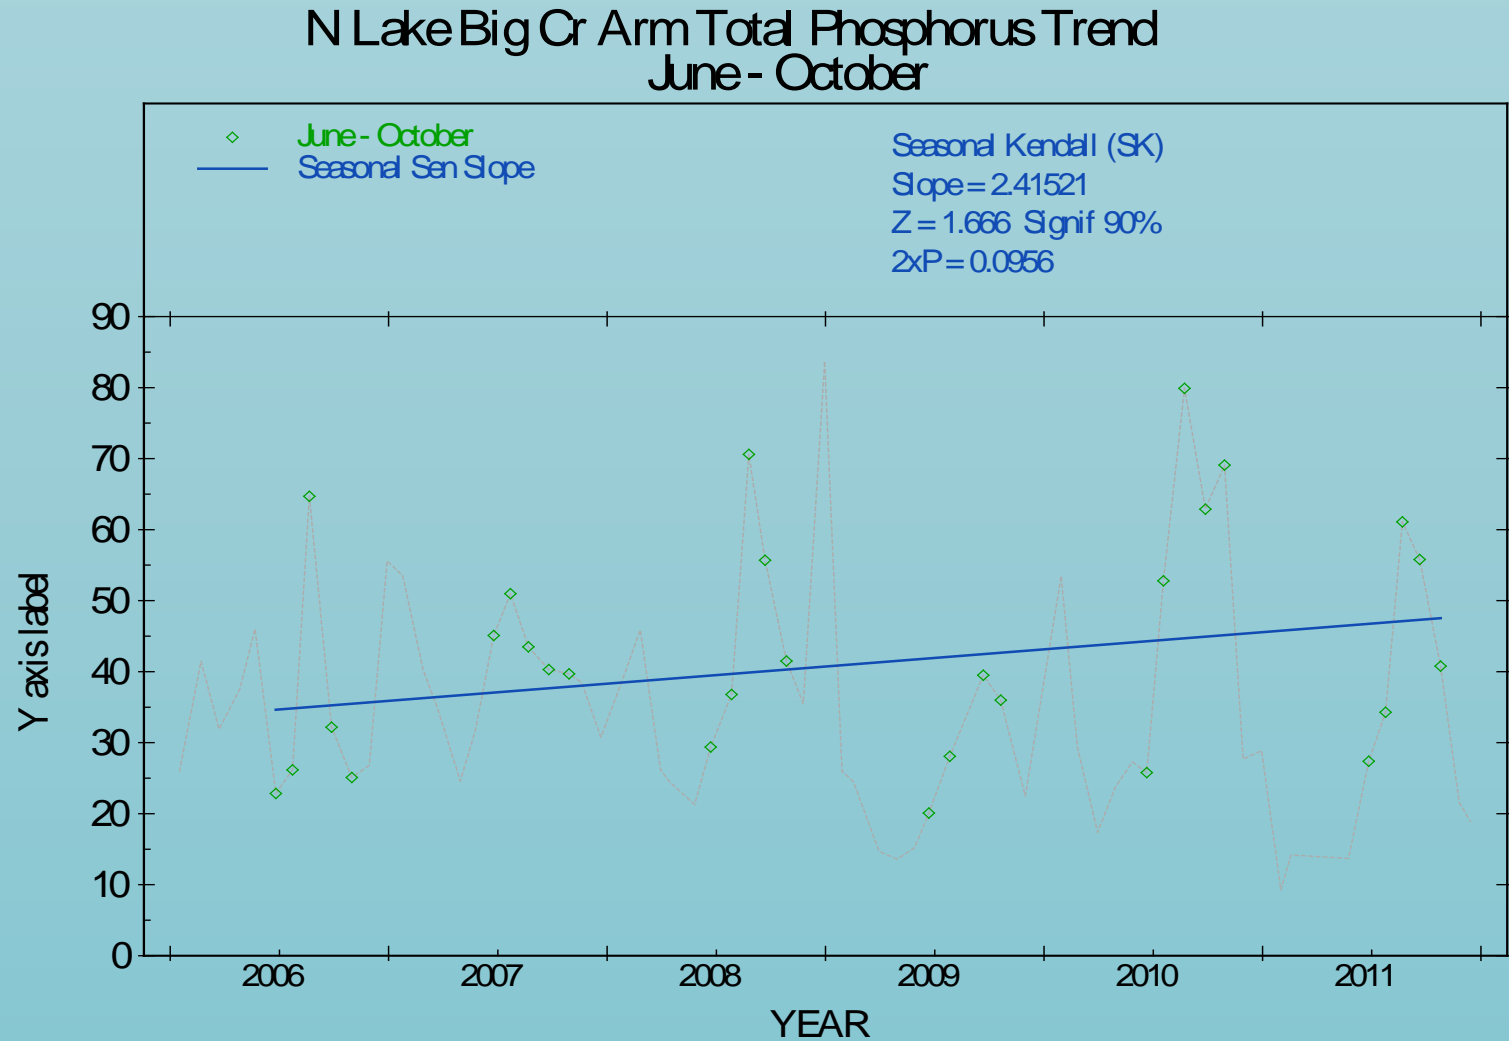
Summer Phosphorus trend is getting worse

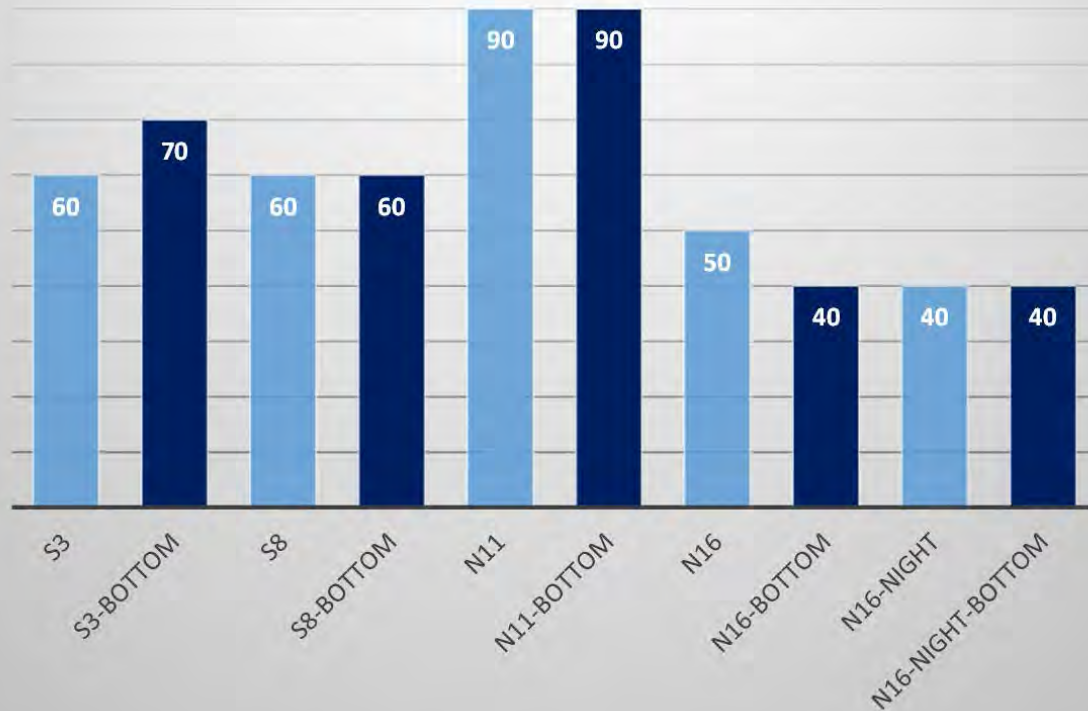
TP ($\mu\text{g/L}$) Tenmile Lakes Summer 2014

Benthic Phosphorous

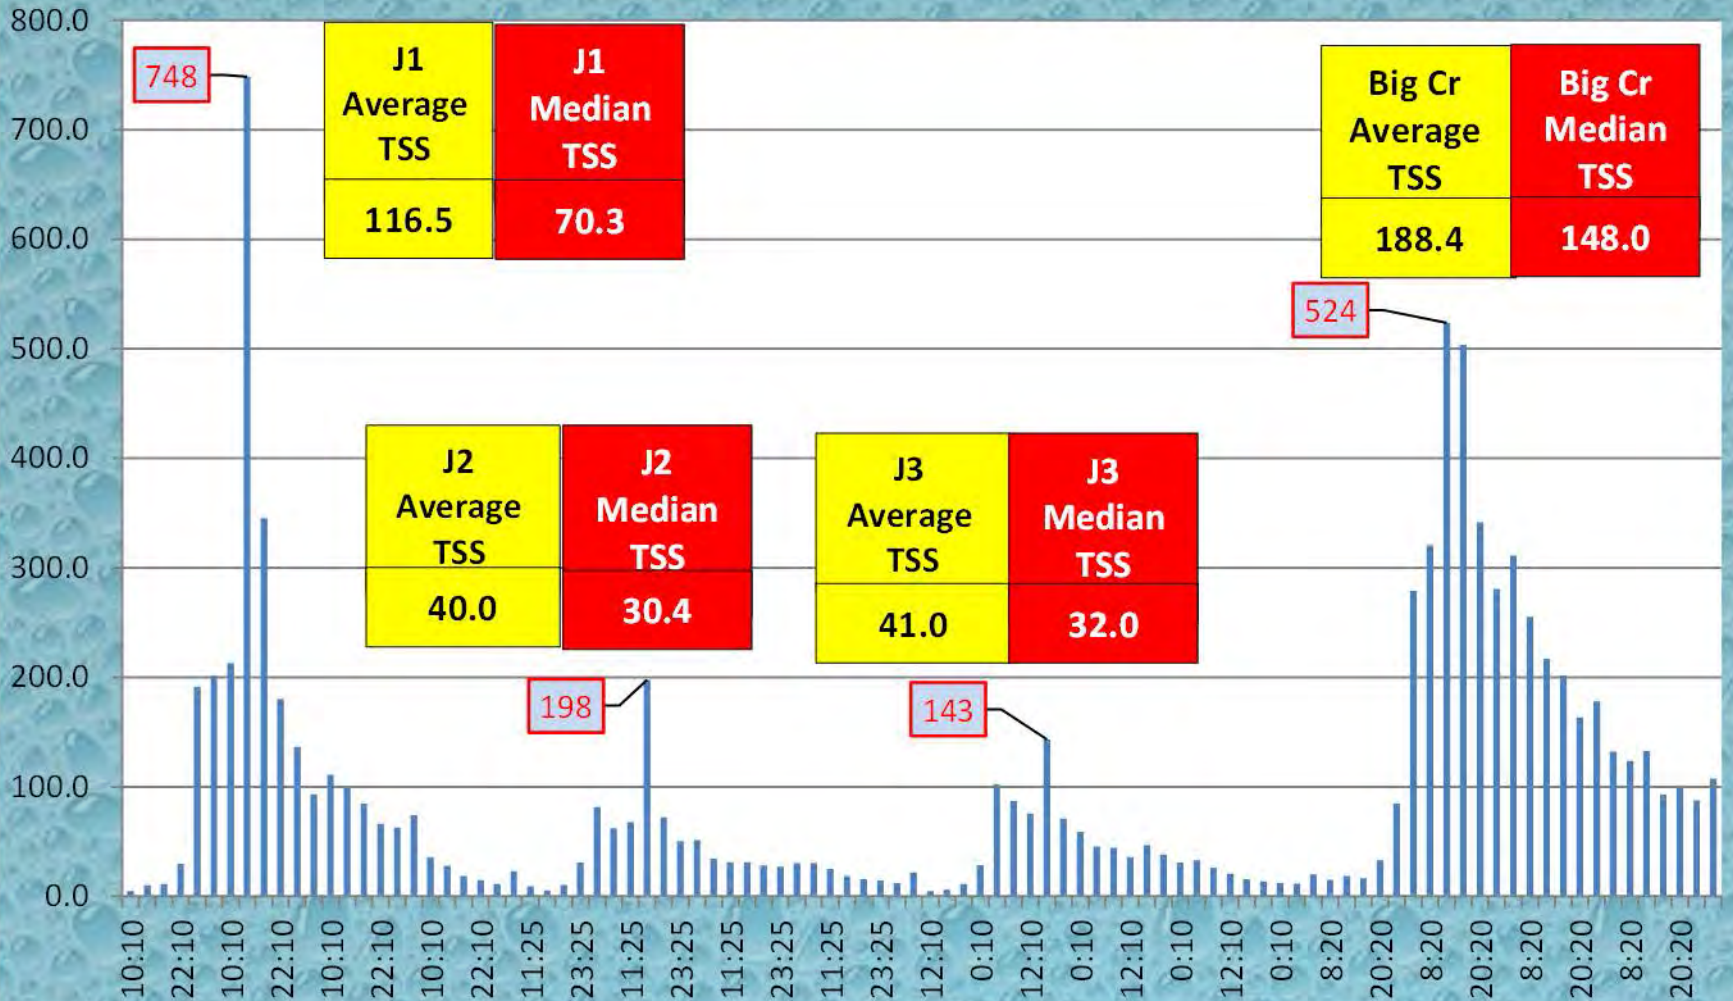
J1, J2, J3, Big Cr 2/05 - 2/09/2015

TSS (mg/L)
