MONITORING REPORT
Contract # 211-2028
Tenmile Lakes Fish Passage

Produced by:
TLBP May 2012

MONSON BRIDGE #1

MONSON BRIDGE #2

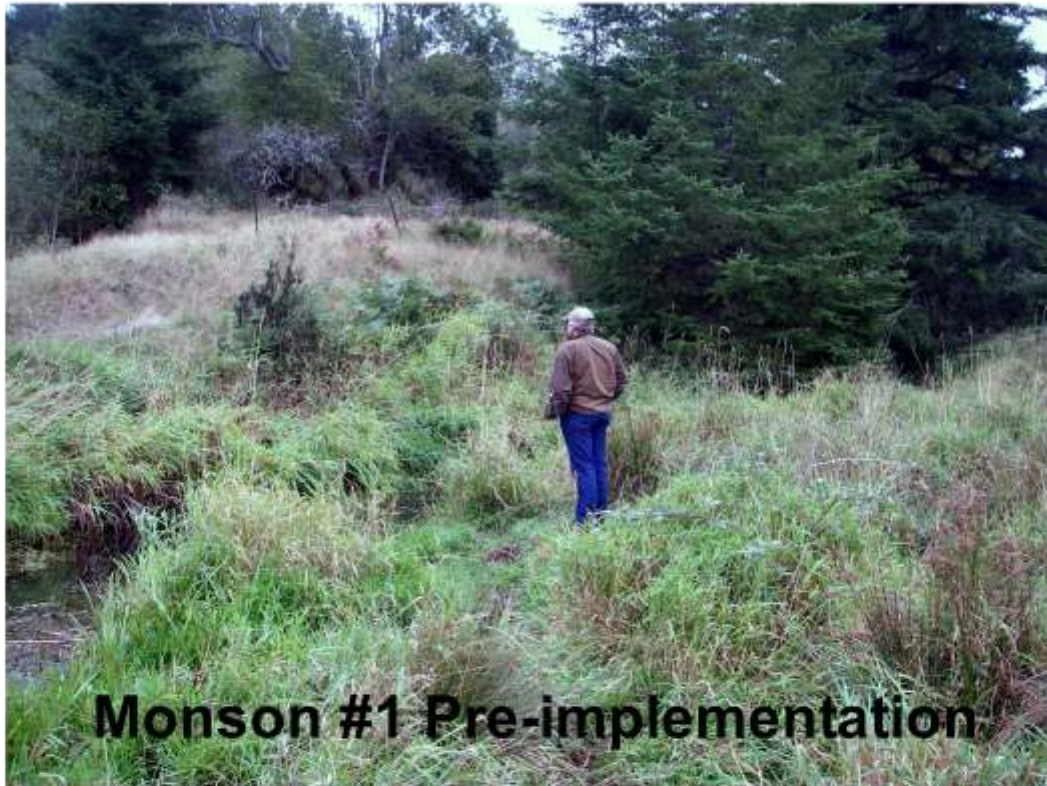
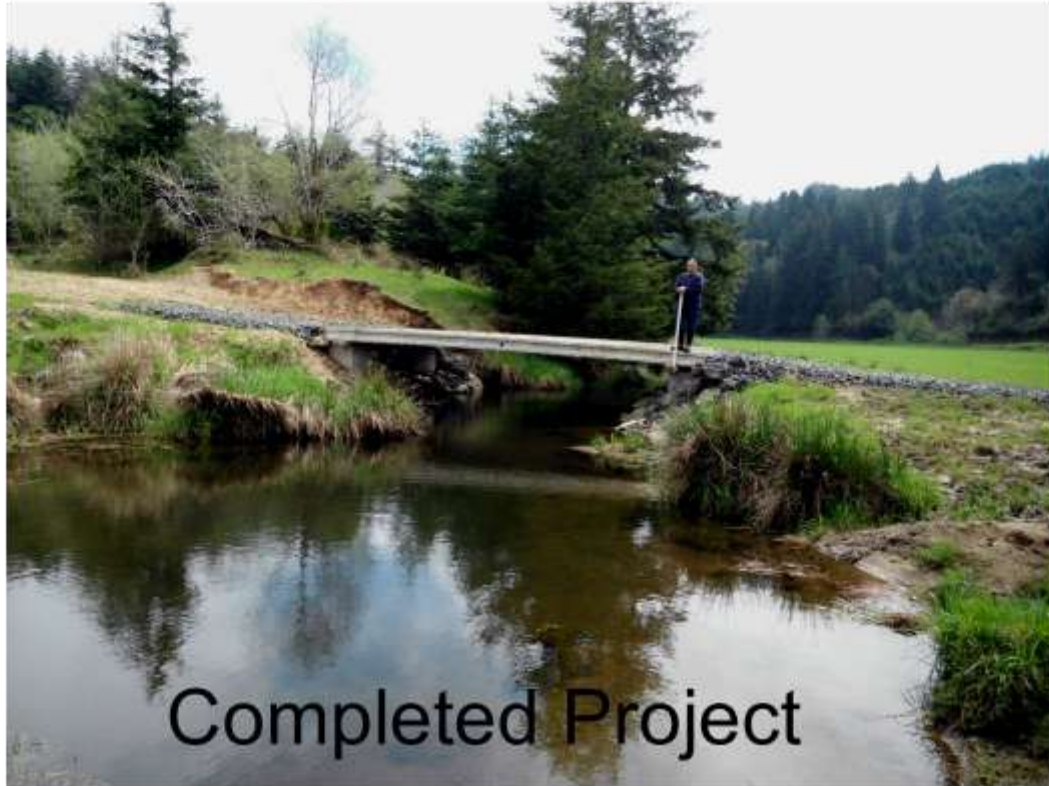
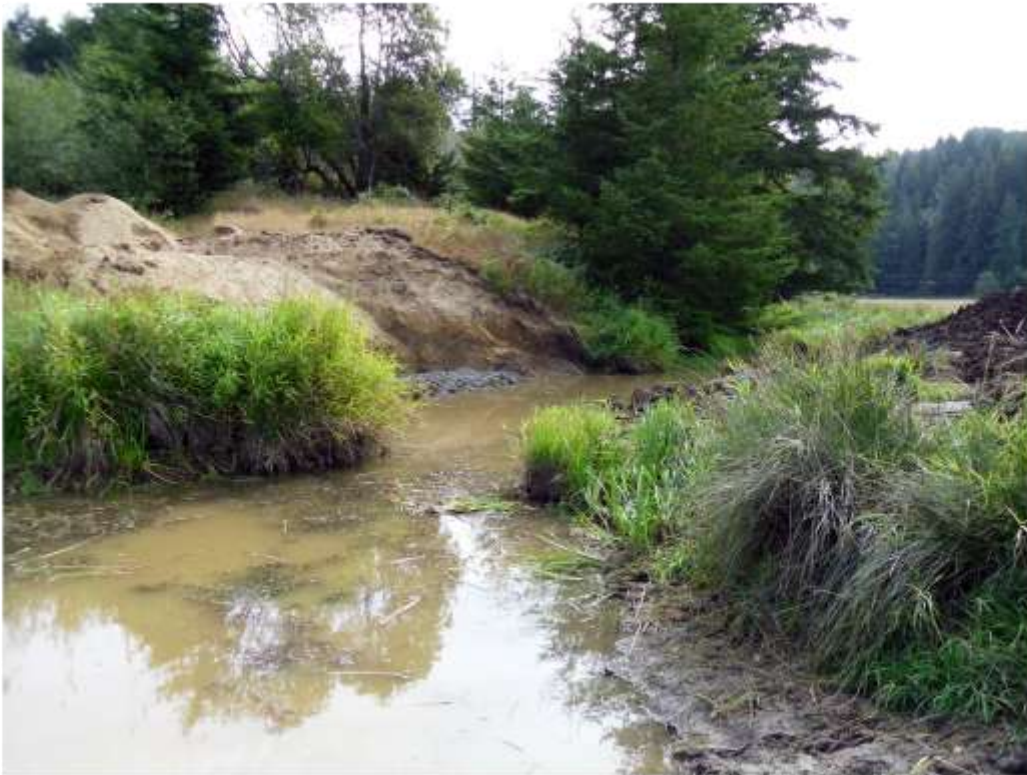
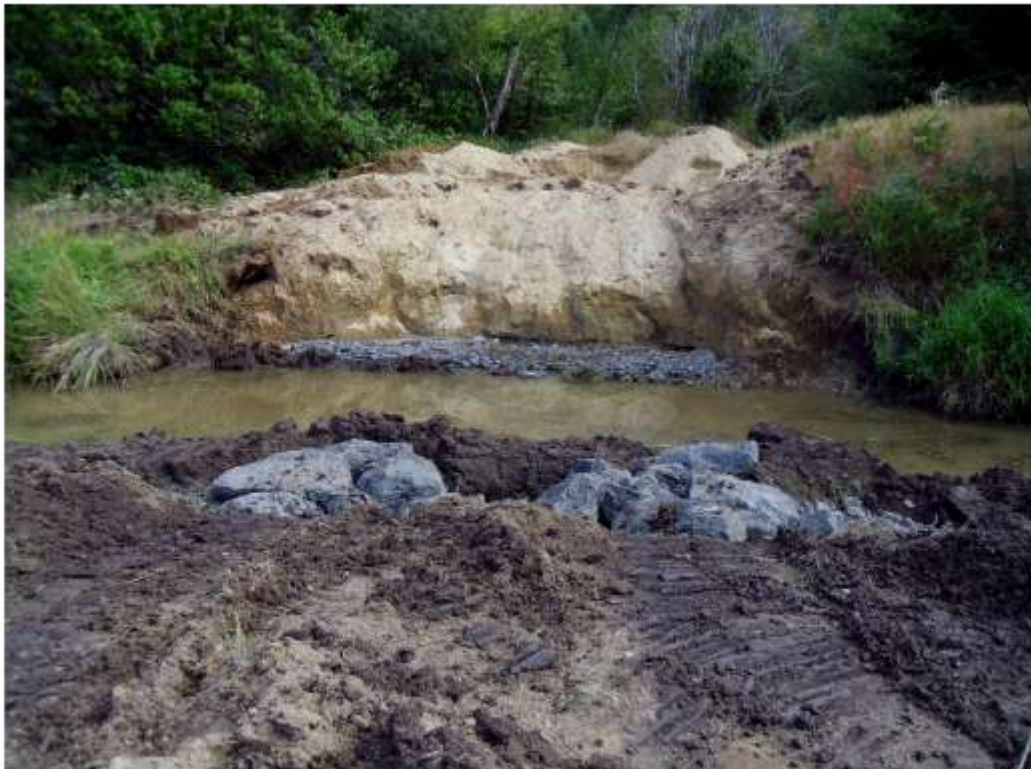
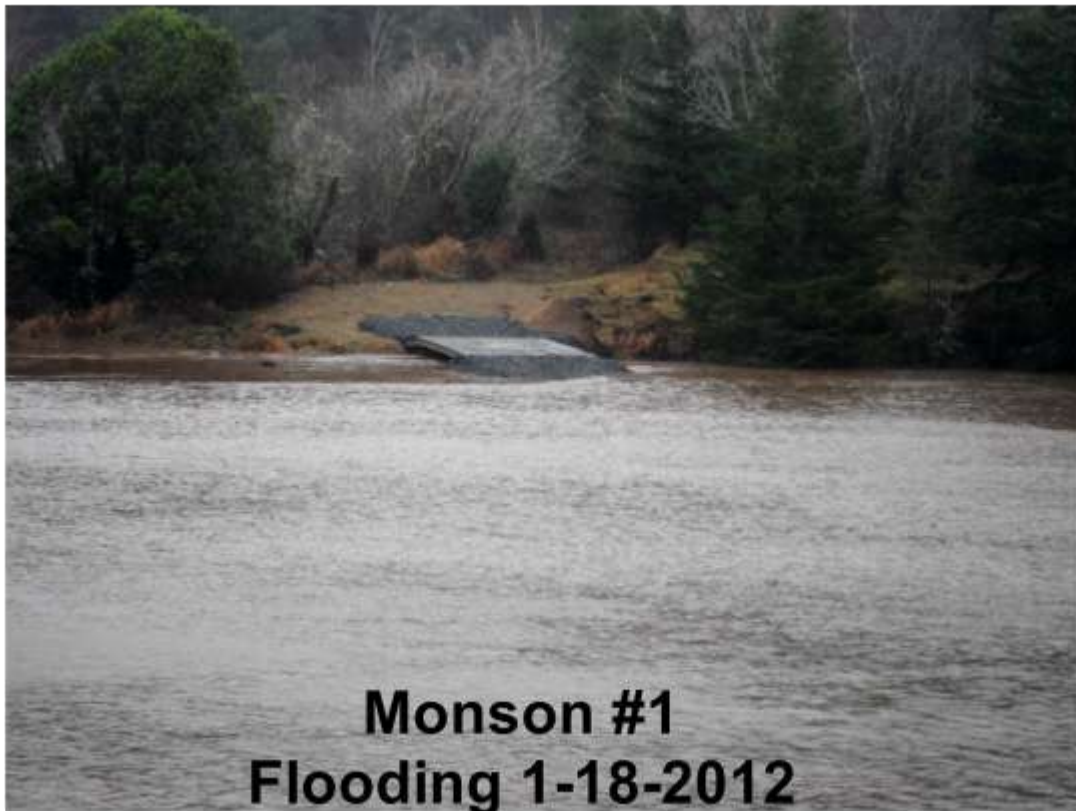
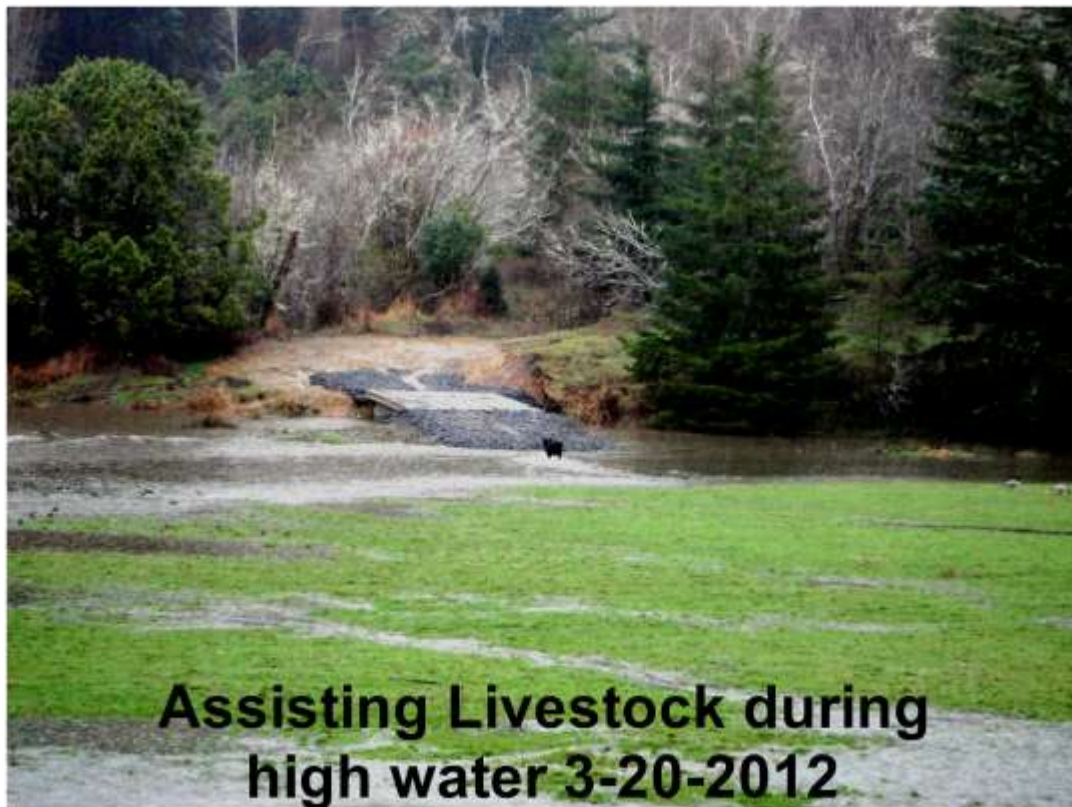
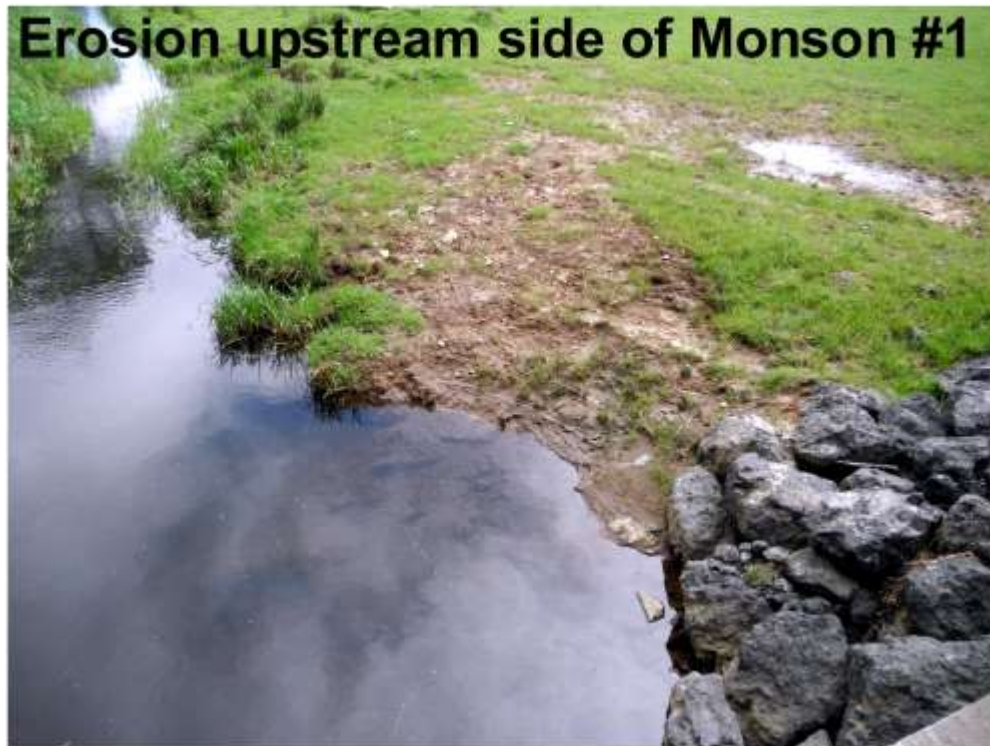
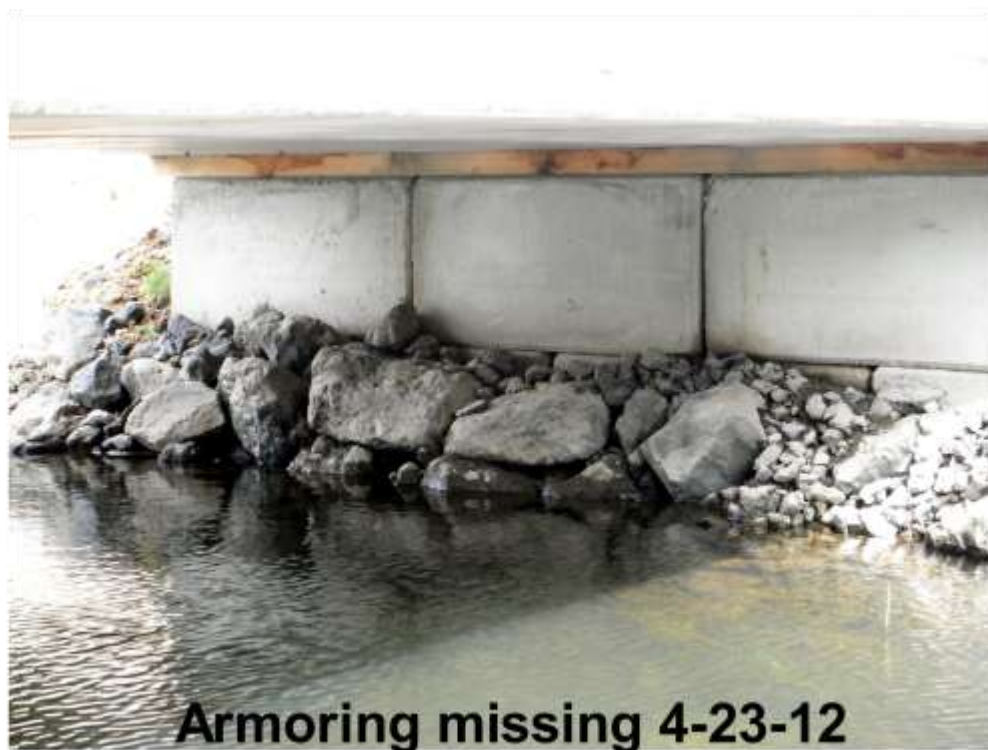
This fish passage and sediment abatement project, Fish Passage Plan site #286, removed a perched 36” x 20’ corrugated metal pipe and replaced it with a 16’w x 30’ concrete stringer bridge. Fish access to approximately 5 miles of stream habitat was improved. In addition approximately 350 cubic yards of perched filled was permanently removed to reduce chronic sediment inputs into this system. Project was completed September 2011.

2012
Current sediment delivery: High-Med-Low	Low
Current bridge condition.	Excellent
Current/approach condition.	Excellent
Armoring and fill condition.	Good-Missing some armoring on upstream, north side
Erosion/scouring above project site?	Small amount on South side
Maintenance records/ <u>dates</u> . Bridge observations. Goal Observations.	Bridge and approach held up well with the flood waters. This project is currently meeting our goals.

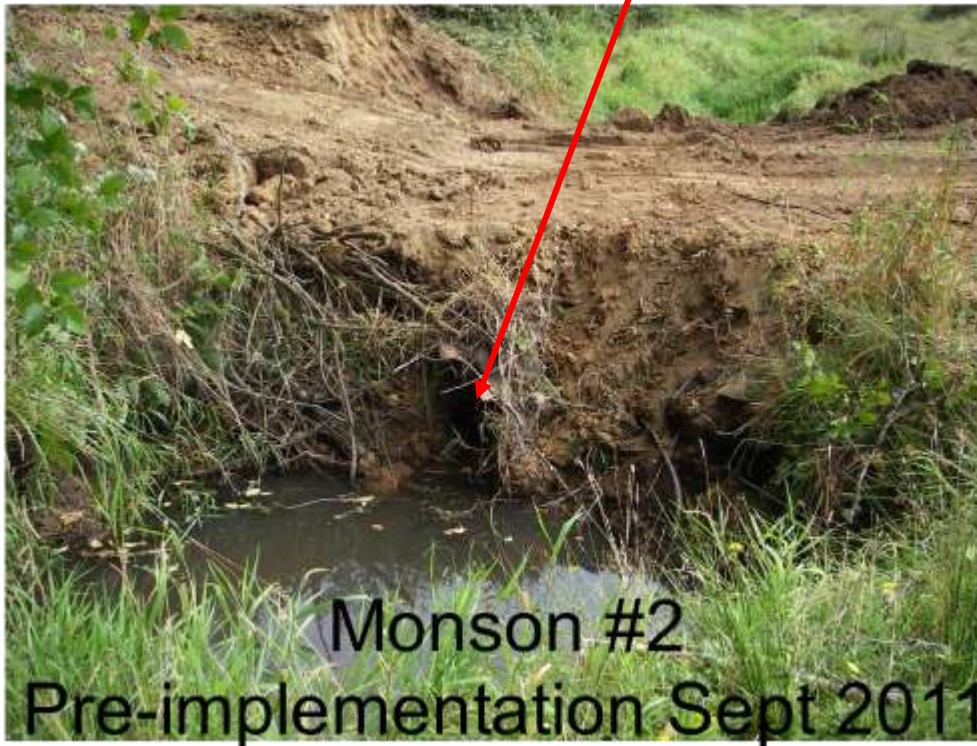
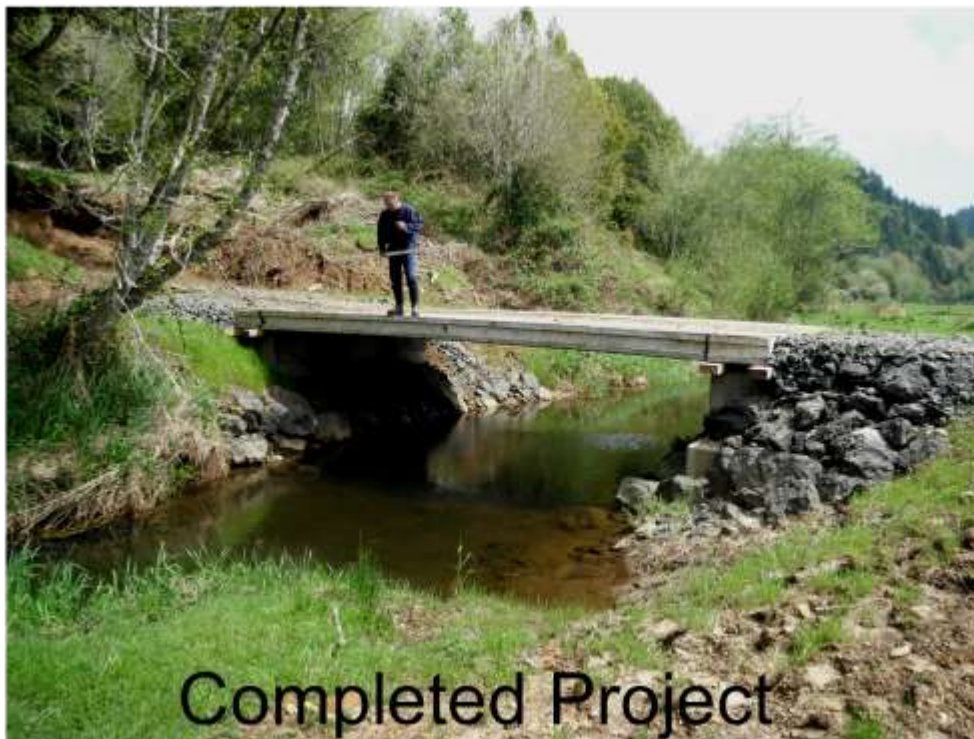
Failed Culvert

This fish passage and sediment abatement project, Fish Passage Plan site #287, removed a perched 36" x 20' corrugated metal pipe and replaced it with a 16' x 30' concrete stringer bridge. Fish access to approximately 4 mile of stream habitat was improved. In addition approximately 400 cubic yards of perched filled was permanently removed to reduce chronic sediment inputs into this system. Project was completed in September 2011.

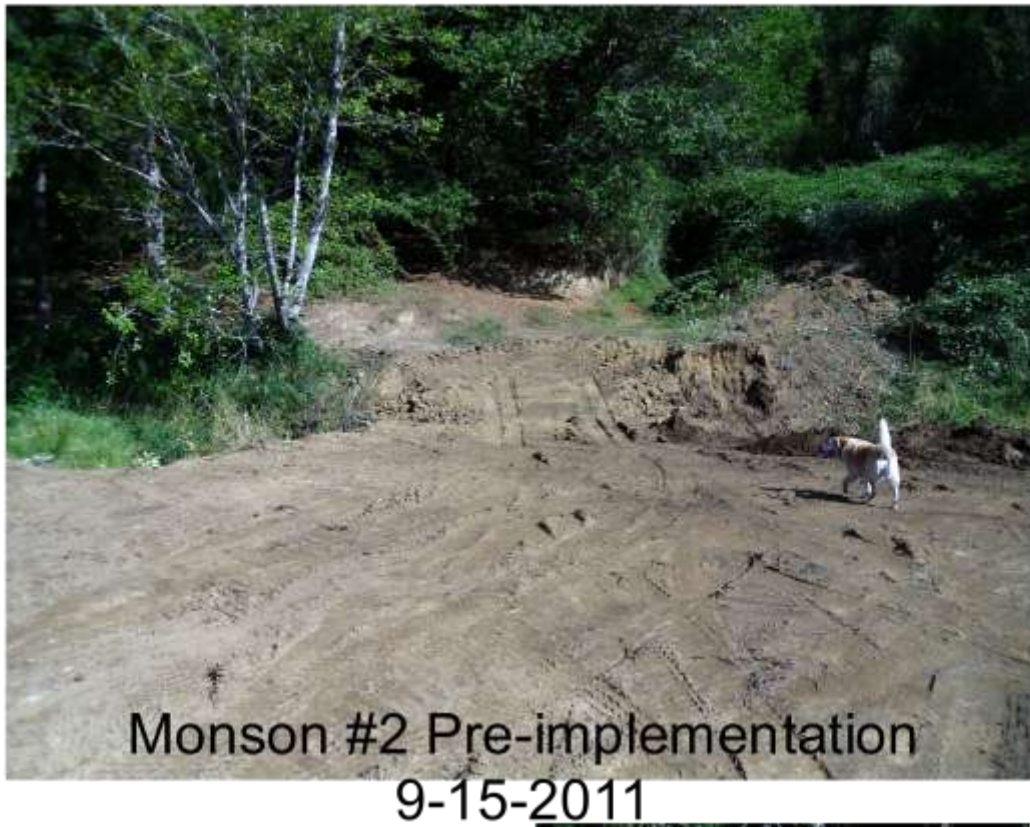
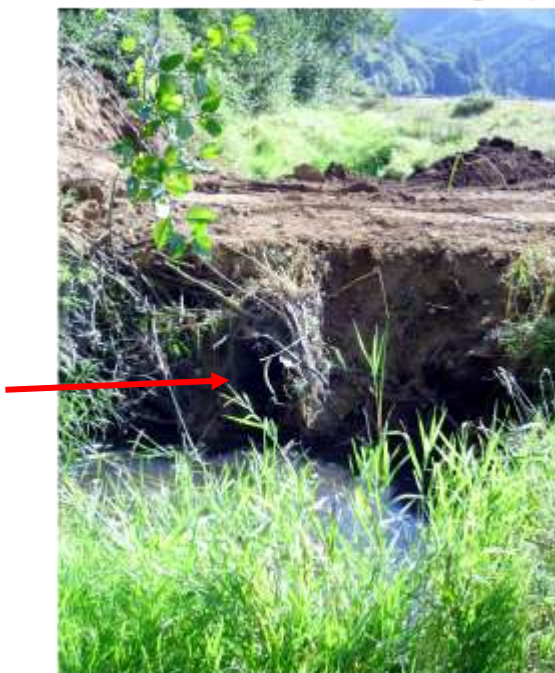
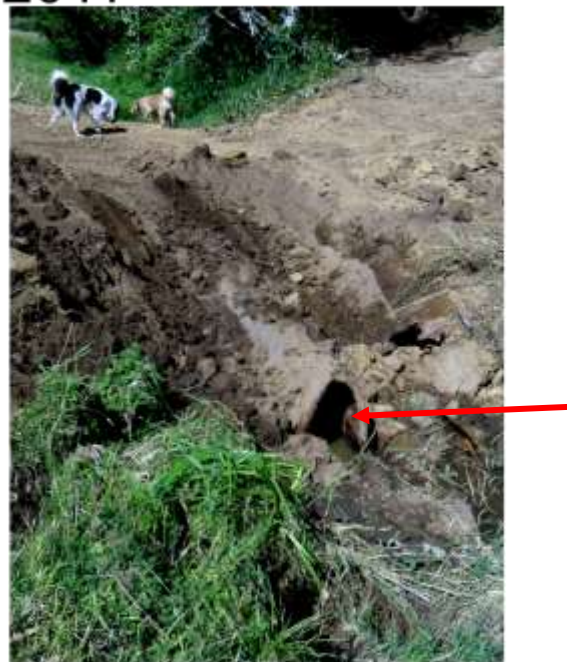
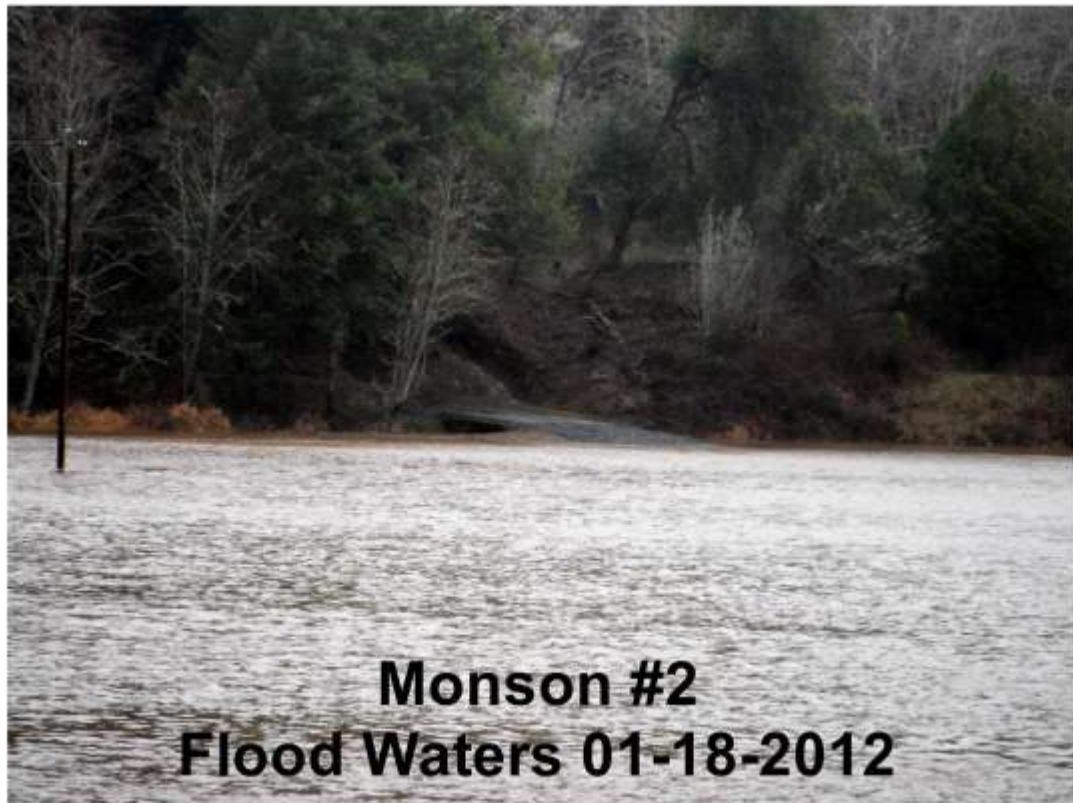
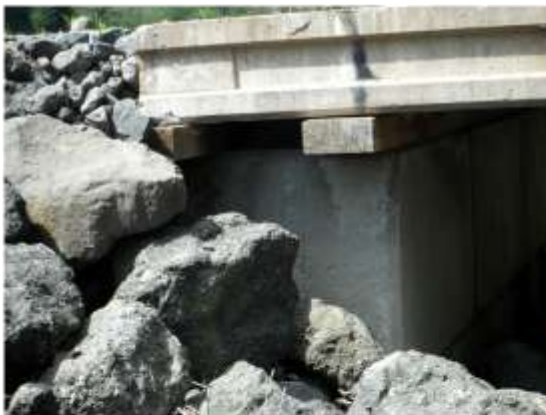
2012
Current sediment delivery: High-Med-Low	Low
Current bridge condition.	Excellent
Current/approach condition.	Excellent
Armoring and fill condition.	Good – Some armoring missing on upstream side
Erosion/scouring above project site?	Small amount on South side
Maintenance records/ <u>dates</u> . Bridge observations. Goal Observations.	Good spawning gravel below site. 2" fish fry observed (probably cutthroat) and a few possible Coho fry. Large numbers of Rough Skinned Newts, 3-Brook Lamprey, & 1 Crayfish.. Project is meeting our goals

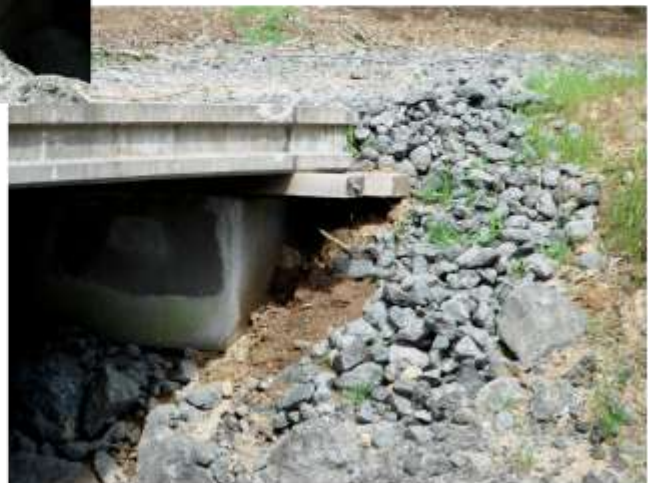
**Armoring missing
4-23-12**
