***TENMILE LAKES' BASIN
PARTNERSHIP'S***

PROJECTS PRESENTATION

2004/05

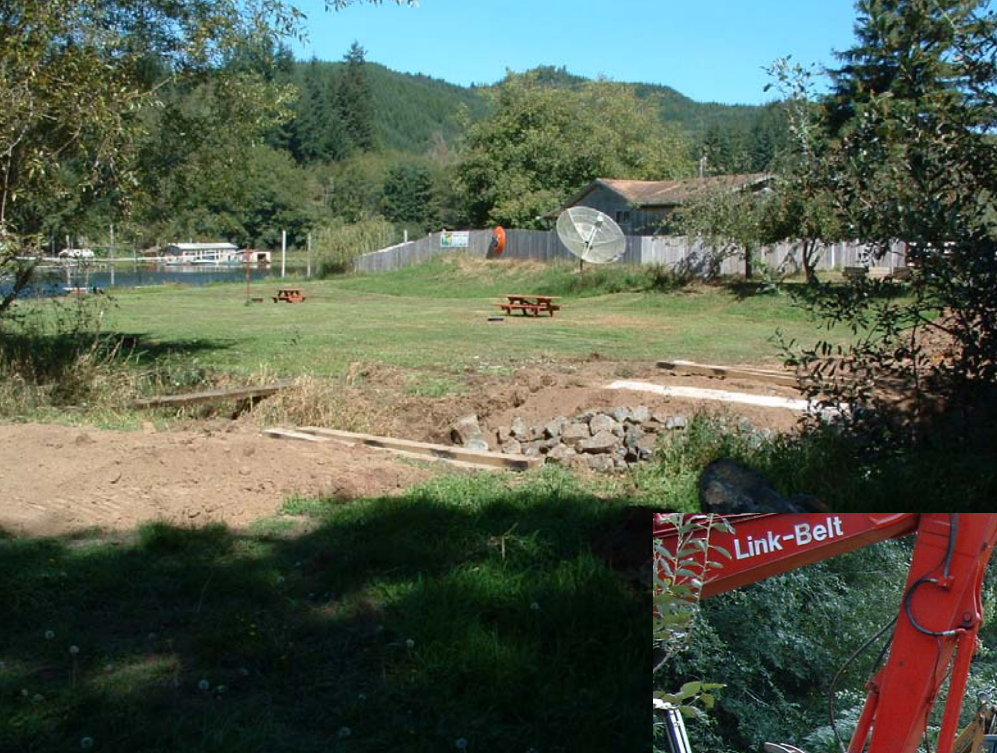
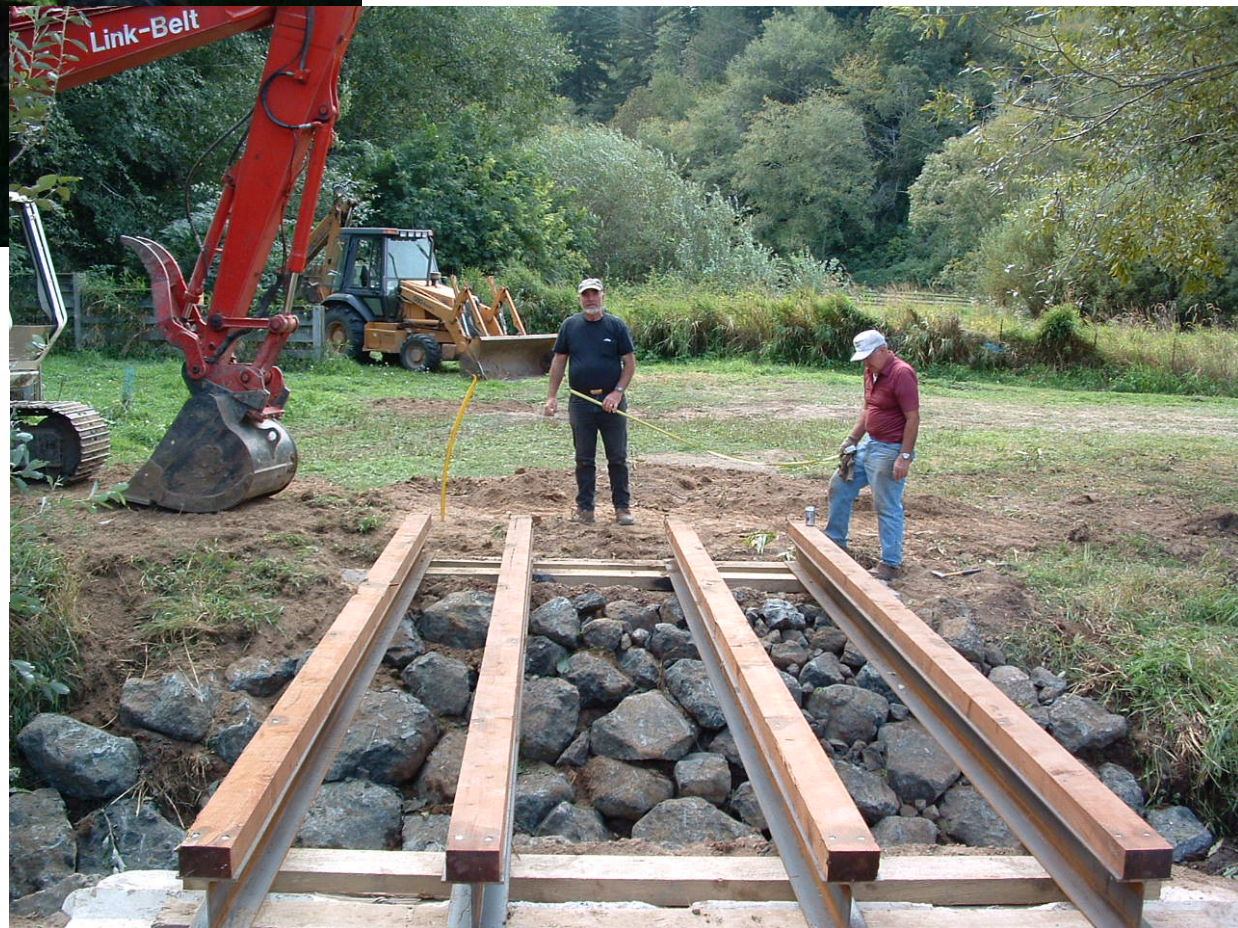
Sunlake Marina bridge

PROBLEMS FOUND

- Undersized and settling culvert
- Chronic sediment source
- Complex work area

Recommendations

- Remove failed pipe
- Replace with bridge

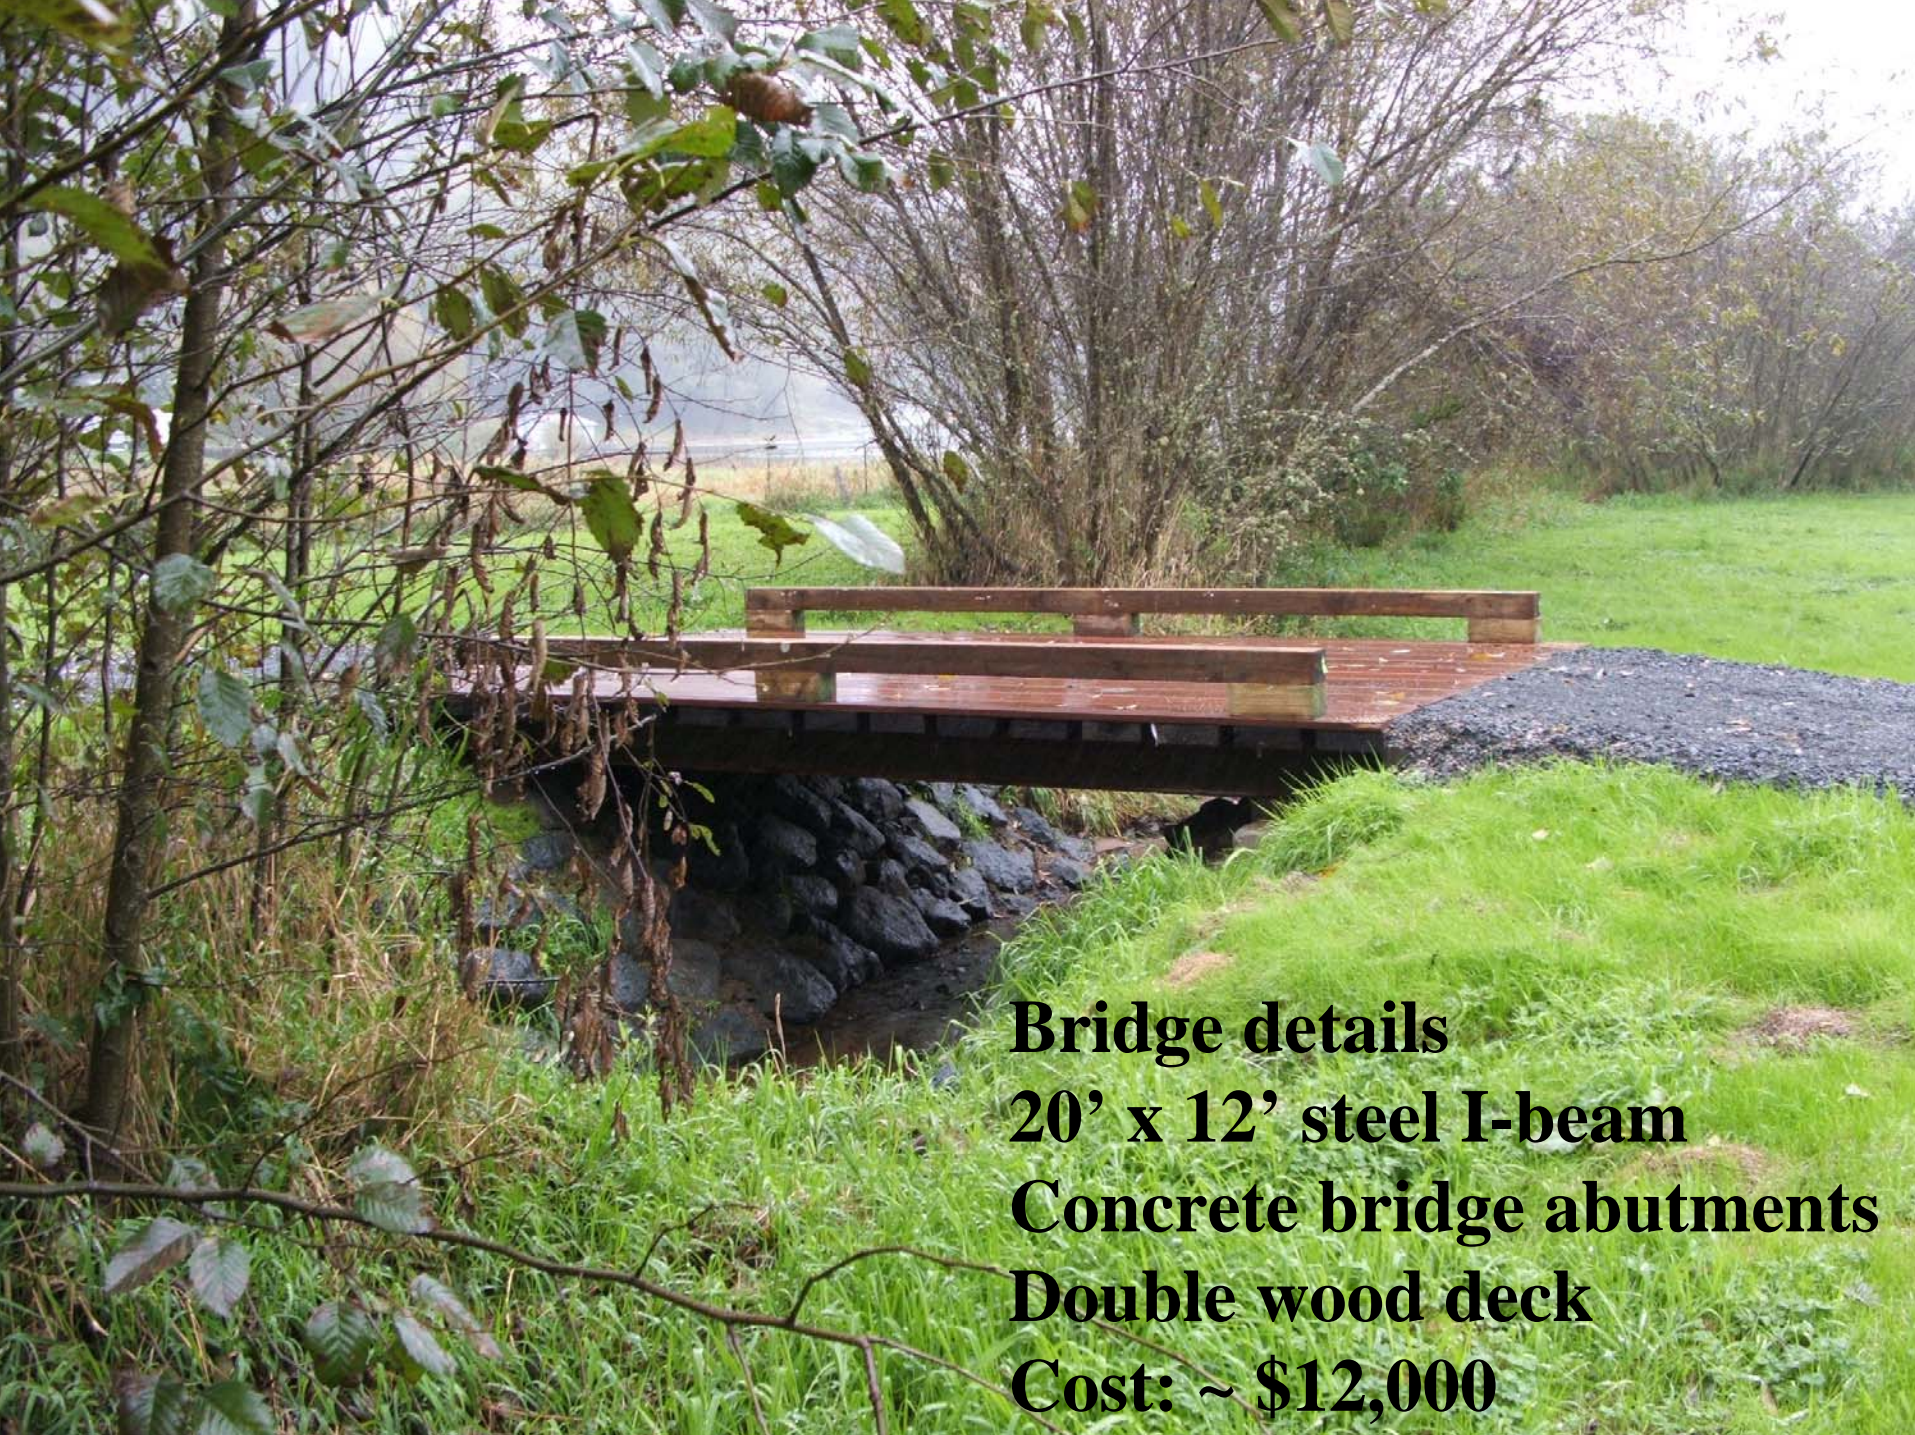
Bridge details

20' x 12' steel I-beam

Concrete bridge abutments

Double wood deck

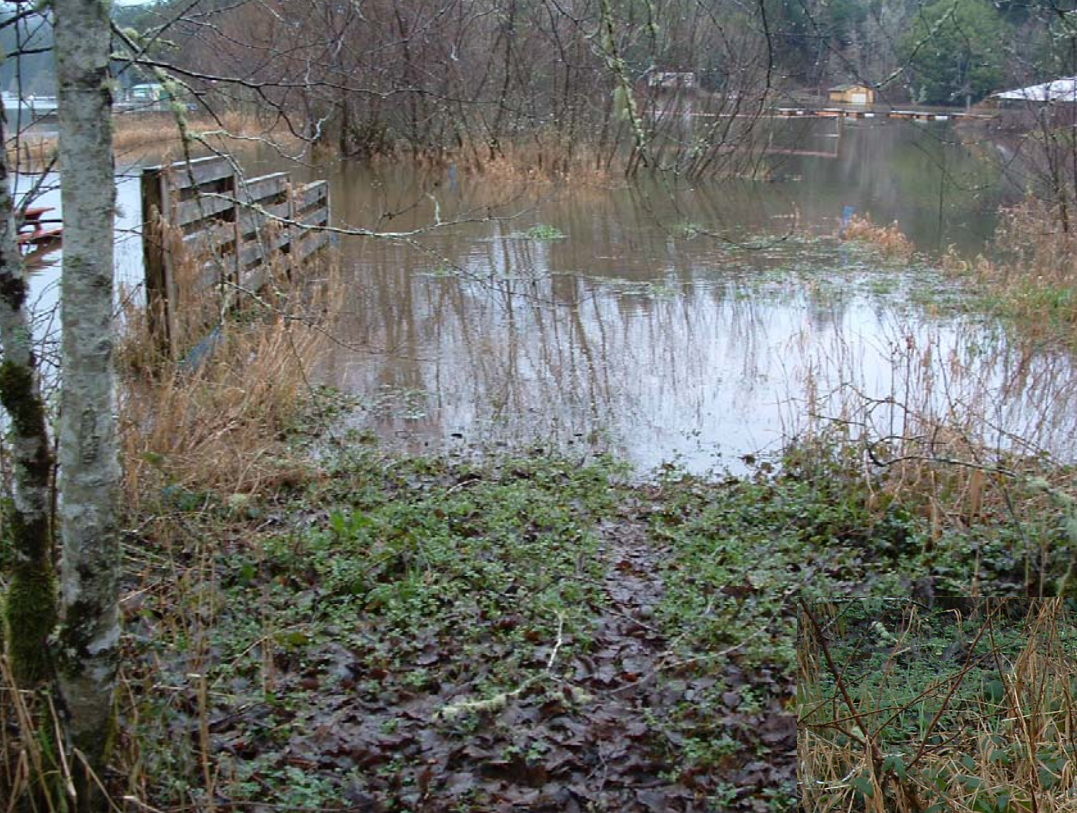
Sunlake Marina culvert excavation

PROBLEMS FOUND

Chronic sediment source

Undersized culvert

Complex work area

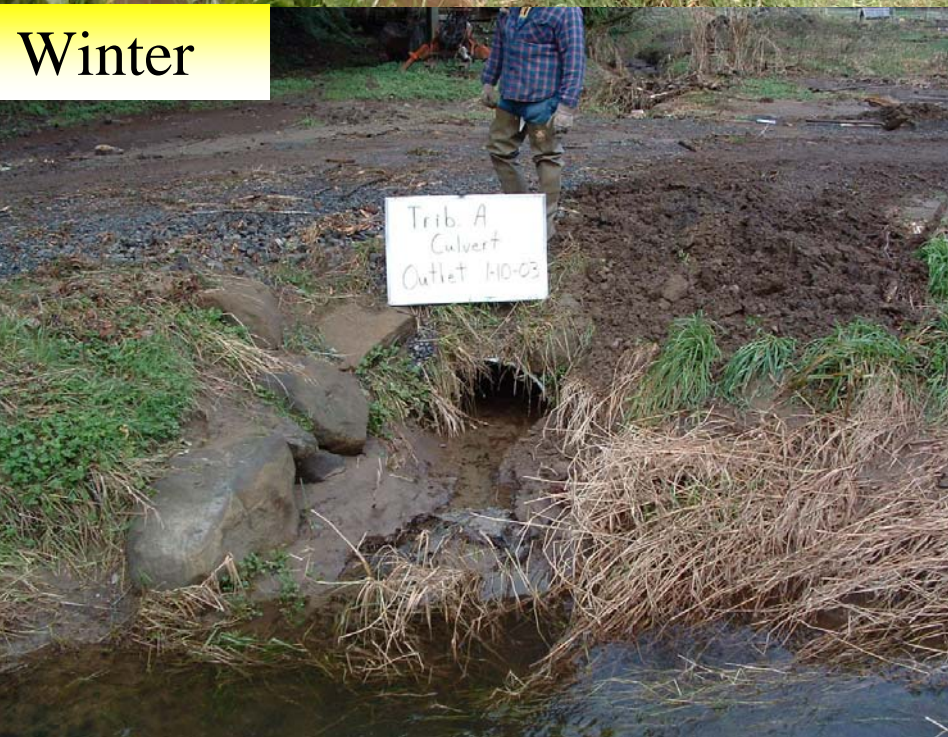
Problems Found:

- Chronic sediment source
- Fish passage issue
- Failed and settling culvert
- High complex work area
- Utilities

Recommendations:

- Remove failed culvert
- Replace with steel I-beam bridge

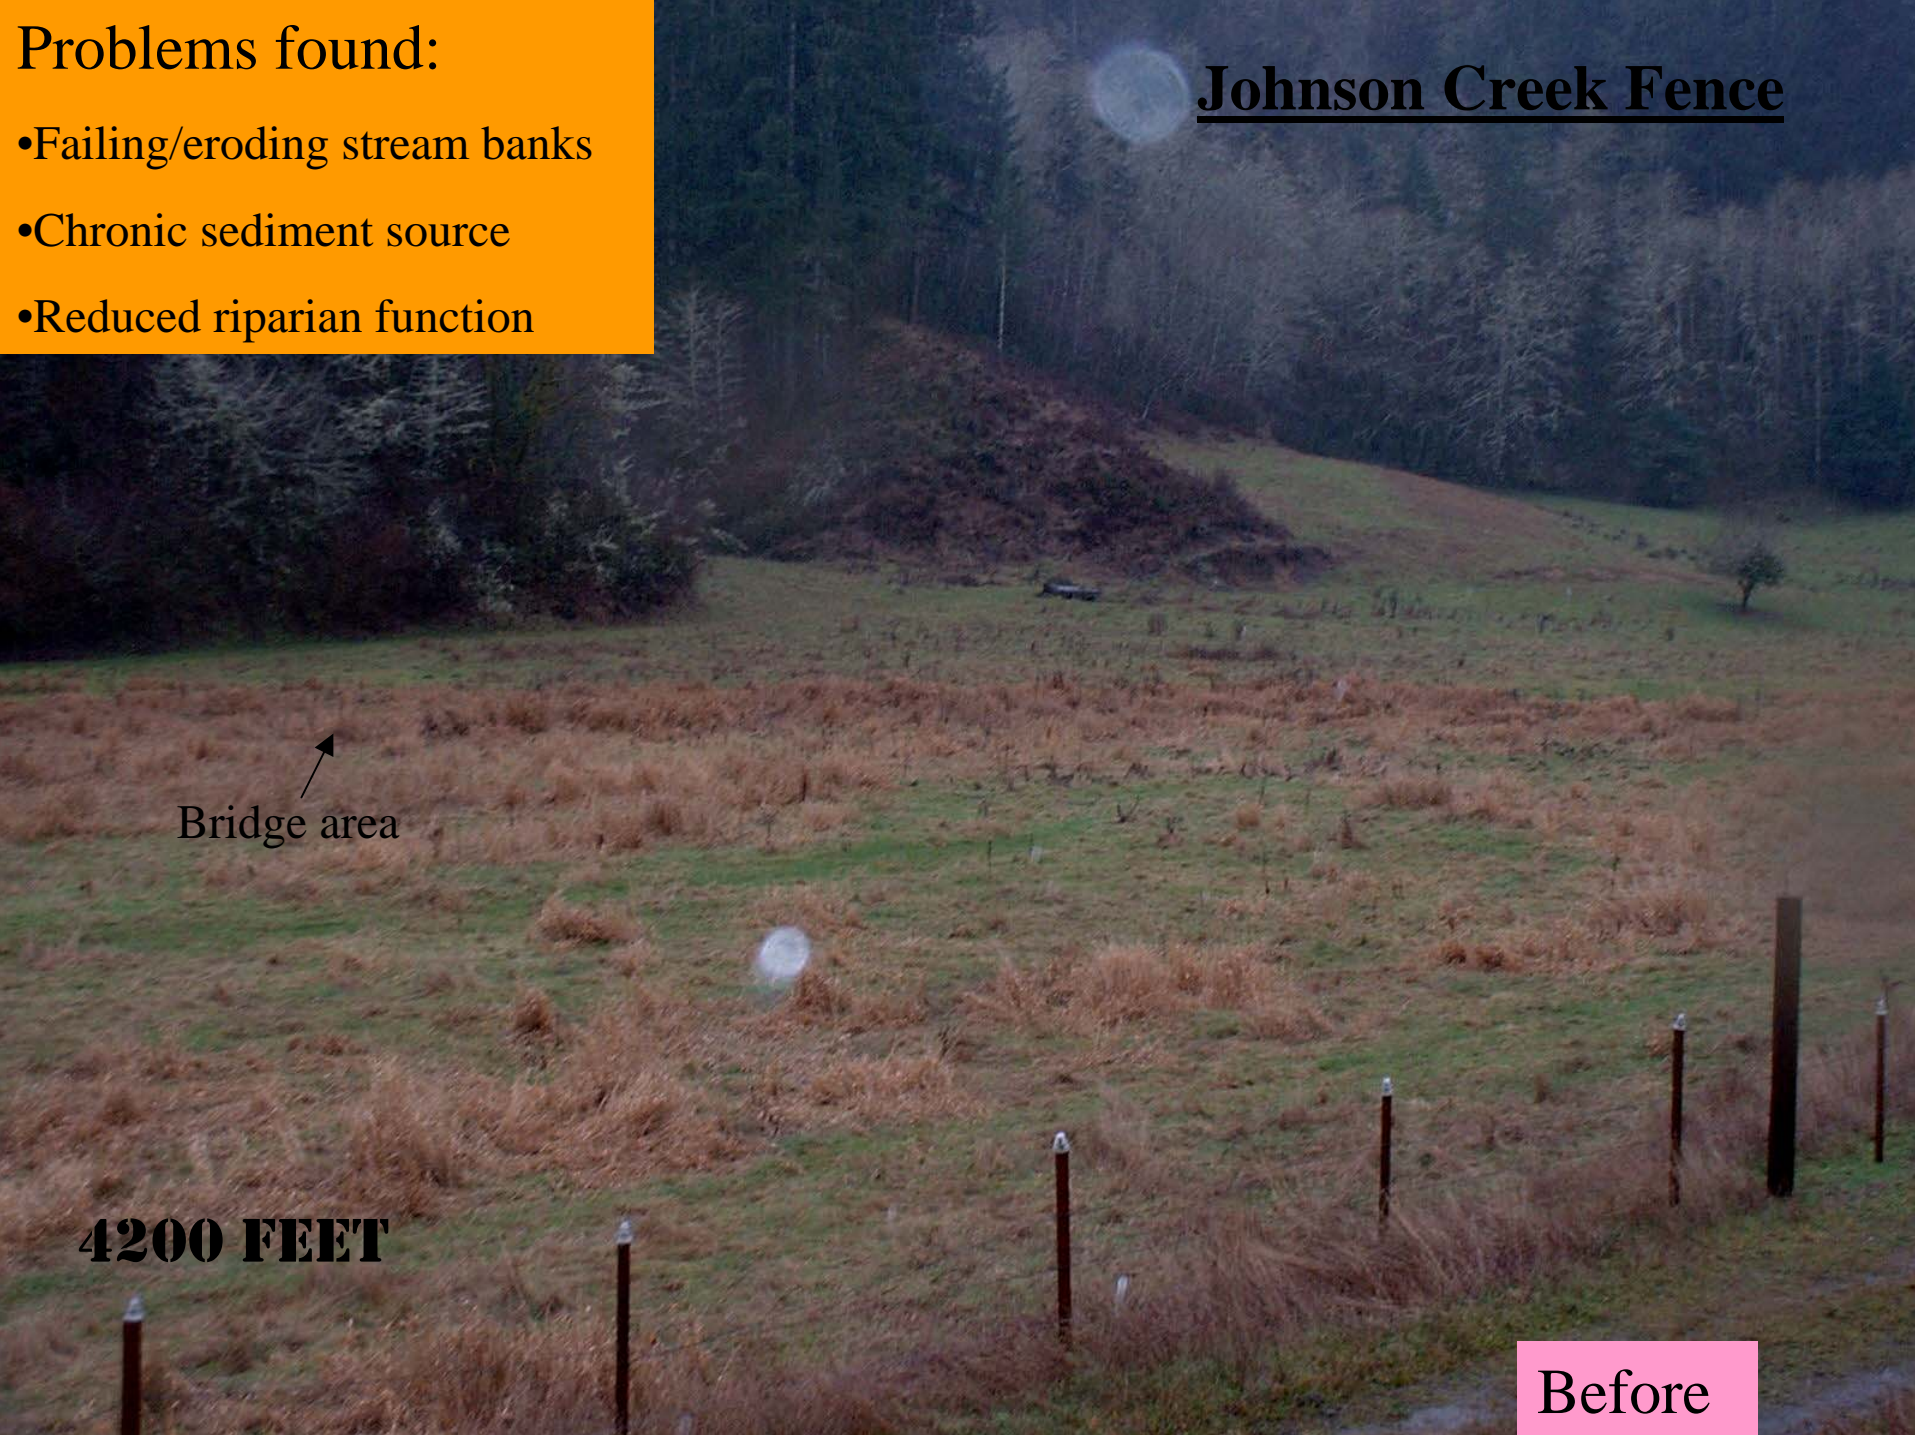
Johnson Creek Fence

- Problems found:
- Failing/eroding stream banks
 - Chronic sediment source
 - Reduced riparian function

Recommendations:

- Construct exclusion fence
- Increase riparian function

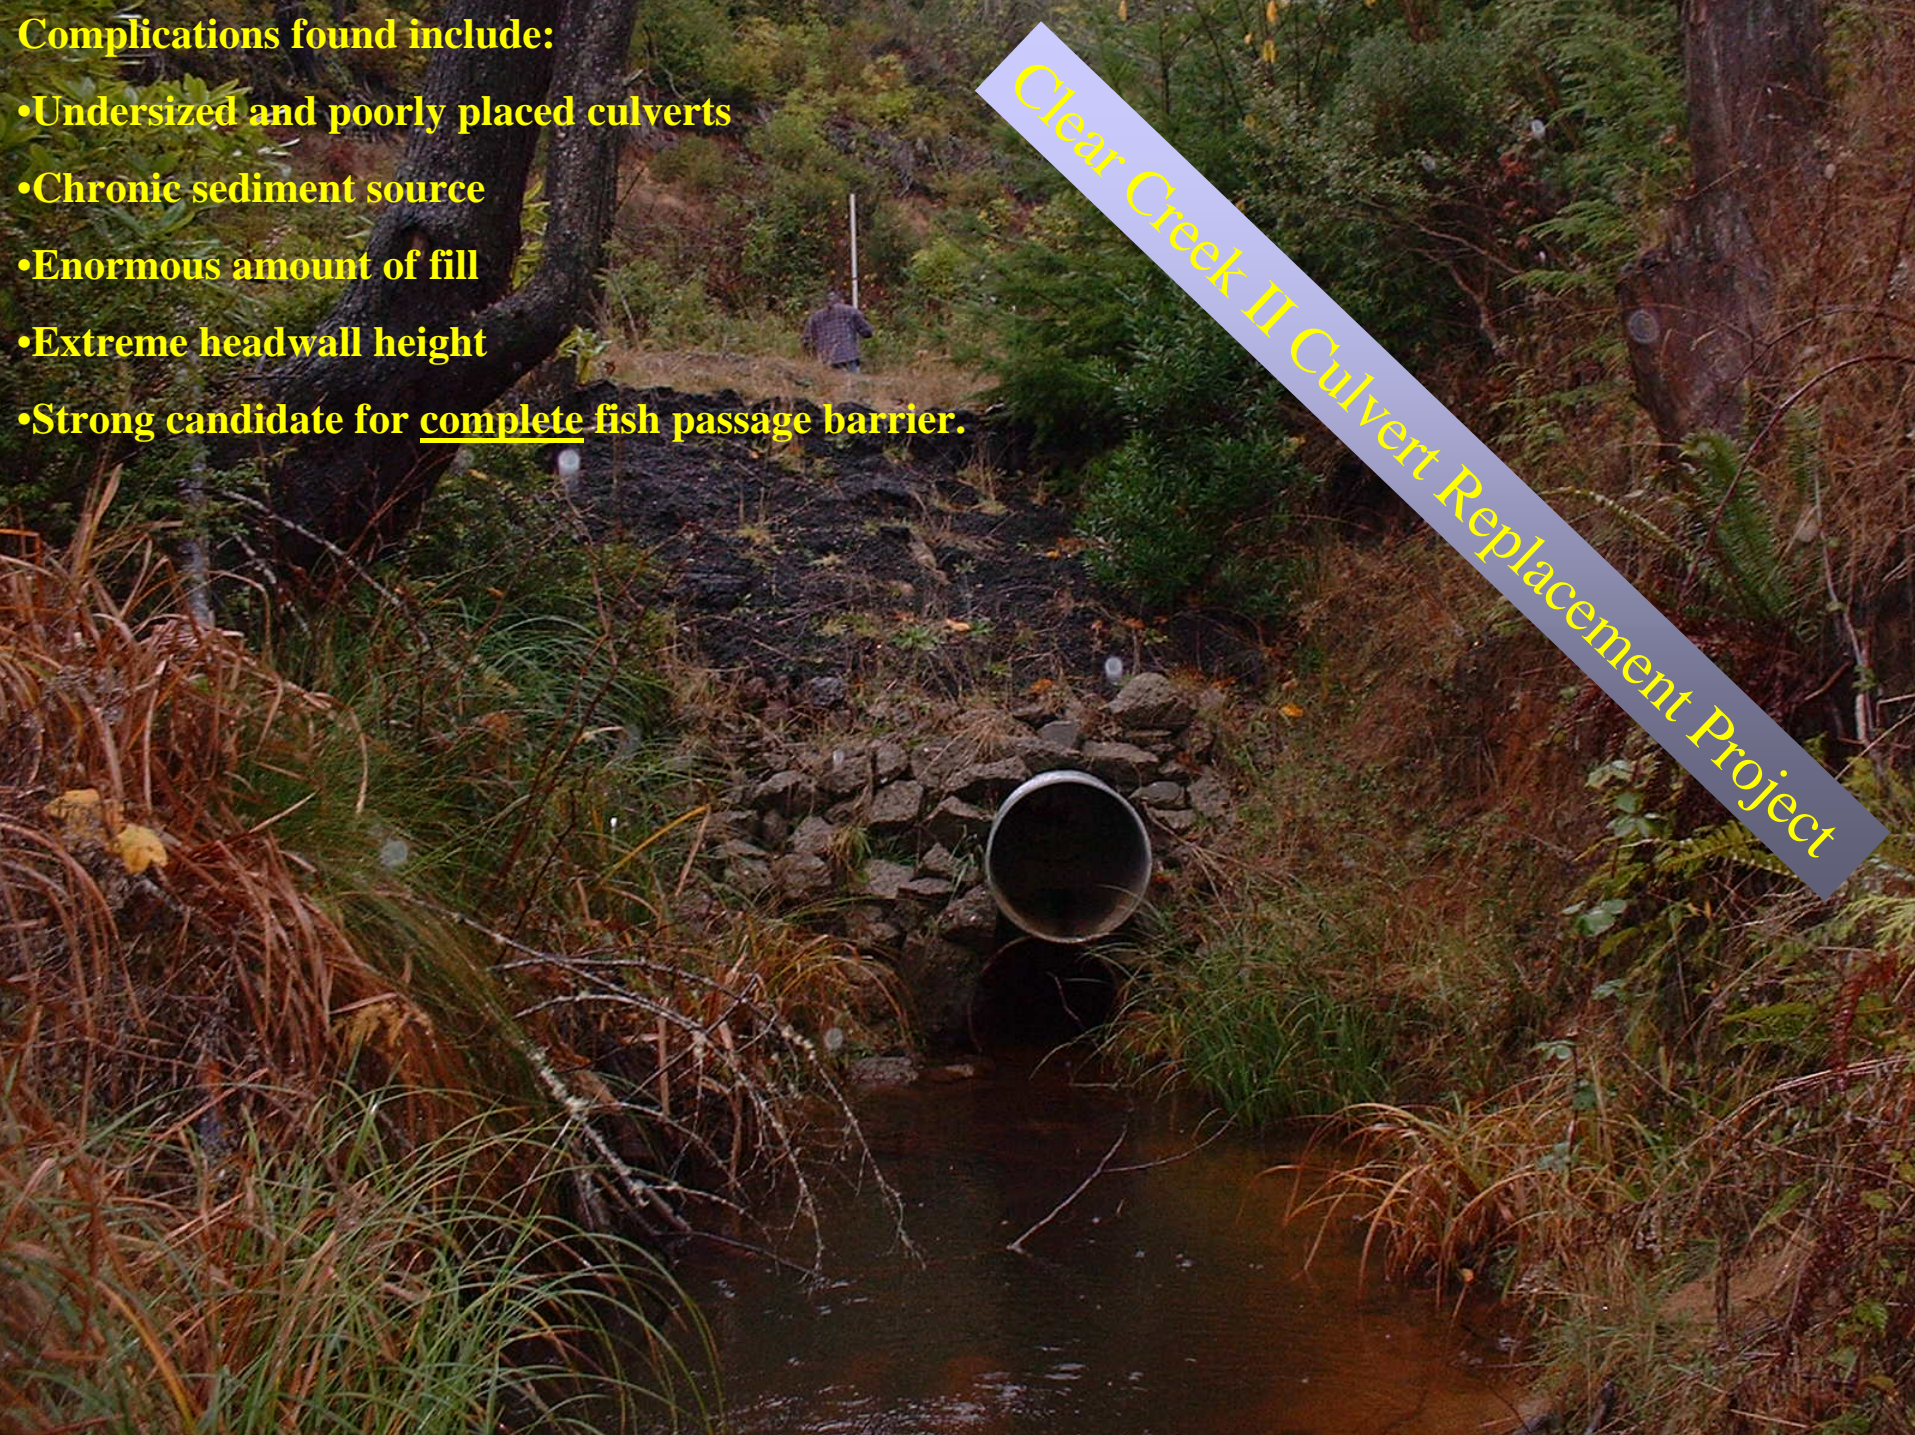
Clear Creek II Culvert Replacement Project

Complications found include:

- **Undersized and poorly placed culverts**
- **Chronic sediment source**
- **Enormous amount of fill**
- **Extreme headwall height**
- **Strong candidate for complete fish passage barrier.**

Excavated Fill at this site involved
over 800 Yards

Solutions

- Remove both failed 24" x 60' culverts
- Replace with one 96" x 50' culvert

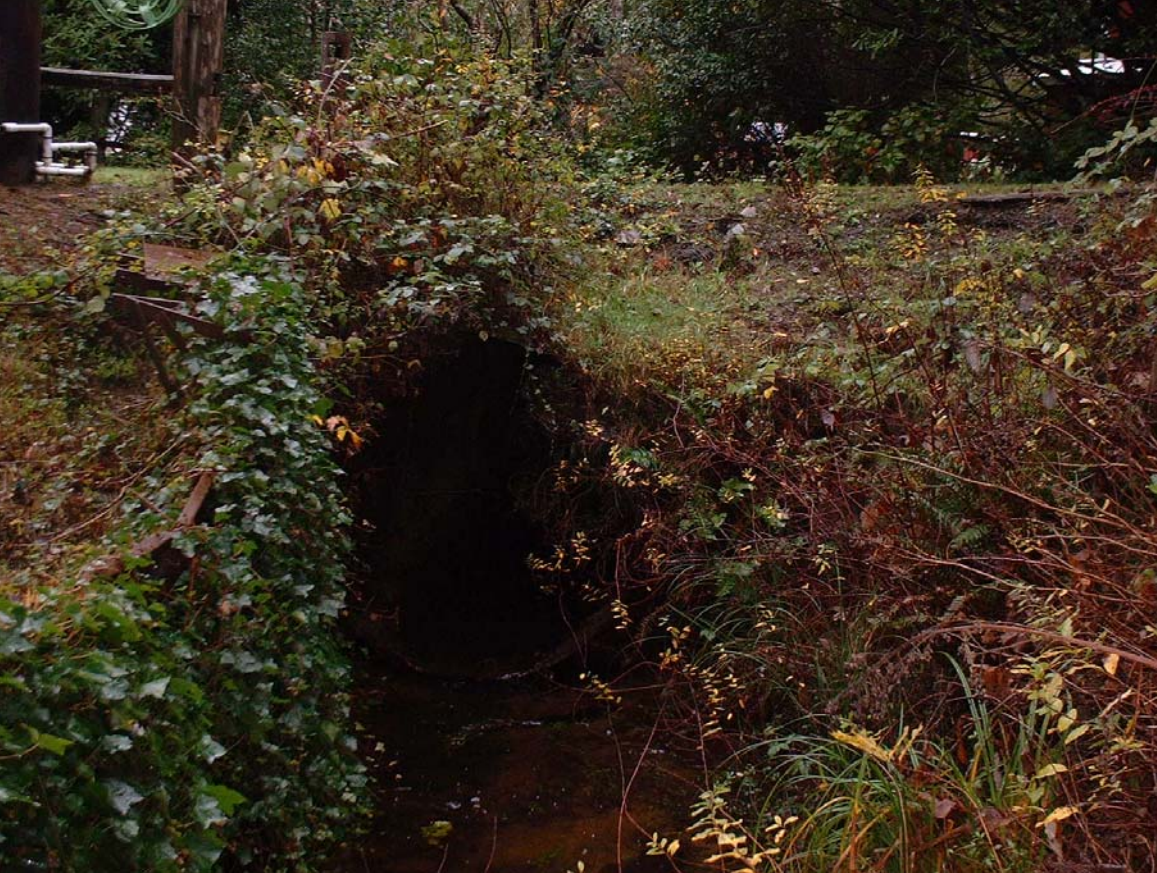
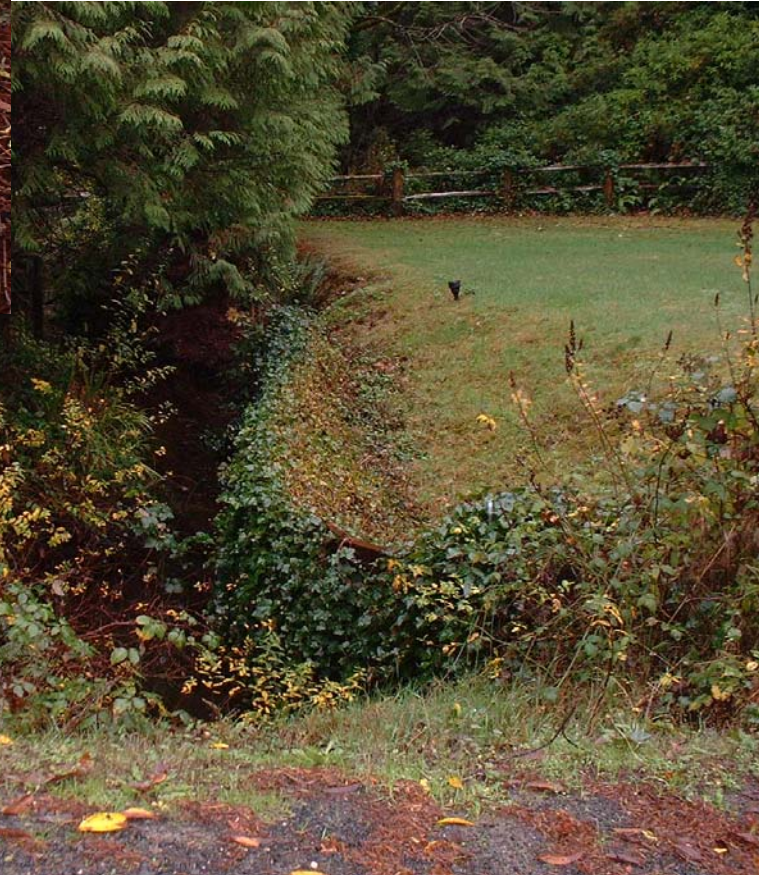
Clear Creek III Culvert Replacement Project

Problems found-

- Failed 60" x 24' culvert
- Chronic sediment source
- Failing retaining wall
- Very complex working environment
- Partial fish passage issue
- Buried utilities

Project Fixes Include

- Removing 60" x 24' failed culvert
- Replacing with 72" x 30' culvert w/ improved placement

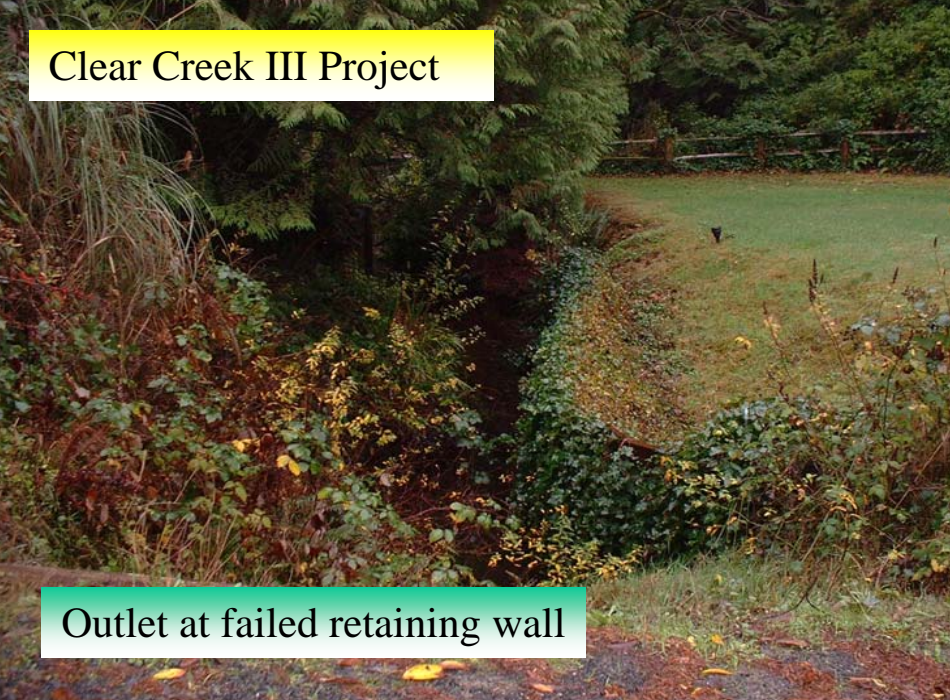
Outlet at failed retaining wall

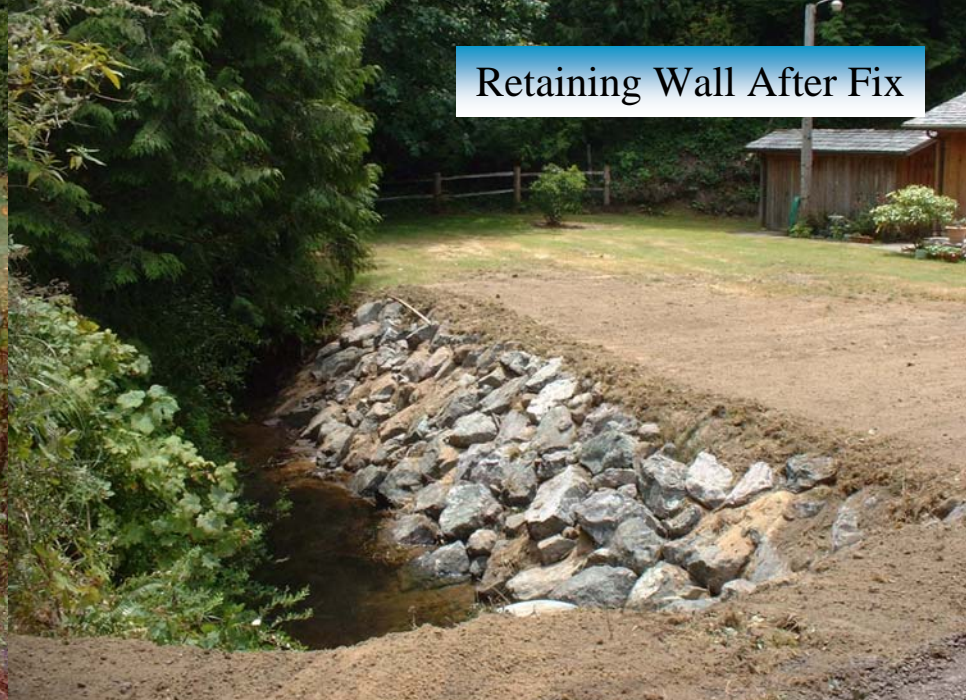
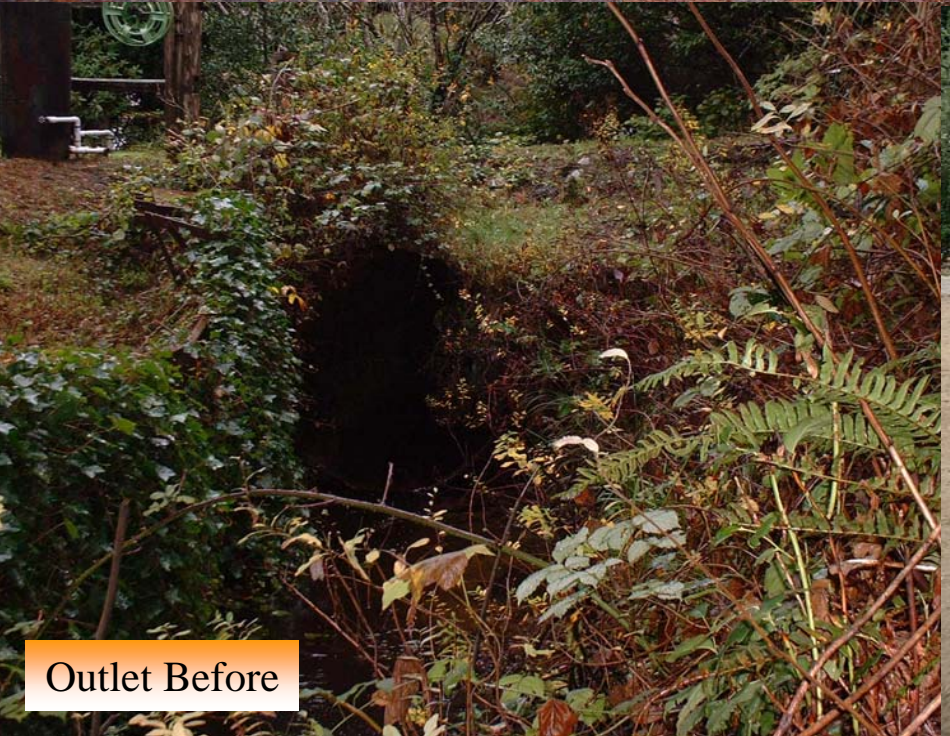
Retaining Wall After Fix

Outlet Before

Outlet after Fix

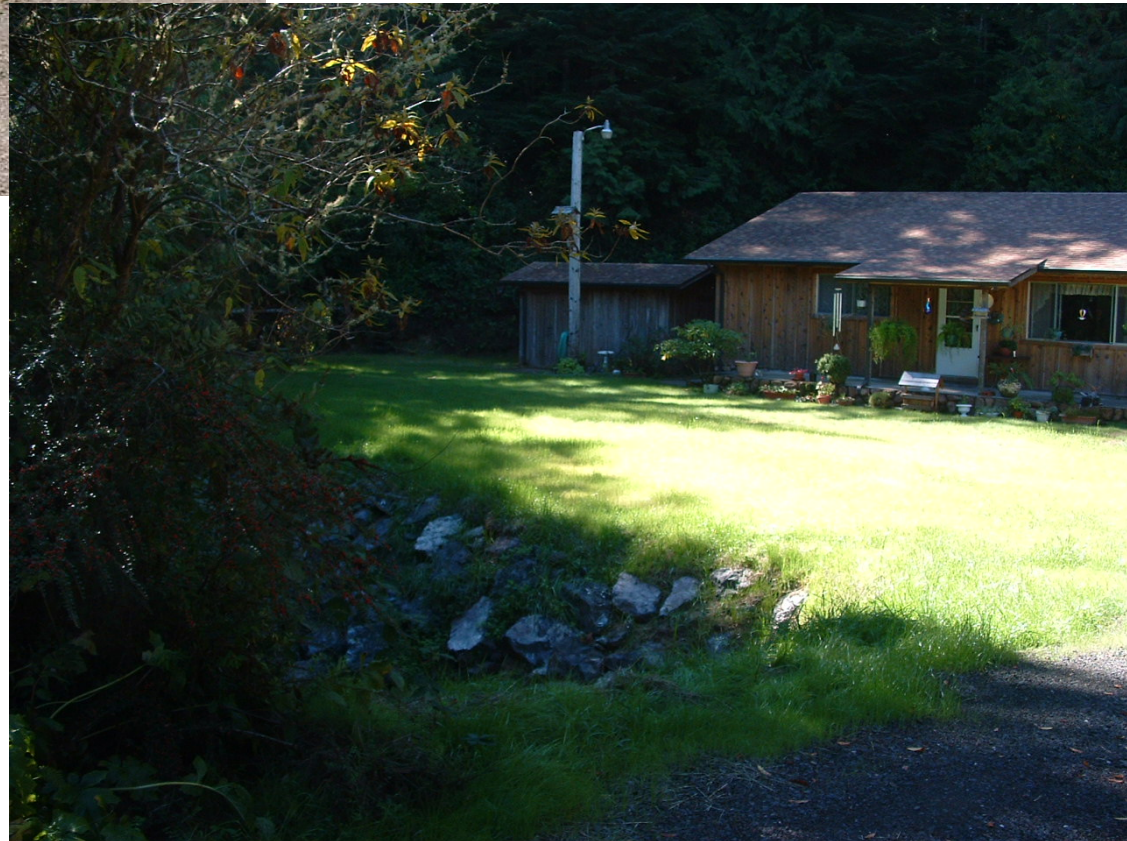
Project site after culvert fix.

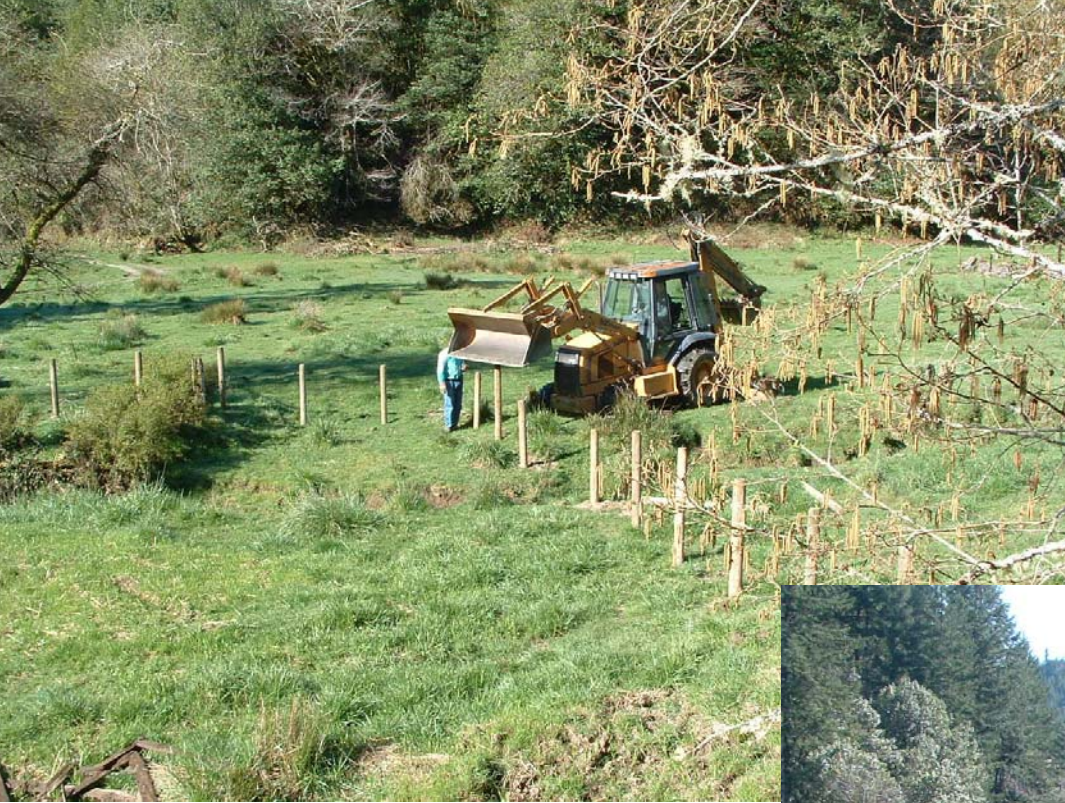
Historic ways of sinking posts

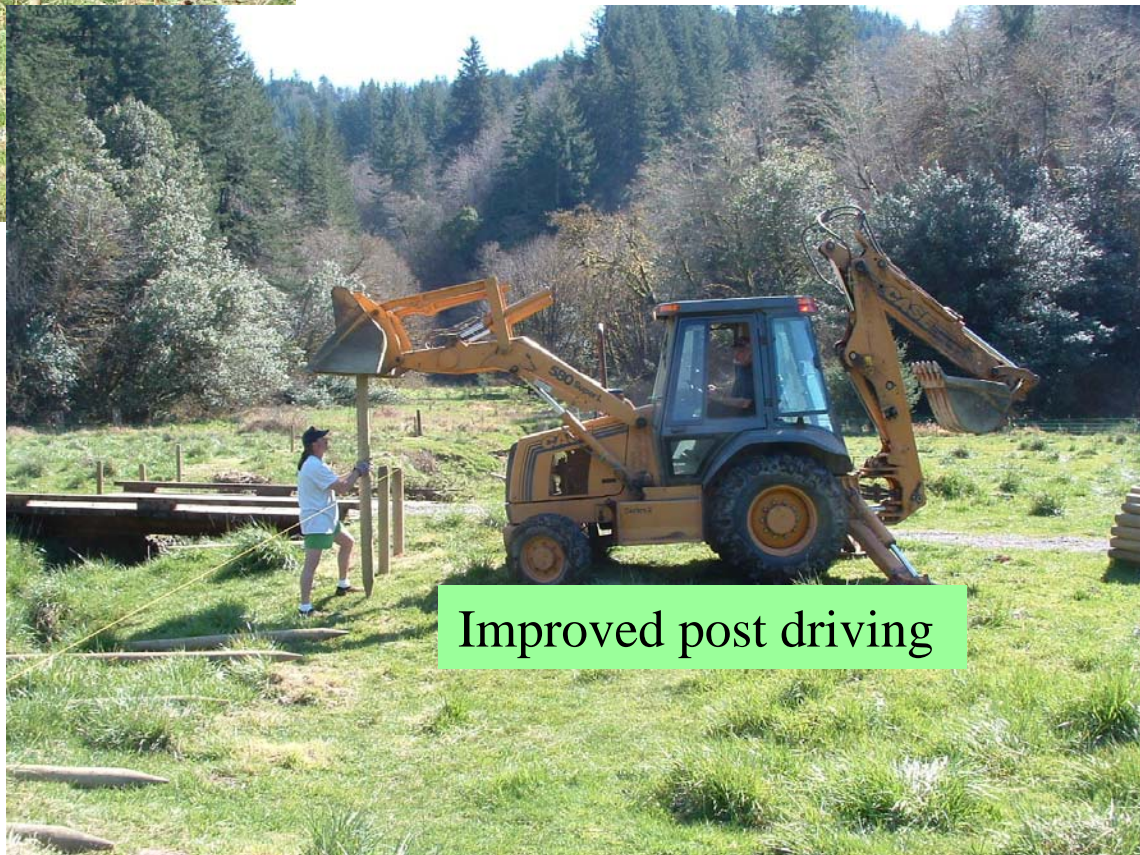
Improved post driving
